Appendix 3 Individual RoW Descriptions

List of RoW Locations Visited			
KP	River / Location	Team	Date Visited
96	NOB-17	Northern	28/9/2011
109	NOB-19	Northern	28/9/2011
22.7	Khandusa River	Northern	29/9/2011
14	Sandy slopes / fault crossing #1	Northern	29/9/2011
36 – 38.3	Access route to Askasi River	Northern	29/9/2011
62	Dagi River	Northern	29/9/2011
67	Tomi River	Northern	29/9/2011

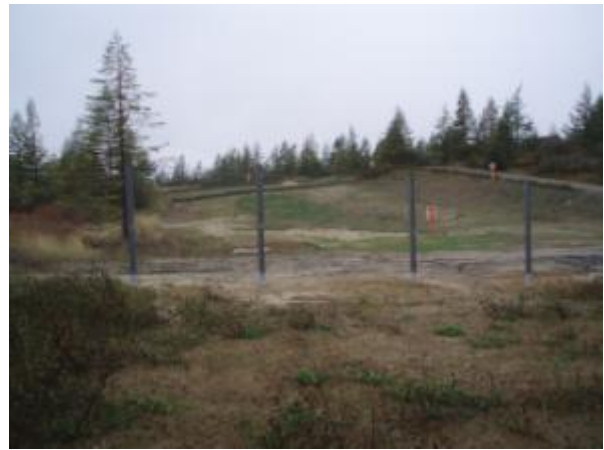
The RoW adjacent to fault crossing was showing patchy/moderate signs of re-vegetation and slope breakers protected with coco matting were in evidence (see Photo 2).

Photo 2 – RoW showing moderate revegetation and slope breakers

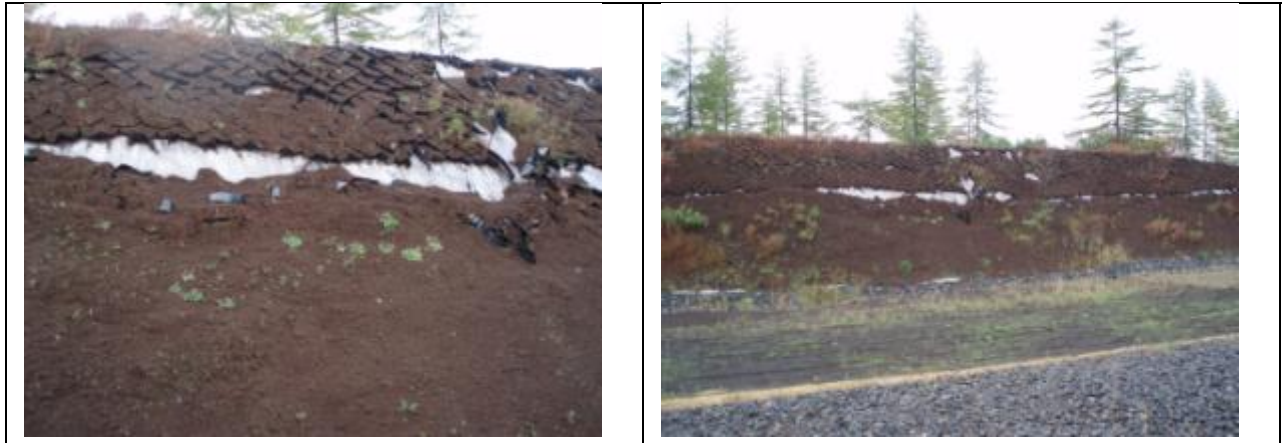
The fault crossing area is fenced off and was found to be in tidy condition, with the running track and drainage controls in generally good condition (see Photo 1). However, some of the side cuts at the edge of the fault crossing were seen to be failing and are in need of both redesign and repair (see Photos 3 and 4).

Photo 3 – Failing side cut

Photo 4 – Failing side cut

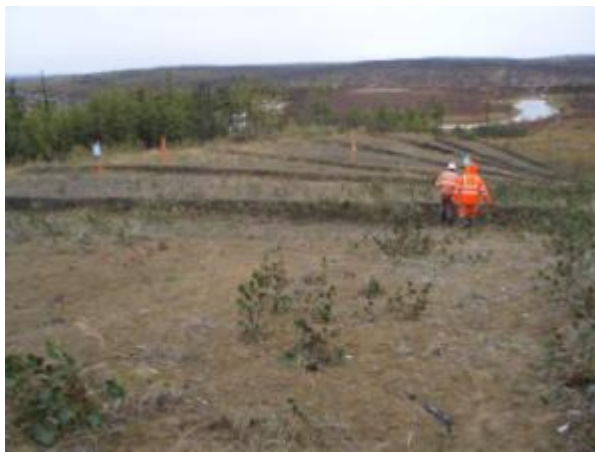
Vegetation at the top of the hill is sparse (Photo 1), although at this site there is no evidence of erosion features forming and the slope breakers are in place and in good condition (Photo 1). The vegetation growth improves further down the hill and is good in the river valley area where there is more peat and organic matter in the soil (Photo 2).

Photo 2 – Good vegetation in river valley

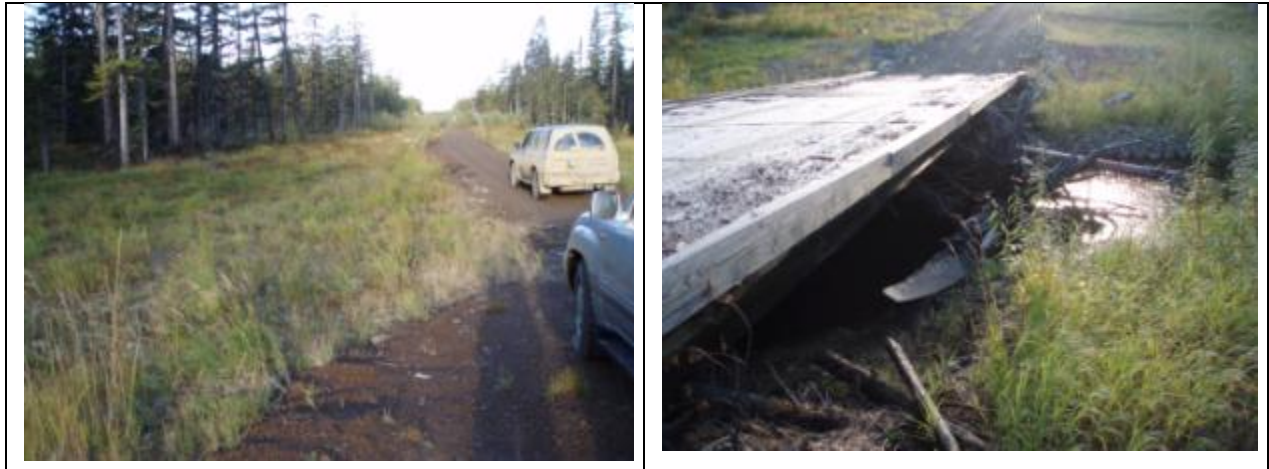
The RoW was generally seen to be re-vegetating well (Photo 1), although in places tree growth was evident that will need to be controlled. Although the access road is in good condition and well maintained, visual inspection in the peat bog areas indicates apparent interference of the groundwater and surface water flows across the access road whereby the southern side is noticeably drier than the northern. The adequacy of cross drainage (e.g. culverts) under the access road will require future monitoring.

The bridge placed over the Orkunie river to allow permanent access to NOB-24 is in generally good condition. However, it was noted that there is no silt protection either on the running area of the bridge or on the parapets which, combined with the open slats between the wood, has the potential to lead to material dropping into the river during vehicle transit. It is recommended that geotextile is placed on the bridge and a form of silt fencing lining the edges (see Photo 2). In addition some debris trapped under the bridge requires removal (Photo 2).

Photo 1 – South road RoW vegetation	Photo 2 – Bridge over R Orkunie
-------------------------------------	---------------------------------

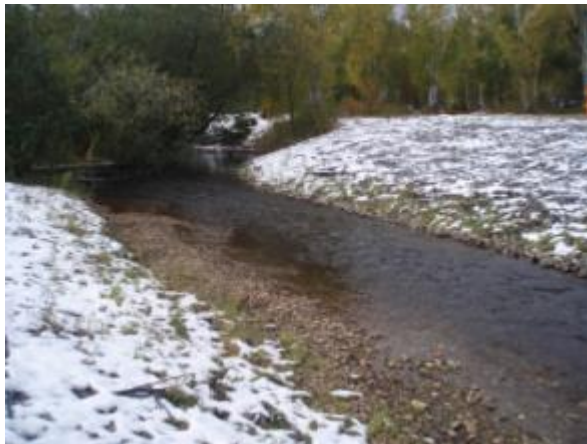
The RoW is showing sparse to moderate vegetation growth in the low lying areas (Photos 2 and 3) and this will require some attention in the form of continued fertilisation to ensure improved growth over the next few growing seasons.

Photo 2 – Moderate/sparse vegetation growth on the RoW

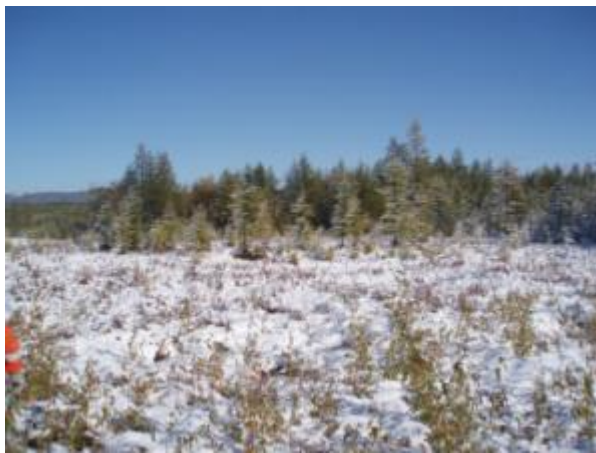
Heavy snow coverage made visual inspection of the RoW into the river difficult, but significant re-vegetation was identified (Photo 1). However, this include tree growth, including some very tall growth that had evidently taken multiple seasons to grow and which is in urgent need of control (Photo 2).

Photo 2 – Significant tree growth on RoW

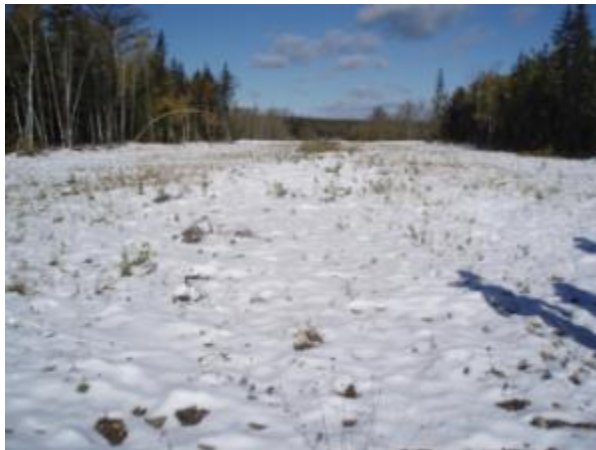
Photo 2 – Slope breaker in good condition

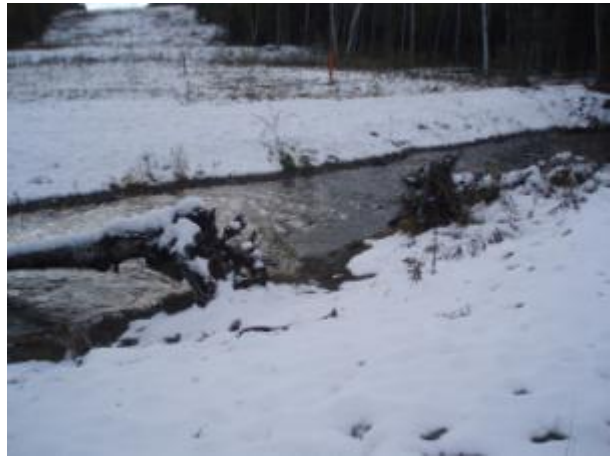
Photo 4 – Riverbank in good condition

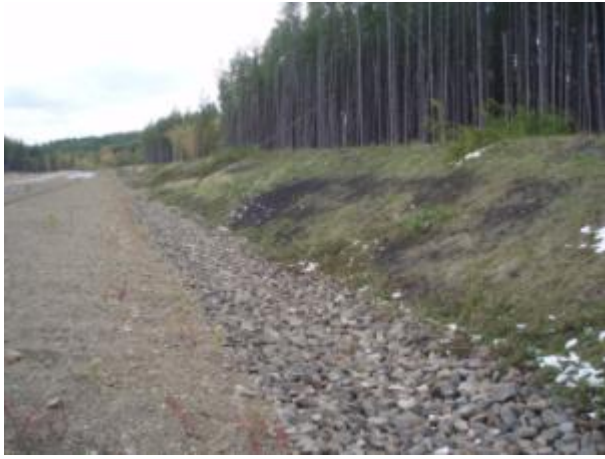
The fault crossing area was found to be in generally good condition, including the running tracking and drainage controls (Photo 2). The side cuts are thought to have previously been hydro-seeded, and evidence of old and new vegetation was noted (Photo 1).

Photo 2 – General view of fault crossing

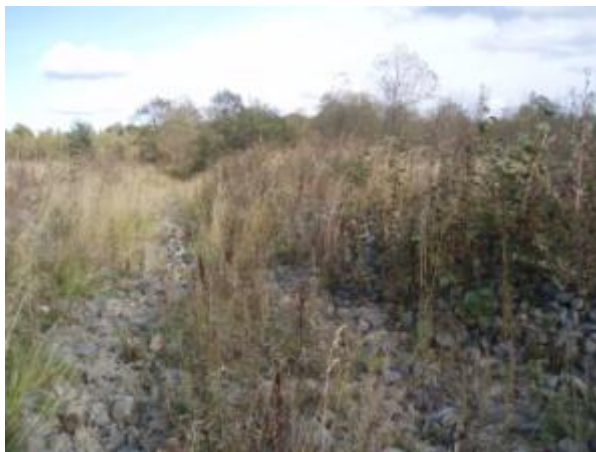
Good re-vegetation was identified on the northern approach to the river (Photo 5) except very close to the river.

Photo 5 – Re-vegetation on RoW

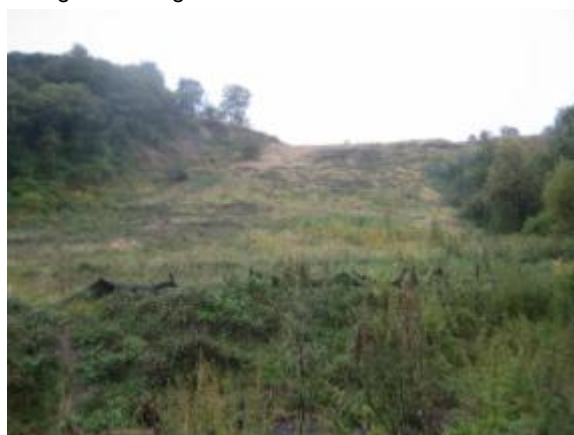
Photo 6 – View of a RoW slope north of the Nitui with good re-vegetation

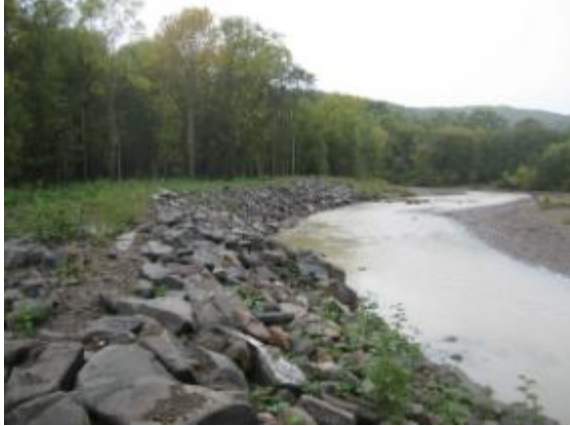
Since then, the upstream bank was fortified with heavy riprap (Photo 1) and a fortified overflow channel was constructed across the RoW (Photo 2). Since the visit in June 2010 additional work was conducted on the upstream meander and the bank fortification was extended further east towards the river crossing.

Photo 2 – View of the overflow channel

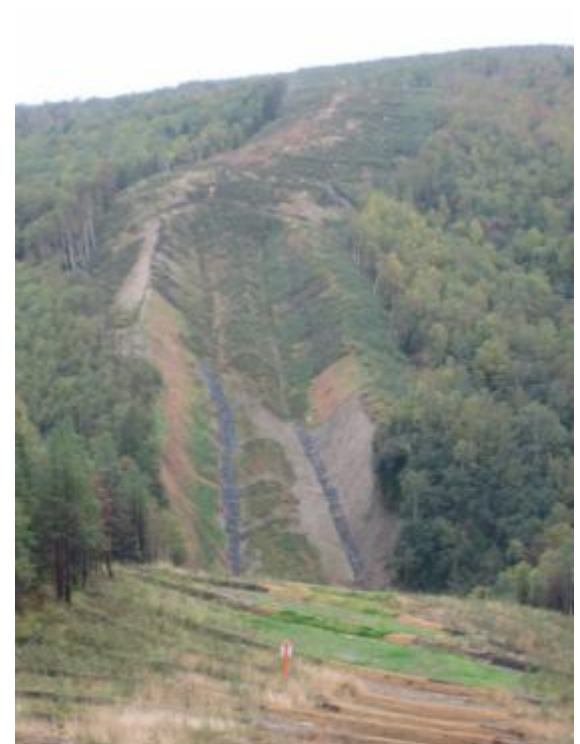
The Gar River slopes were observed from the north Slope only due to weather concerns and access road condition. The Gar crossing was damaged during the 2009 typhoon season but has since been repaired. The north Slope appeared to be in good condition and reportedly the river crossing itself held well during the last spring and summer. The slope was well vegetated with grass and saplings and access track from the last repair activity had been protected with fortified and reseeded slope breakers (Photo 1). On some of the slope breakers there is already good evidence of re-vegetation. The southern slope was also observed (short of the very bottom portion) and appears to hold well in the central and upper portions. A recent daily report that was provided by SEIC indicates that there was a slope movement on the oil and the gas pipe trenches at the lowest most part of the southern slope and that it was repaired. The southern slope is only partially vegetated and there is a need to continue seeding slope and seeding and protecting the side cuts (Photo 2).

Photo 2 – View to the south showing a partially vegetated south slope. The slope is covered in green vegetation and brown soil, with a road visible in the foreground.

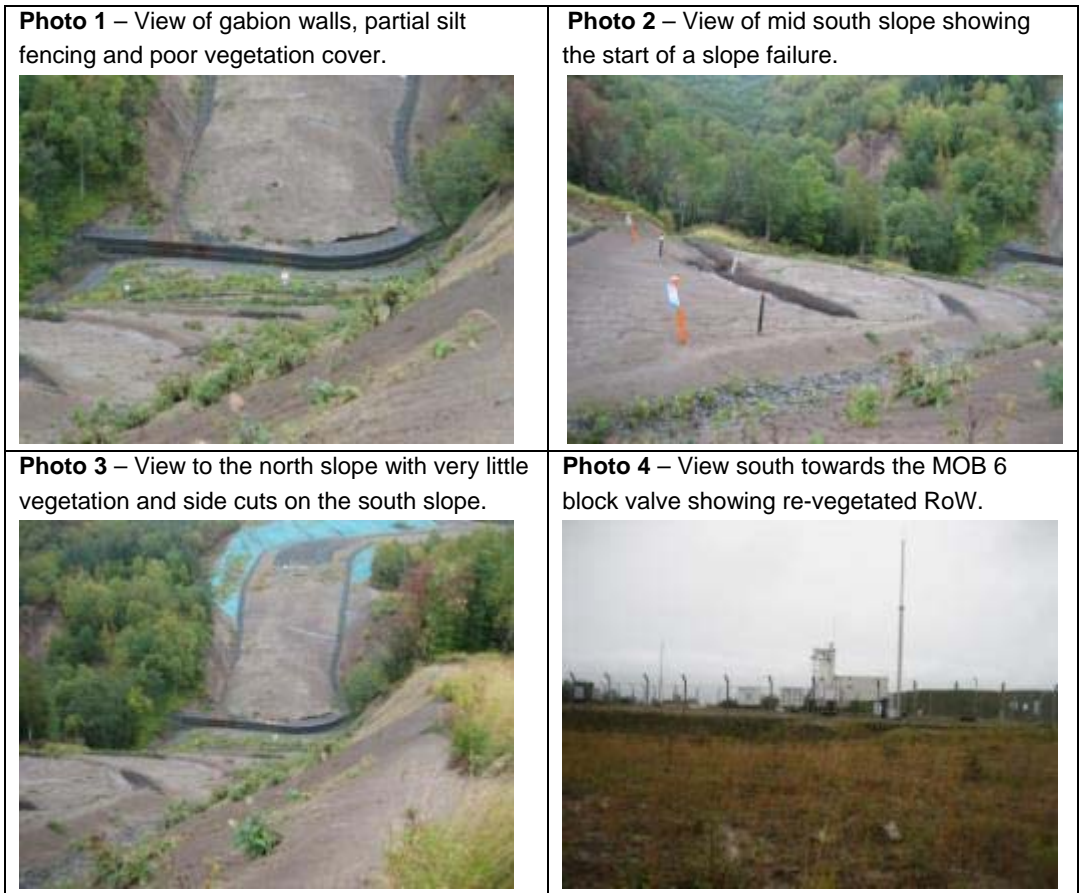
The Kormovaya River crossing was observed from the southern slope. The crossing appears to be holding well and the banks are protected by gabion walls (Photo 1). The silt fencing above the gabion walls on both banks is in urgent need or repair/replacement due to slopes almost devoid of vegetation.

The southern slope is vegetated well at the upper reaches but has almost no vegetation in the steep central and lower portions as well as the side cuts. A significant failure (Photo 2 and 3) at the central section of the south slope has not been repaired since last year's visit but it hadn't visibly moved since then. Reportedly, it is on the repair list.

The northern slope is also almost devoid of vegetation almost to the top (Photo 3). Both slopes are in urgent need of further bio-restoration. The upper part of the south slope and the RoW to the top where the MOB 6 block valve is situated is well vegetated (Photo 4

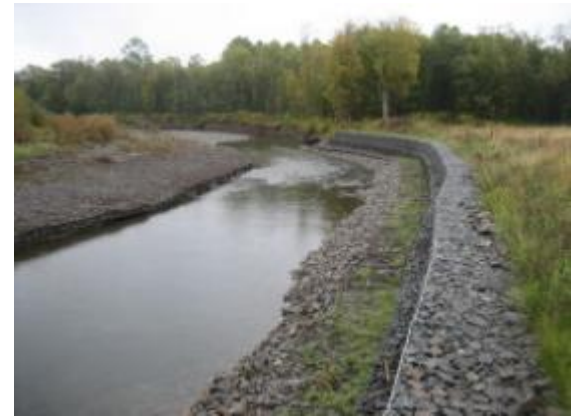
The RoW on each side of the river is densely vegetated (Photos 3 and 4). The south slope was repaired since last year's visit and shows repair surface and improved drainage control (Photo 3).

Photo 3 – View of slope showing repaired slope and well vegetated RoW.

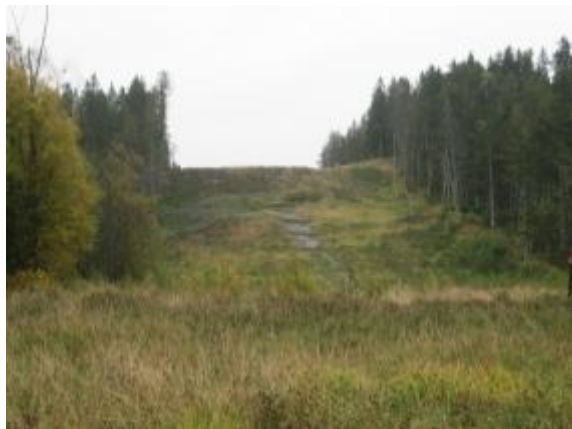
Photo 4 – View north showing well vegetated RoW.

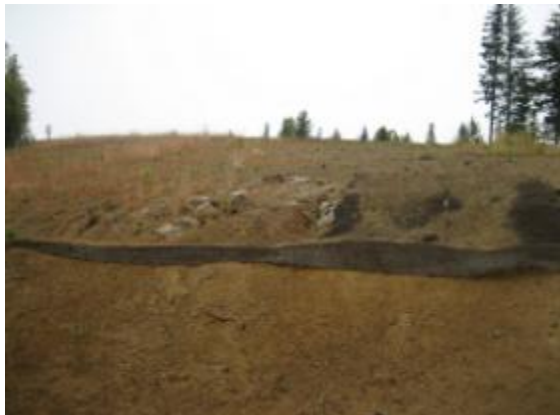
Photo 4 – View of a slope with very sparse vegetation
