**KP 370.2 Lasnaya 1 River**

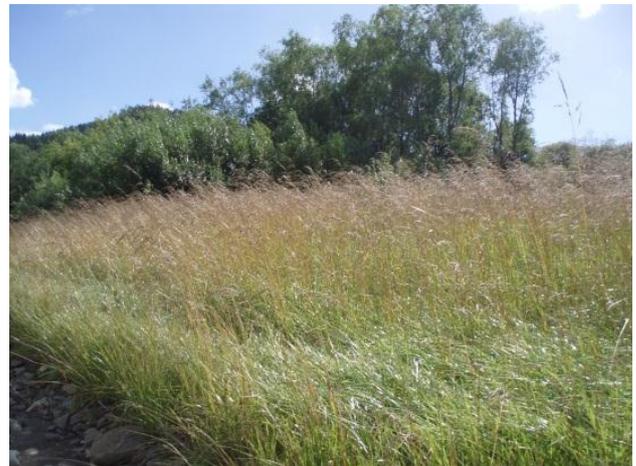
The Lasnaya 1 River crossing is protected by Reno mattings and a gabion wall on the north bank (Photo 1). The south bank consists of natural river gravel deposits on top of Reno matting. The RoW on both sides is densely vegetated (some tree saplings are appearing that need to be removed). An armoured drainage ditch within the gabion wall appears to be functioning well (Photo 3).

**Photo 2** – View of dense vegetation on southern bank.

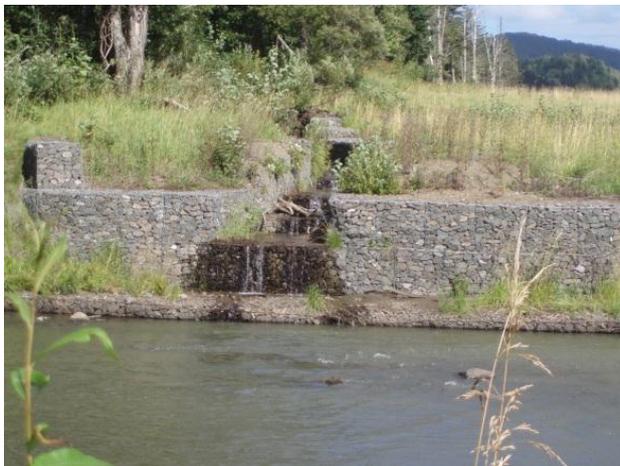
**Photo 3** – View of Drainage ditch with northern bank gabion wall.

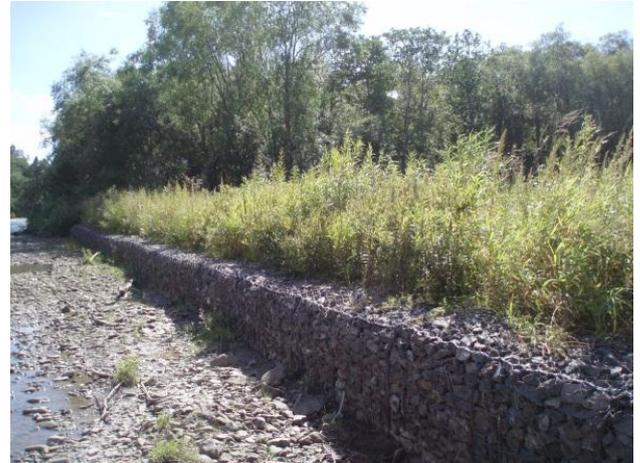
**Photo 2** – View of southern bank gabion walls.

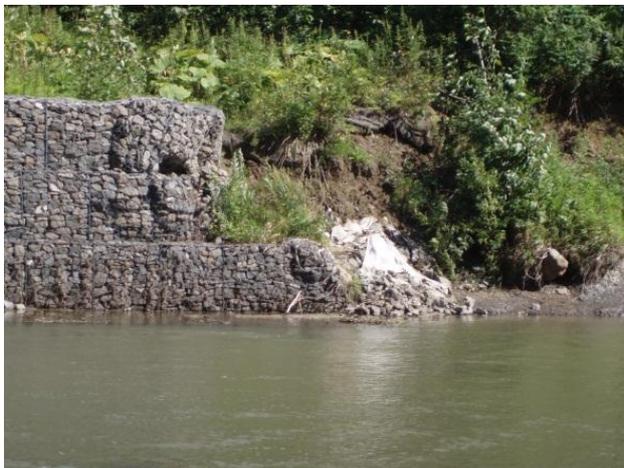
The Lasnaya 2 River crossing is protected by Reno mattings and a gabion wall on both banks (Photos 1 and 2). Some erosion and damage to the gabion wall was visible at either end of the northern bank gabion wall (Photo 3).

**Photo 3** – Erosion and gabion damage on the northern bank

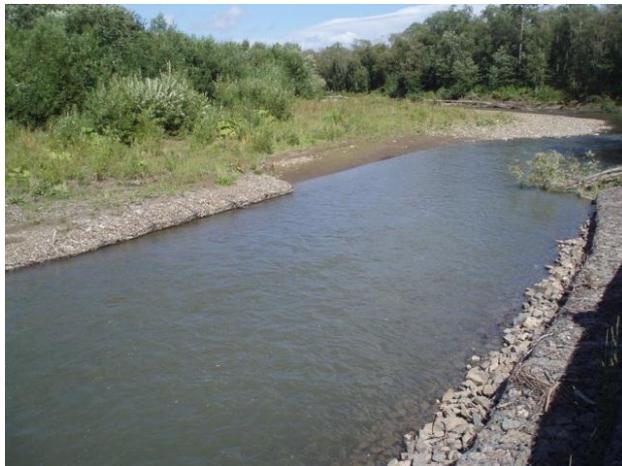
The river crossing is protected by gabions on the south bank and Reno matting on the north bank (Photo 1). The placement of the reno matting on the northern bank has noticeably narrowed the river compared to the river width up- and down-stream (Photo 1), and this is leading to some under-cutting of the matting. Erosion of the upstream southern bank has occurred but this is protected by good size riprap at present (Photo 2).

**Photo 1** – View downstream showing Reno matting on the north bank and gabions on the south bank. Visible narrowing of the river is seen on the northern bank.

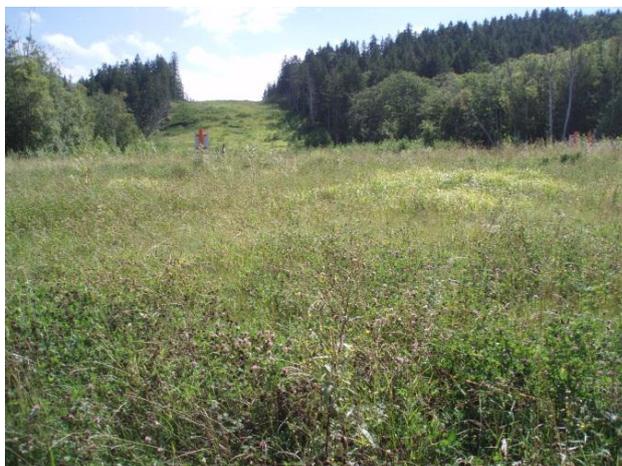
**Photo 3** – View of RoW to south with good re-vegetation.

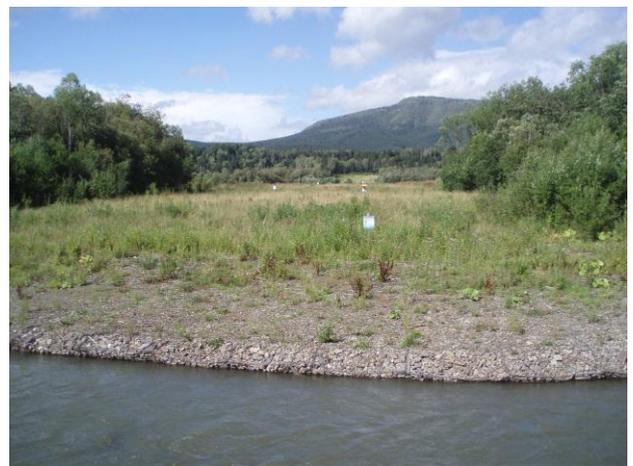
**Photo 4** – View north showing well vegetated RoW.

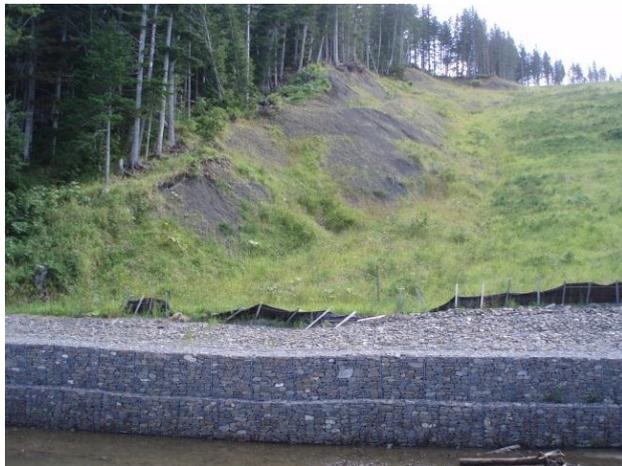
The RoW on the north side of the crossing has good vegetation cover (Photo 2). The south slope is also well vegetated but with partially bare side cuts (Photo 3). The silt fencing on the south side is damage and in need of repair (Photo 3).

**Photo 3** – View south showing the south slope with generally good vegetation cover, but bare side slopes and silt fencing in need of repair.

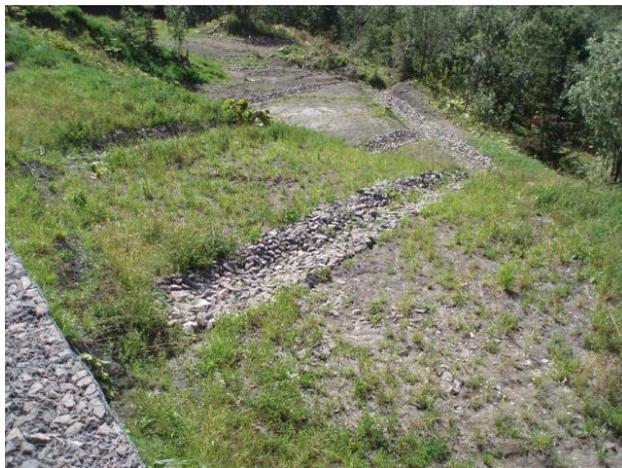
**Photo 2** – View of gabion wall

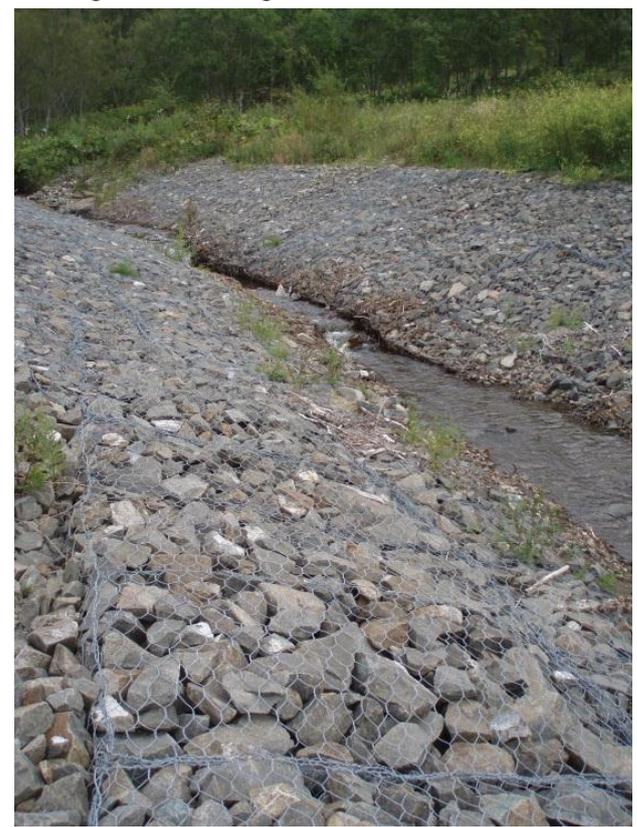
The main channel is protected on both banks by reno matting, but the positioning of these have resulted in a noticeable narrowing of the channel (Photo 2) and this had also resulted in some under-cutting of the reno mats themselves. Also 'steps' in the river bed were evidence at the crossing (Photo 4).

**Photo 2** – Reno matting on the main stream leading to narrowing of the channel.

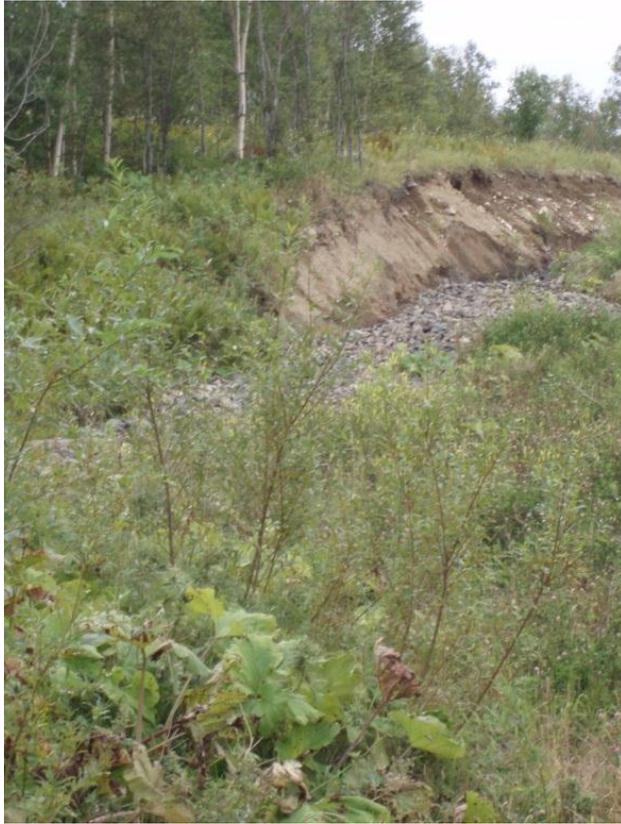
The drainage channel on the eastern side of the south slope to the main channel was partially washed-out and minor collapse of the side cut was evident (Photo 3). This was resulting in minor sediment flow into the river.

**Photo 3** – Erosion of side cut on eastern side of south slope to main channel

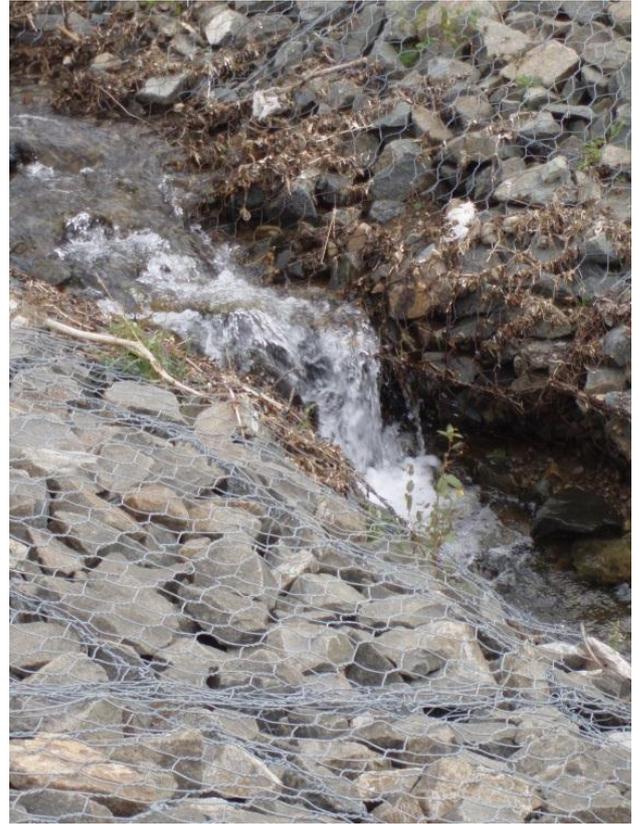
**Photo 4** – ‘Steps’ in the bed of the main channel

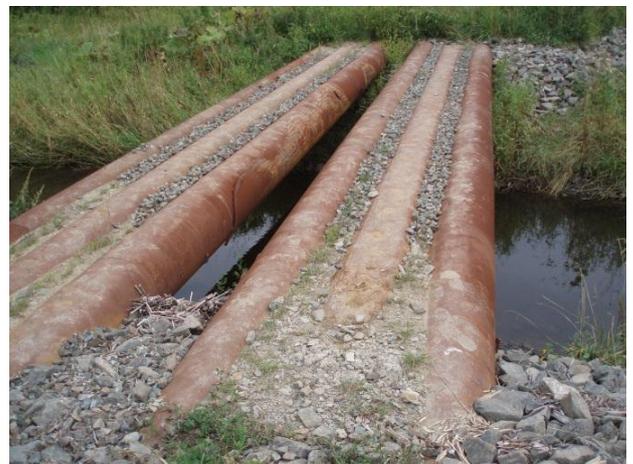
A temporary bridge is still in place (Photo 2) despite previous reports that it would be taken out, and the marks of the running track are visible to the south (Photo 3).

**Photo 2** – View of temporary bridge

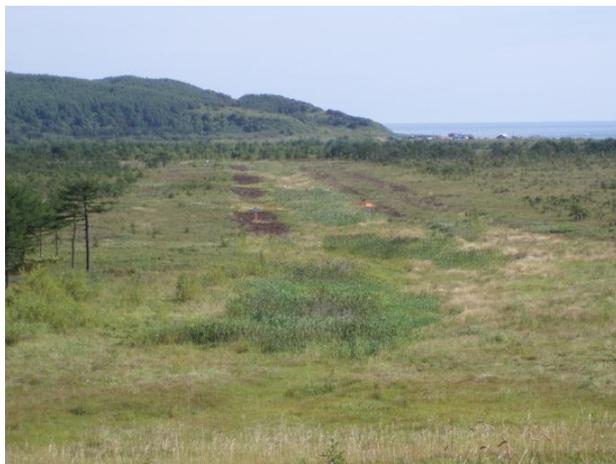
The Manui River is approached from the south through a wetland area. Re-vegetation of the wetland area was of mixed quality, with bare soil visible over much of both pipelines and the FOC (Photo 1). Closer inspection also revealed: the presence of imported material (soils/gravels), especially on the old running track (Photo 2); significant areas of pooling due to depression between the pipeline (Photo 1 and Photo 3); and, where re-vegetation was occurring plant species remain significantly different from those evident outside of the RoW. Recovery was generally found to be most advanced nearer the river, and we note that this is the location of the monitoring transect (which therefore may provide a generally optimistic picture of the overall recovery of the wetland area).

**Photo 1** – View wetland. Bare soils over pipelines and FOC and depression between pipelines visible

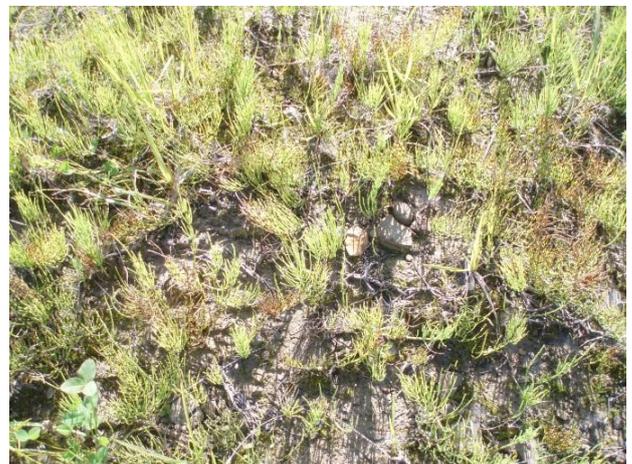
**Photo 2** – Imported material visible on RoW

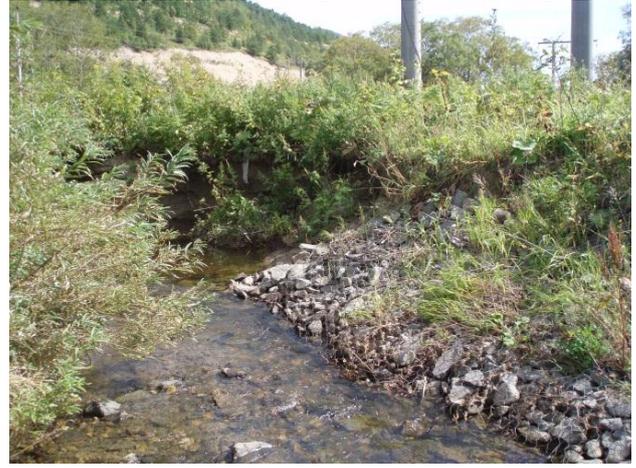
The riverbanks are protected with reno matting through which good vegetation has grown (Photo 3). Some minor damage was evident to reno matting on the western bank in the downstream direction (Photo 4), which is likely to be due to is being placed too far into the channel.

**Photo 4** – Minor damage to reno matting

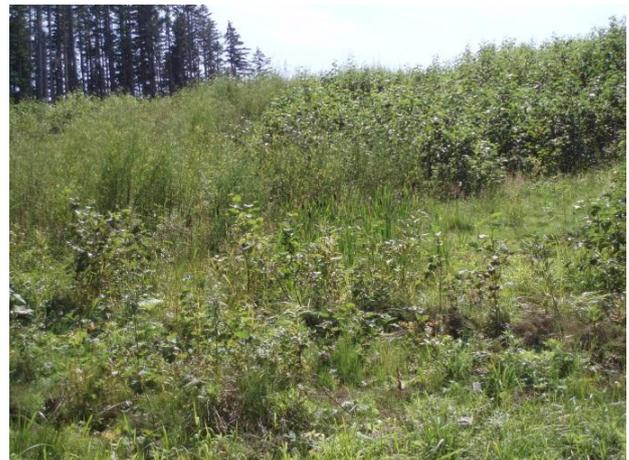
On the northern approach to the river, vegetation growth is mixed, with some areas of good growth, some areas of significant tree growth that needs to be removed (Photo 2), and other areas of bare soil (especially on the previous running track where imported material was still visible – Photo 3). A side cut on to the south of the river is bare and while geojute is in place it offers no protection (Photo 4).

**Photo 2 – Vegetation with tree growth on northern approach**

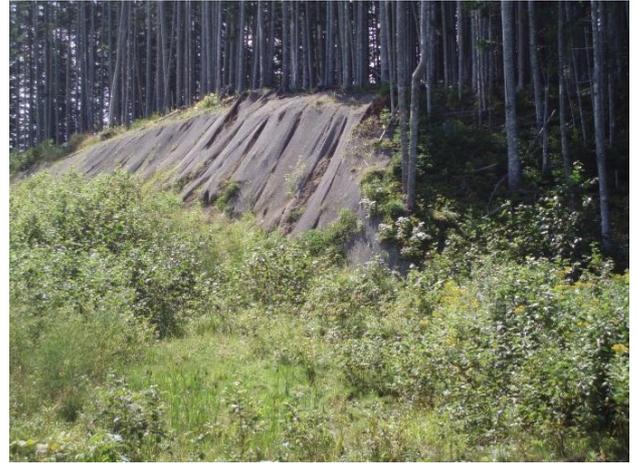
**Photo 4** – Side cut on south side of river

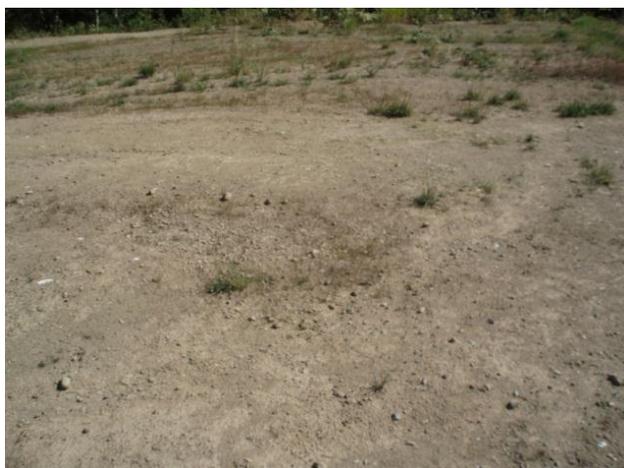
The sandy slopes between KP513 to the Ai River show some improved levels of vegetation over previous years (Photo 1), including some areas where seeding effects are evident (Photo 2). However, overall re-vegetation of these sandy slopes remains limited with some areas still showing very limited or no vegetation at all (Photo 3). The slope breakers which were installed along the sandy area mostly function well but in places need increased in frequency. The sandy area will need surface preparation and re-seeding for improved bio-restoration.

**Photo 3 – Poor re-vegetation of sandy slopes**

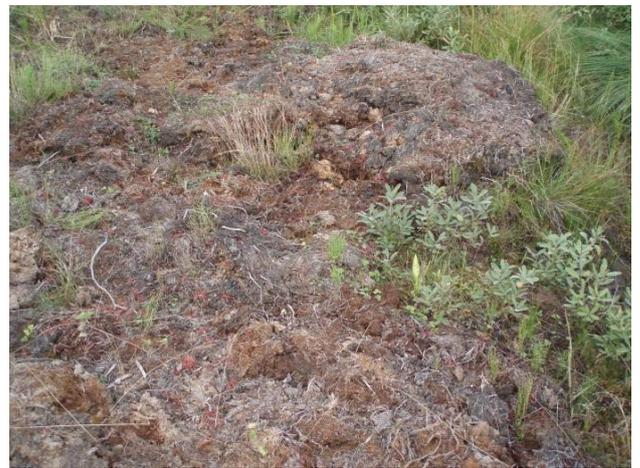
- In some areas over the pipelines and removed running track re-vegetation is sparser and dominated by pioneer species (Photo 2).
- Significant tree growth was evident (Photo 3) but at the time of the site visit a tree-control maintenance crew was working at this location on the RoW.
- The vegetation on the RoW still shows distinct difference from adjacent area immediately outside of the RoW (some locations off the side of the RoW also appeared to be more marshy than was evident on the RoW itself).

**Photo 2** – Areas of sparse re-vegetation on RoW

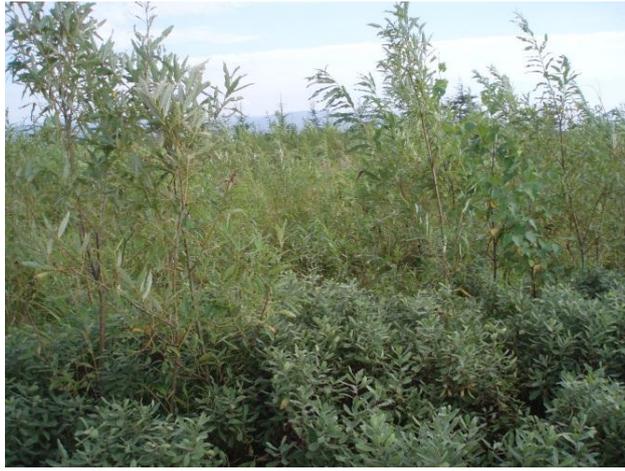
**Photo 3** – Tree growth on RoW

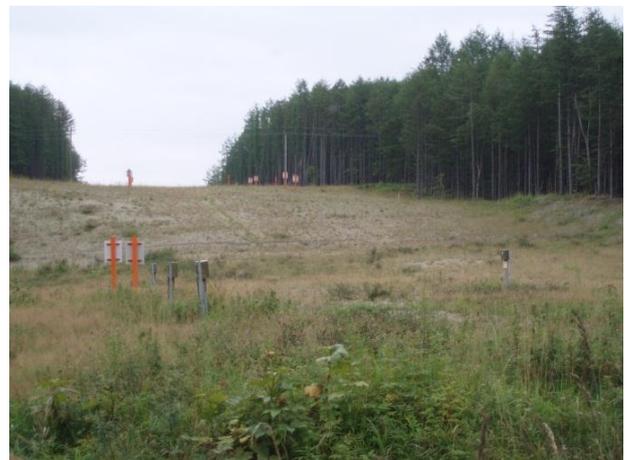
The lower river valley has good vegetation cover (Photo 2) but the slope leading to the river from the north has very poor vegetation and shows strong erosion (Photos 2 and 3). This slope is need of additional and more effective slope breakers and full bio-restoration.

**Photo 2** – View north showing river valley with good vegetation but slope without vegetation.

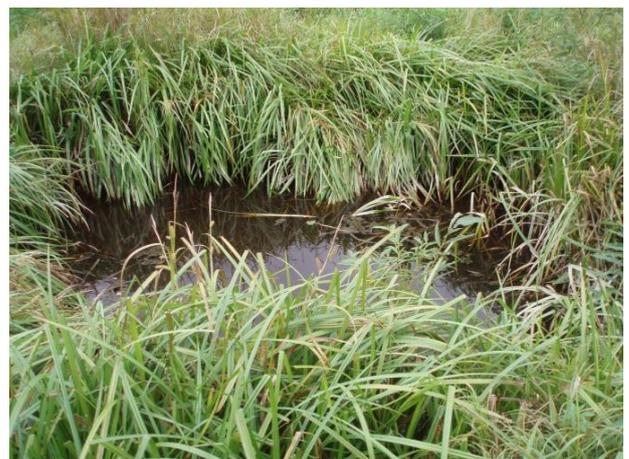
Water pooling over the pipeline was visible at the location where a pit had been installed for the thrust boring equipment during construction (Photo 4). This requires technical survey by Sakhalin Energy.

**Photo 4** – Water pooling over pipeline at location where the bore pit had been installed
