## **Annex D: Individual RoW Descriptions**

**Chaivo peninsula landfall, RoW and Pigging Station KP 71.5 – 74 and KP 0 - 4**

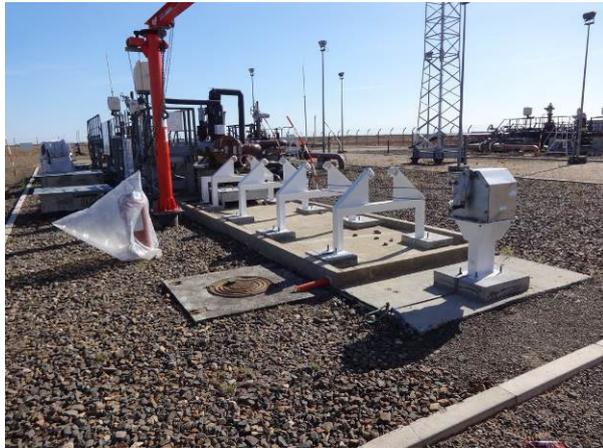
**Photo 1** – Pig trap and subsurface sump (with manhole cover)

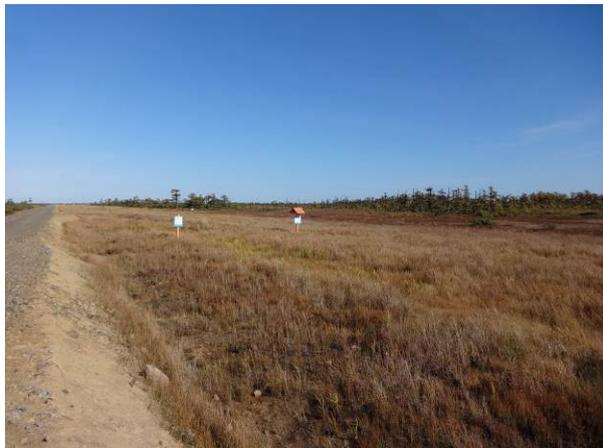
The RoW between the Piggling Station at KP 0 and the HDD site at KP 4 is well vegetated and generally in good condition. The access road to the Piggling Station is elevated and includes several large flume pipes along its length to allow water to freely move to the other side of the road.

**Photo 1** – View north showing well vegetated RoW along an elevated access road.

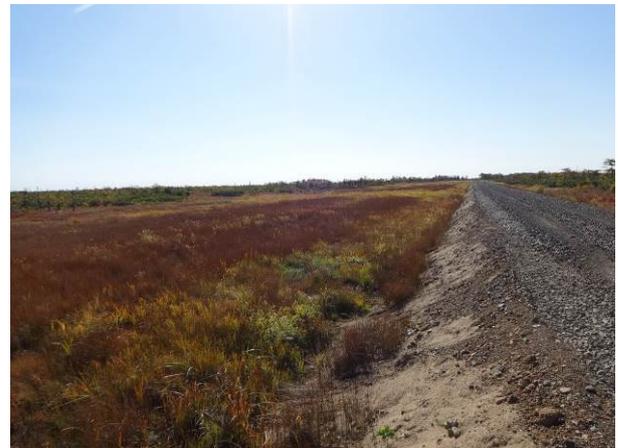
**Photo 2** – View south showing well vegetated RoW along an elevated access road.

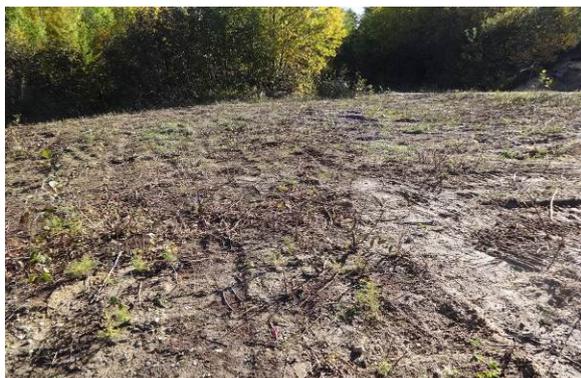
**Photo 3** – (to left) View to north of the road crossing showing growth of pine saplings in the area where Alder was removed.

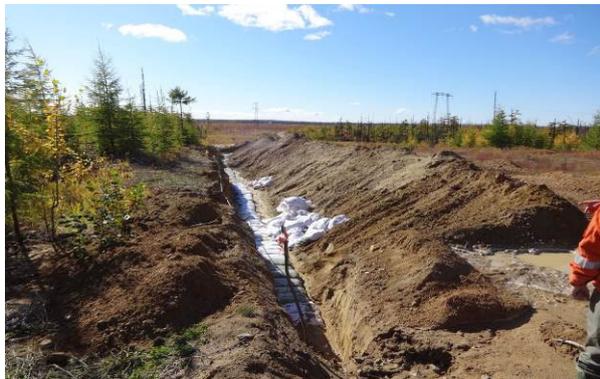
A Category 2 repair work was conducted on the edge of the access road to NOB-12. The RoW (and road) follow a long slope and the drainage along the road produced deep erosion at the bottom of the slope. The erosion exposed the Fiber Optic Cable (FOC) (Photo 1). During the visit repair work was in progress and it was reported that better erosion control measures will be introduced farther up the slope to prevent re-occurrence. The ROW in the area is well vegetated and includes trees (Photo 2).

**Photo 1** – View to the west towards NOB-12 showing repair work in progress.

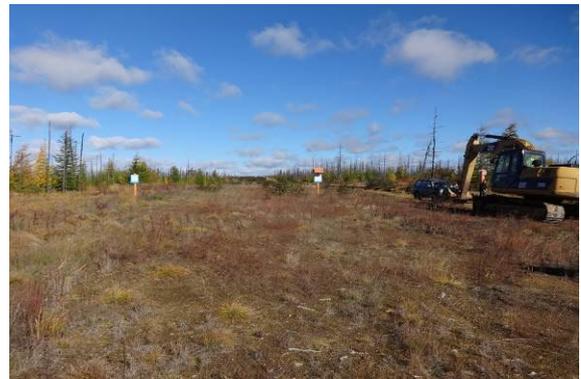
**Photo 2** – View to the east showing well vegetated RoW with grass and trees.

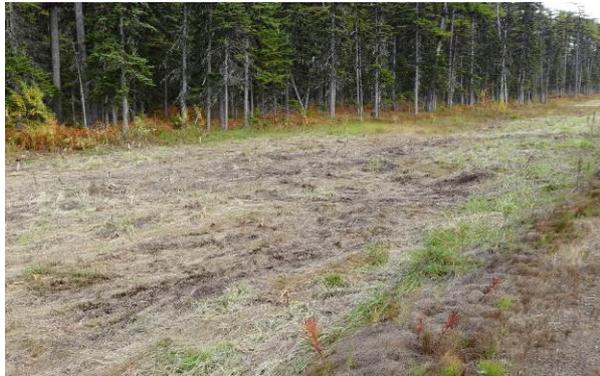
**Photo 2** –View of RoW where trees were cut using tracked equipment

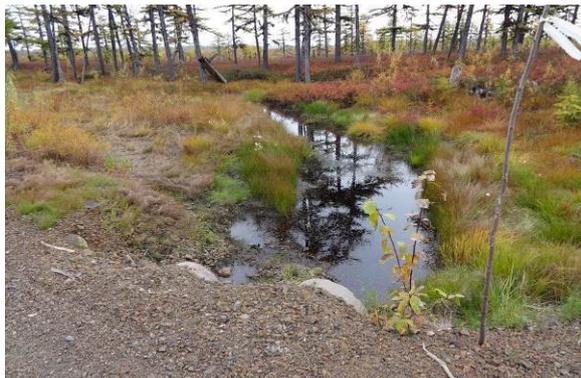
The wetlands, which start at approximately KP 152.7, are well recovered (Photos 4). A previous BIODIV.07 Item was raised regarding inadequate drainage across the access road on the wetlands. The Company addressed the item by improving flume/culvert construction across the road (Photos 5 and 6).

**Photo 5** – View of repaired flume pipe(s) in the wetlands across the access road to NOB 24

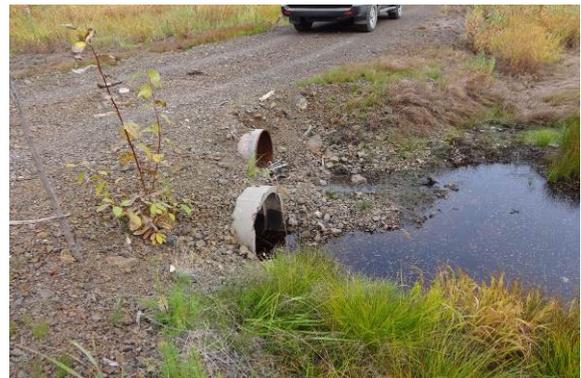
**Photo 6** – View of repaired flume pipe(s) in the wetlands across the access road to NOB 24.

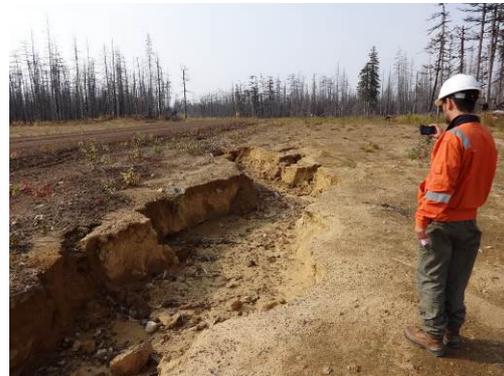
The river was accessed by a long access road starting at KP 21 and ending at KP 15 at the river crossing and the Block Valve stations NOB 01 and NGB 02. The RoW along this section generally has good grass cover (Photo 1). However the north end of the section and just south of NOB 01 there is a long slope with poor vegetation cover and in one area a deep erosional channel has formed (Photo 2).

**Photo 2** – View of a RoW section in the area of KP 15 to 16 showing poor vegetation cover and a development of erosion channels.

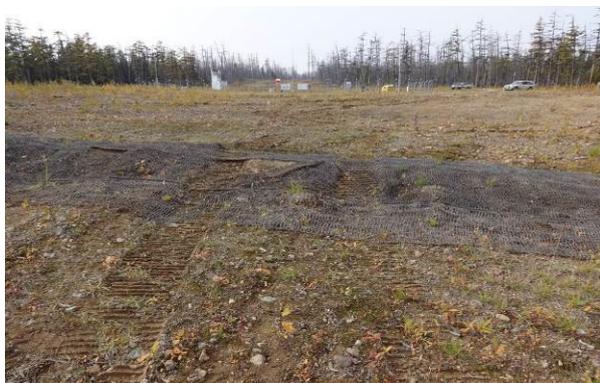
The RoW in the section between NOB 01 and the river is scarred by the activity of (unknown) heavy track vehicles, which caused damage to the reinstatement and to a slope breaker (Photo 3).

**Photo 3** – (to left) View of damaged slope breaker by an unknown activity of tracked vehicle.

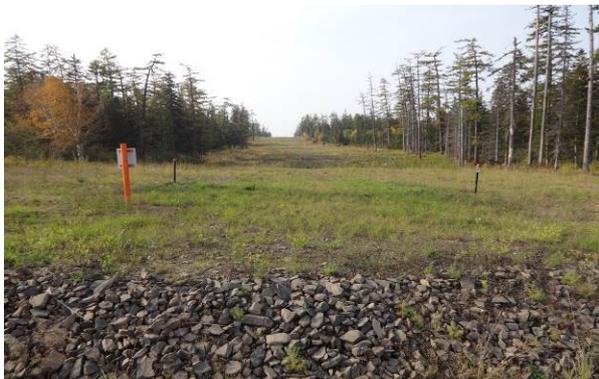
**Photo 2** – View to the northeast showing good slope breakers and vegetation cover.

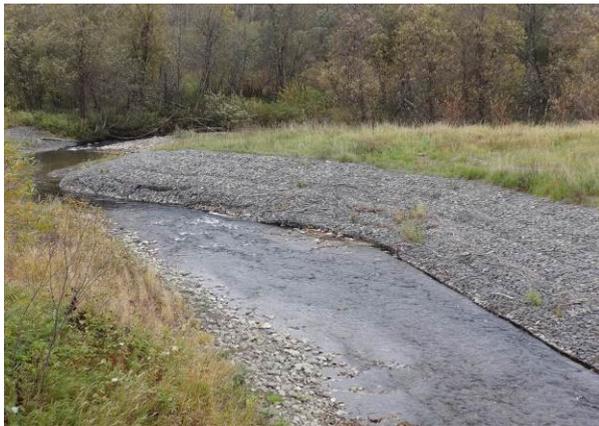
The Zvanka River crossing banks are protected by extensive Reno matting on each bank. The east bank matting is in good condition but the west side Reno mats are partially damaged and will need to be monitored and repaired when condition dictate (Photos 1 and 2).

**Photo 1** – View downstream showing damaged Reno matting on the west bank.

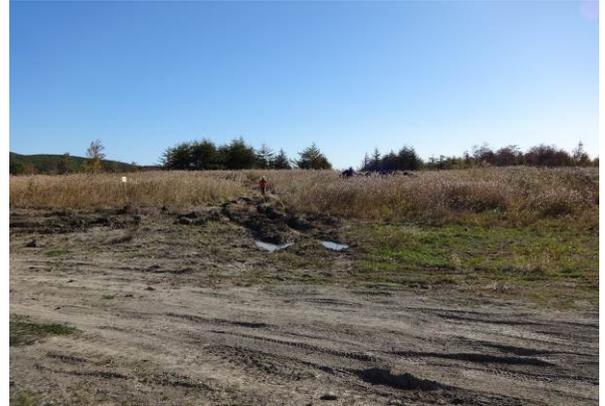
The river was visited using an access road from the north – the opposite side of the river from the wetlands area. The RoW north of the river is well vegetated but damage was observed on the RoW, which is reportedly due to the activities of the FOC contractor (Photos 3 and 4).

**Photo 4** – Damage to vegetation on the RoW due to FOC contractor activities.

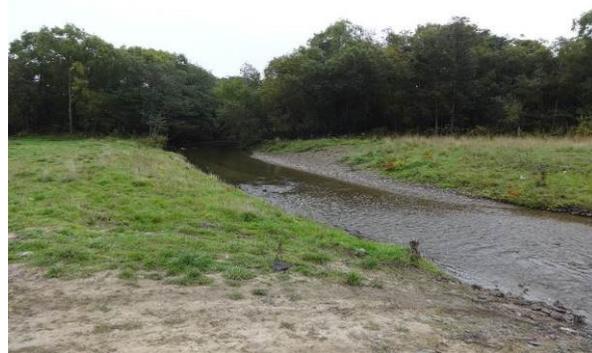
**Photo 1** – View downstream showing well vegetated RoW and banks but also a road across the river.

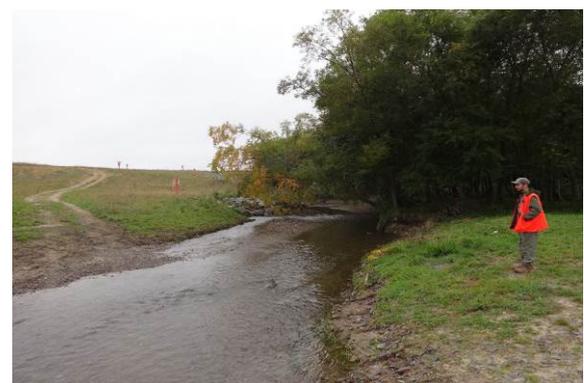
**Photo 2** – View to the upstream showing the south bank partially damaged by driving up the Reno mats.
