Sakhalin Energy Investment Company Limited

Sakhalin-2 Phase 2 Project Finance Parties

February 2016

SAKHALIN-2 PHASE 2 LENDERS' INDEPENDENT ENVIRONMENTAL CONSULTANT MONITORING REPORT OCTOBER 2015

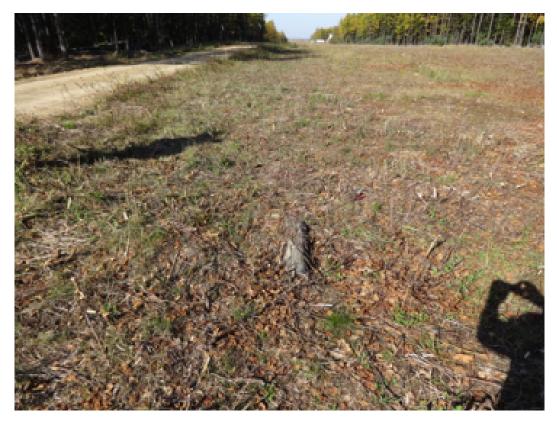
It was observed that trees/saplings are cut at approximately 10 to 15 cm above ground (Photo 1) and that the cuttings are temporarily stored in piles on the RoW. The Company reported that the piles are being shredded/mulched using a shredder powered by a Bobcat. The shredding activities were not observed during the visit but shredded cuttings were observed spread on the RoW.

Photo 1 – KP 64 – RoW section with high concentration of tree saplings cut by manual means. Note the grass in place

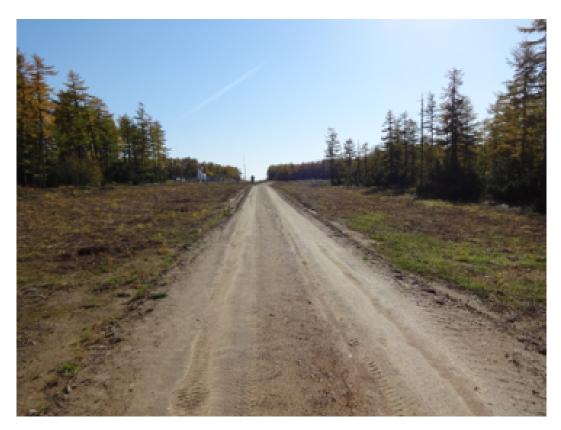
An area that was previously cleared using the mechanised method is now observed to be recovering (Photo 2).

Photo 2 - KP 63 - RoW section where tree saplings were two years ago removed by tracked, mechanised methods. The non-tree vegetation is now showing recovery

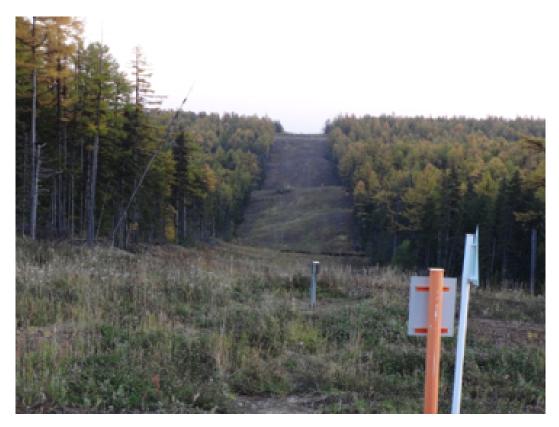
Photo 3 - KP 87 - good vegetation cover observed on steep slope

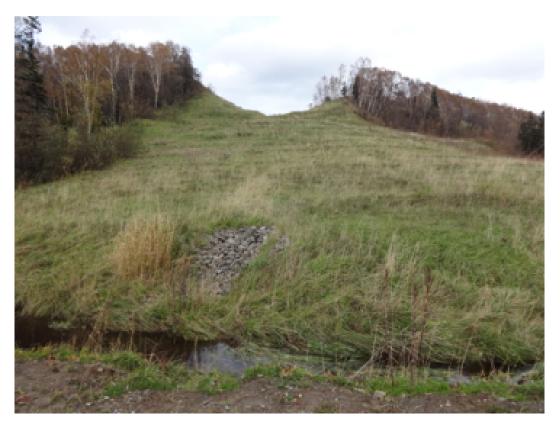
Photo 4 - KP 510.5 - Sovietskoy Ridge - Steep slope with good slope breakers and vegetation cover

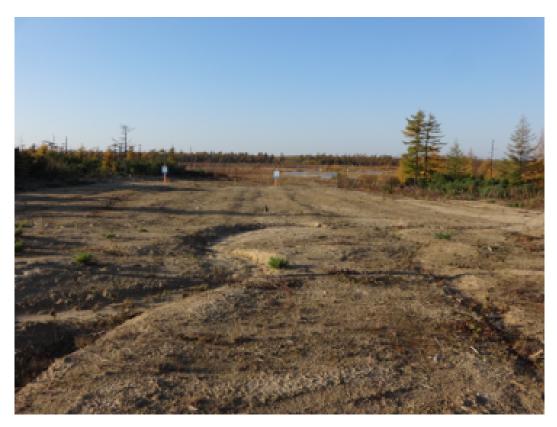
An ongoing concern is erosion control of sandy slopes that have partial or poor vegetation cover. The issue is not limited to those with a steep gradient – gentle slopes of sandy soil readily develop erosional features when vegetation cover is not adequate. One example of this was seen at the southern approach to the Evai River crossing where an erosional channel is developing on a gentle sandy slope towards the river (Photo 5).

Photo 5 - KP 48 - Showing erosional channel on a gentle sandy slope

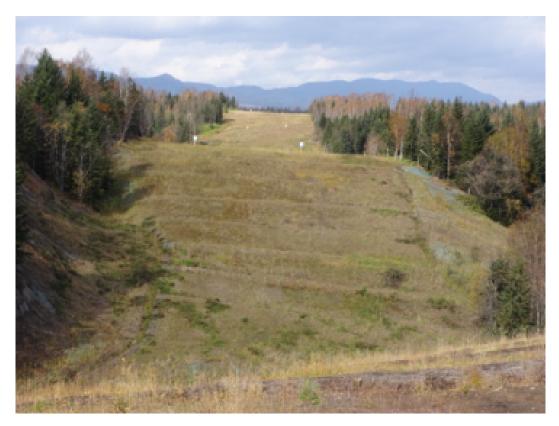
Other sandy slopes observed during this visit were at KP 514 where a combination of steep (but short) slopes and sandy soil with partial vegetation cover is considered to require additional revegetation efforts and maintenance of drainage and erosion control. This issue is being tracked as Finding LAND.16.

Photo 6 - KP514 - Showing partial vegetation cover on sandy slopes

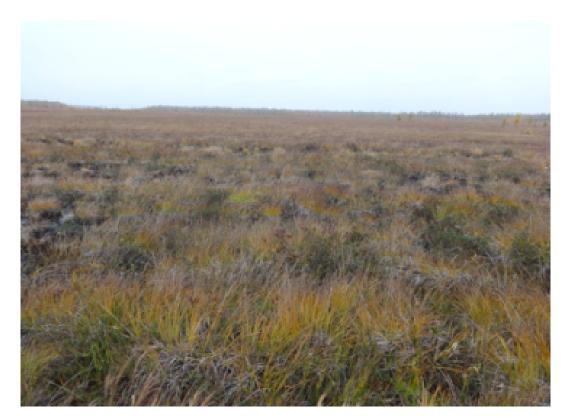
Photo 7 - KP 150 a view south across the RoW showing the recovering wetland with an area of undisturbed wetland in the background

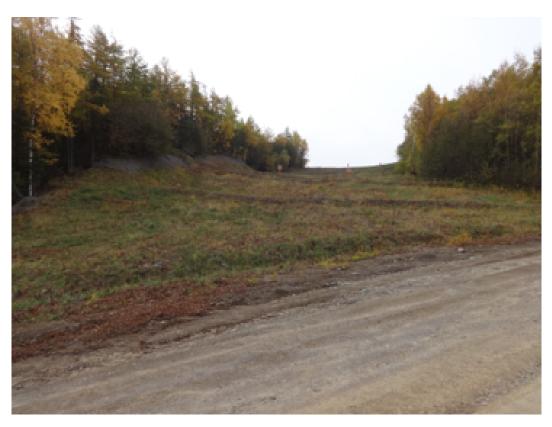
Photo 8 - KP 97 showing steep slope with slope breakers

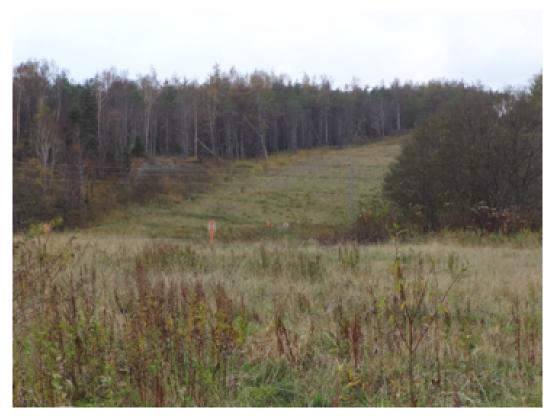
Photo 9 - KP 502 showing a slope with good slope breaker construction

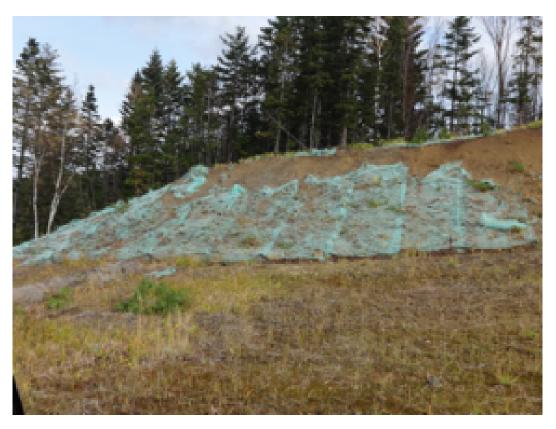
During the October 2015 monitoring visit the use of both types of matting was observed in several locations. In most areas the matting is performing well and vegetation is being reestablished. In other areas there is significant deterioration in the condition of the matting, which is a natural course of events. However the soil on which the matting was placed is still mostly bare (for example side cuts around KP 514, as shown in Photo 10).

Photo 10 - View of one of the side cuts in the vicinity of KP 514 showing deteriorating geojute and bare side cut

Opportunity for Improvement: Sakhalin Energy could consider the value of replacing the deteriorating geojute on the side cuts in the vicinity of KP 514 and using better placement and re-vegetation technique.

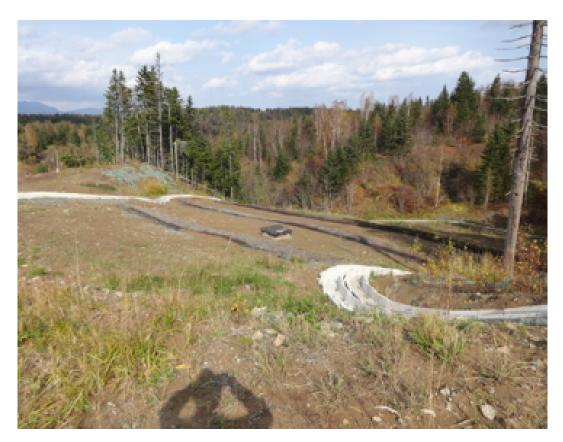
During the October 2015 monitoring visit a recent, mostly complete Category 3 Geotechnical Work was observed at KP 514. Work was being conducted to stabilise a landslide that had impacted the eastern portion of the RoW. The works also included drainage and erosion control measures – see Photo 11 below. It was also reported and demonstrated with recent photographs that the extensive Category 3 works have been conducted at KP 382.5 on stabilising a landslide. Other Category 3 works are in the process of design and work will commence in later this year and in 2016.

Photo 11 - View to the east from the RoW at KP 514 showing a Category 3 geotechnical repair work on a landslide

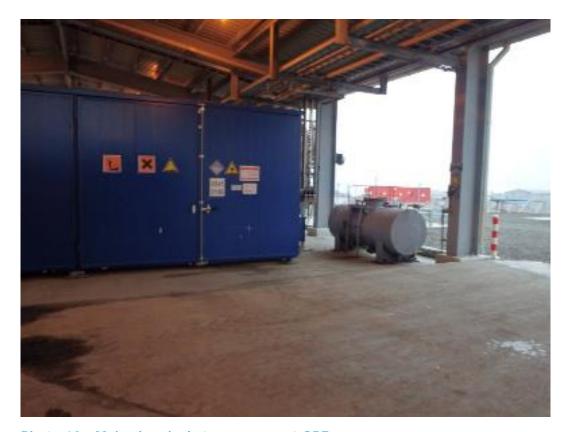
Photo 12 - Main chemical storage area at OPF

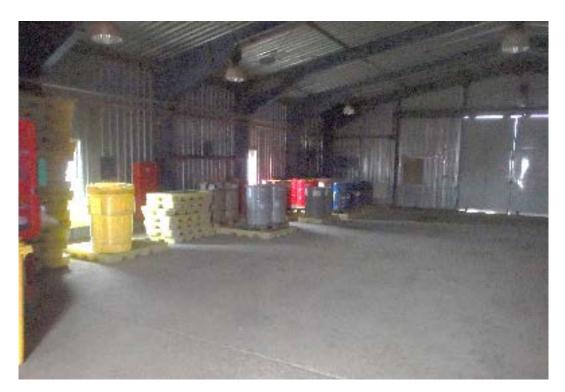
Photo 13 - Main store for drummed oil at OPF

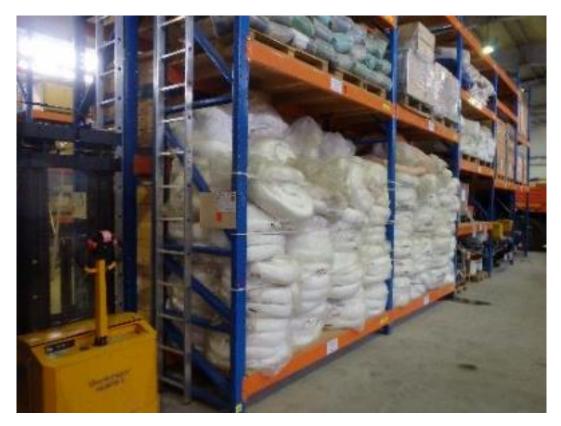
In general, Ramboll Environ observed a very high standard of housekeeping, chemical and oil storage, as well as maintenance and availability of oil spill response (OSR) equipment in a dedicated warehouse.

Photo 14 - OSR equipment warehouse at OPF PMD

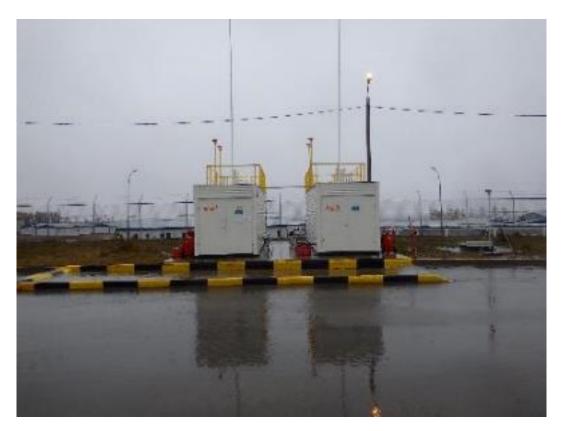
- Integrally bunded above ground storage tanks and dispensing system for diesel re-fuelling, maintained in excellent condition and provided with a dedicated re-fuelling apron with contained drainage system.
- Drip trays deployed under mobile oil-filled equipment and parked vehicles.
- Clear labelling on drums and MSDS readily available.
- The entire yard area drained via an oil/water separation system.

Photo 15 - Refuelling area at OPF PMD

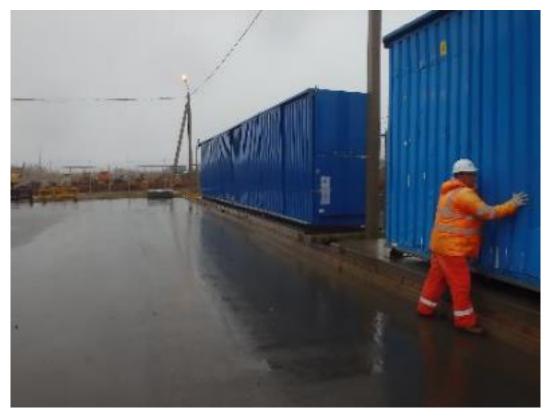
Photo 16 - Oil and chemical storage lockers at OPF PMD (unlocked)

Opportunity for Improvement: The integrally bunded purpose-built lockers for oil and chemical storage located in the yard area were missing padlocks on their sliding doors. These locks should be replaced in order to prevent unauthorised access to these stores.

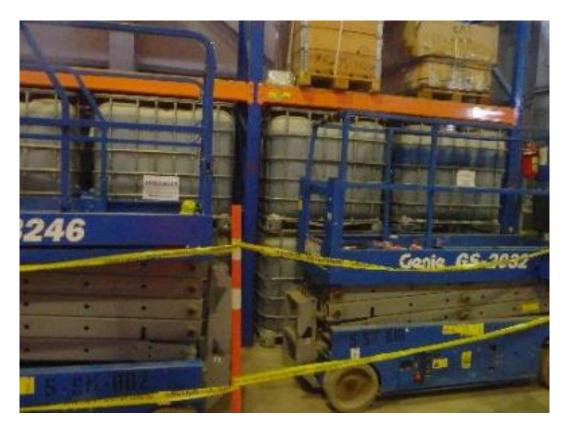
We note that the floor was in good condition, sealed throughout with a chemical resistant coating and had no floor drains.

Photo 17 - AFFF concentrate storage in the warehouse at OPF PMD

Opportunity for Improvement: Ramboll Environ identified some ten Intermediate Bulk Containers (IBCs) of aqueous film-forming foam (AFFF) concentrate (Alcoseal 3-3) currently being stored without secondary containment in the PMD warehouse (Photo 17). While the product's MSDS reports the product to be "detergent-free, readily biodegradable and virtually non-toxic" and is required to be stored at a controlled temperature, the PMD warehouse is not designed for bulk chemical storage. Therefore, it is recommended that this storage practice be reviewed and an alternative location and/or additional containment be considered. As a minimum, IBCs should be moved further away from the warehouse entrance.

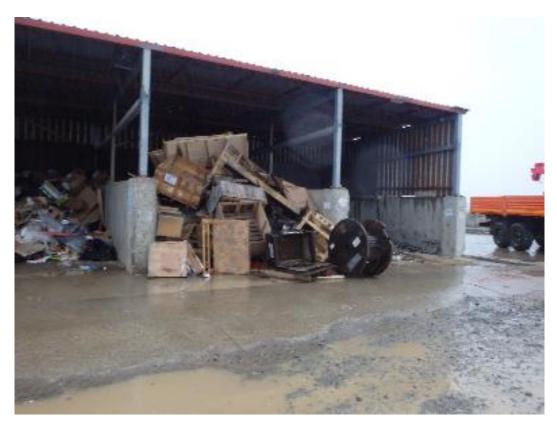
Photo 18 - Non-hazardous waste storage bays at OPF Waste Transit Area

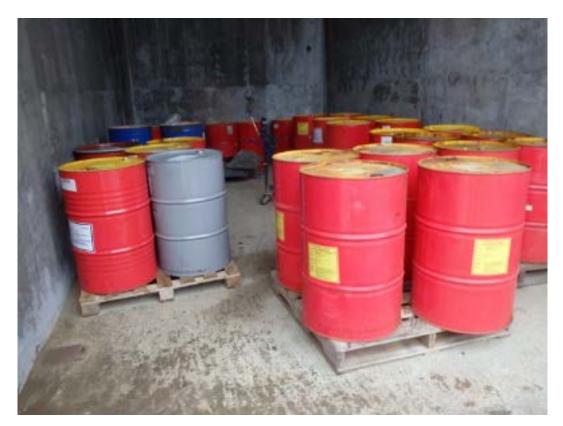
Photo 19 - Waste oil drum storage at OPF Waste Transit Area

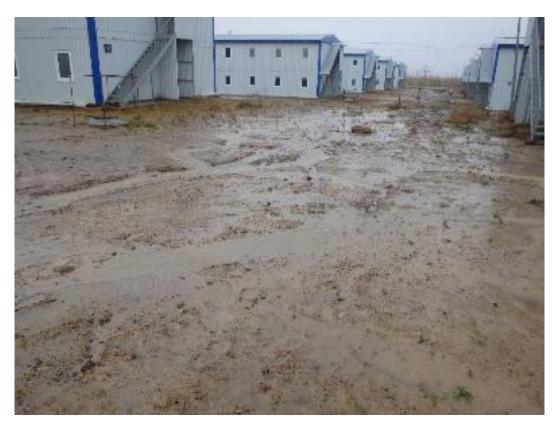
FINDING: Ramboll Environ observed that there was a clear need for urgent improvements to drainage and erosion control arrangements around the temporary construction camp. The fly camp area was water-logged and rivulets of silt-laden water were flowing across the camp area and into surrounding drainage ditches (Photo 22). These drainage ditches were not properly constructed, with no side-wall protection (vegetation, geotextile or ballast) and the check-dams in place were not frequent enough, nor properly formed (as seen elsewhere on the OPF site) (Photo 23). Furthermore, there was no settlement pond in place, nor any de-watering procedures or other silt reduction measures in place to reduce the silt load in the ditches. Ramboll Environ observed at least one location where silt-laden water was exiting the OPF site to the north and entering what appeared to be a natural stream. Such a discharge is not compliant with the HSESAP (Water Use Standard – Appendix 7 Onshore Facilities Aqueous Discharges²).

Photo 22 - Fly camp area under renovation - poor drainage and erosion control

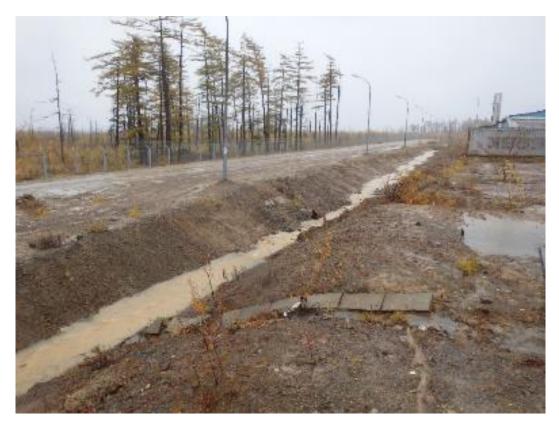
Photo 23 - Silt-laden storm water discharging off-site without treatment

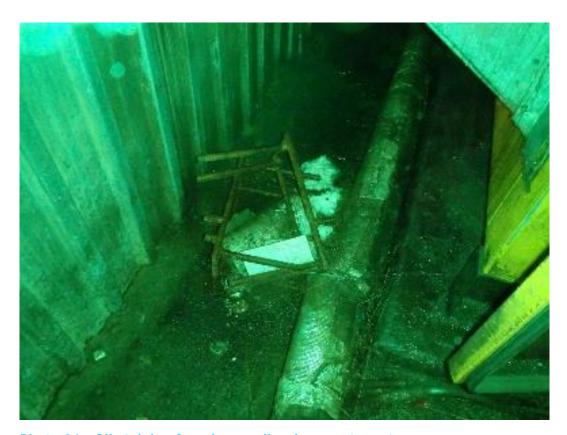
Opportunity for Improvement: Inspection of two redundant generator units in the northern boundary of the main camp, which were awaiting decommissioning and scrapping, identified oil or oily water sitting in the drip pans within the generators, the access panel to the generator open, the enclosure in which the generators sit in disrepair (i.e. not weather-proof), hydrocarbon staining on the ground below the fill point on one of the units and what appeared to be oil staining on the concrete to the rear of the units, adjacent to the back of the enclosure (Note: full access to this area was not possible and light levels were very poor).

Photo 24 - Oil staining from legacy diesel generators at camp

Whilst no staining was evident on the ground immediately outside of the enclosure, it is recommended that action be taken as soon as possible to drain the residual oil/oily water in the generators and clean-up any surface oil sitting on the concrete floor. Given that there has been an environmental incident already recorded in relation to oil leakage from legacy plant and equipment at this camp (see OPFC Project Incident #1402381 discussed below), it is surprising that measures have not been taken to ensure that there is no potential for a repeat incident in relation to these generators.

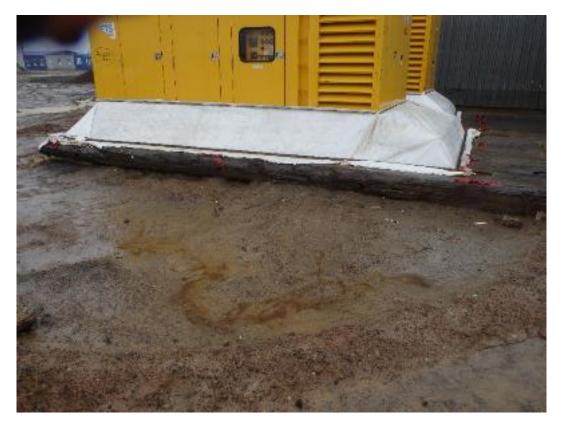
One notable environmental incident related to construction occurred in May 2015 and involved a leak of oily water from redundant diesel-fired generator units (DGs) in the main camp area (Ref. OPFC Project Incident #1402381). The generators had been out of operation since 2009 but not appropriately managed by the Company's contractor (subsequently replaced with another contractor). Approximately 5-10 litres of oily water reportedly overflowed from drip pans in the generators and onto the ground. Following the incident, the generators were fitted with secondary containment systems and protective skirts (Photo 25) and the oily material and impacted soil was excavated and removed as hazardous waste.

During an inspection of the impacted area, measures taken appeared adequate, however, a very minor residual oil sheen was observed by Ramboll Environ on the surface of storm water in the locality.

Photo 25 - Legacy DGs linked to OPFC Project Incident #1402381
