IEC Lenders' Independent Environmental Consultant: Monitoring Report April 2010 Sakhalin-2 Phase 2 Project

Report to Sakhalin-2 (Phase 2) Project Finance Parties

Restricted – Commercial
AEAT/ENV/R/3042 Issue 2
July 2010

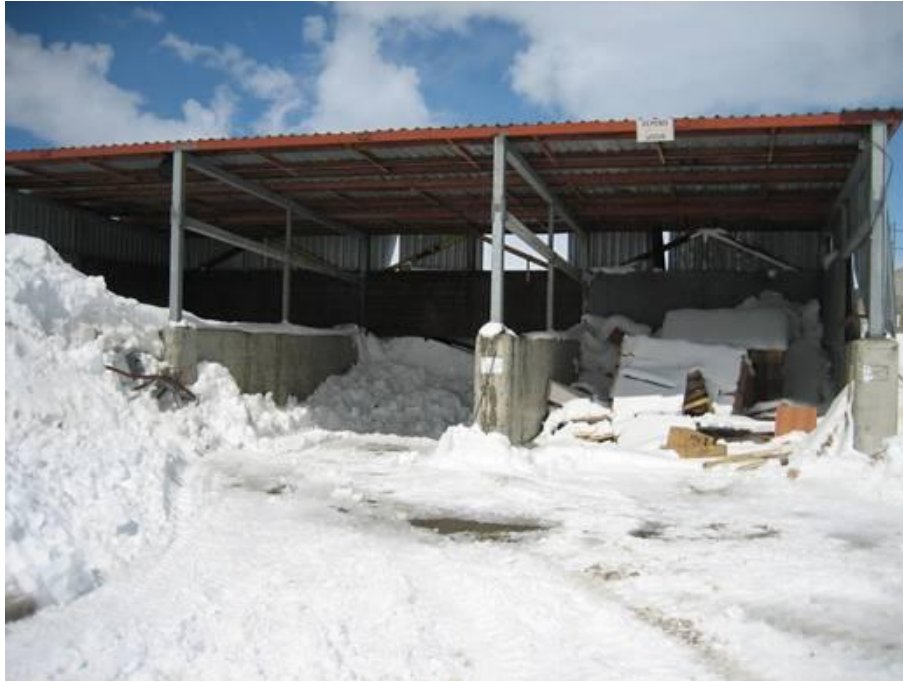
Photo 1 **Non-hazardous waste collection bays, OPF**

Both hazardous and non hazardous wastes are collected at the station and segregated as required. For non-hazardous waste there are two collections bays for wood and metals (Photo 1). These are both recycled – wood is given to the local community for general use and metal is taken for recycling. Plastic is also collected and sent to a recycler.

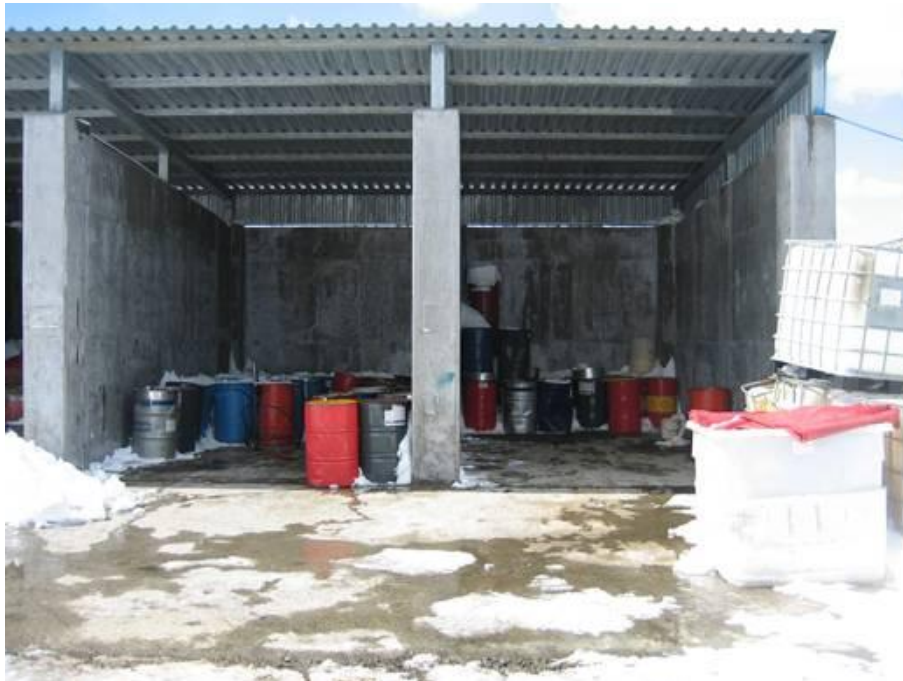
Photo 2 **Hazardous waste storage bays, OPF**

Hazardous waste storage comprises three roofed concrete bays (Photo 2), shipping containers and IBCs. The three concrete bays store empty drums in one bay, drums with waste oil and legacy waste oil in the second, centre bay and used PIGs, oily rags and oily soil in the third bay. Legacy waste oil is uncharacterised and currently without applicable waste passport. As a result, Korsakov “Grot Oil” will not accept the material for recycling. Reportedly, Sakhalin Energy is currently testing the material and developing applicable passports so that future disposal will be possible.

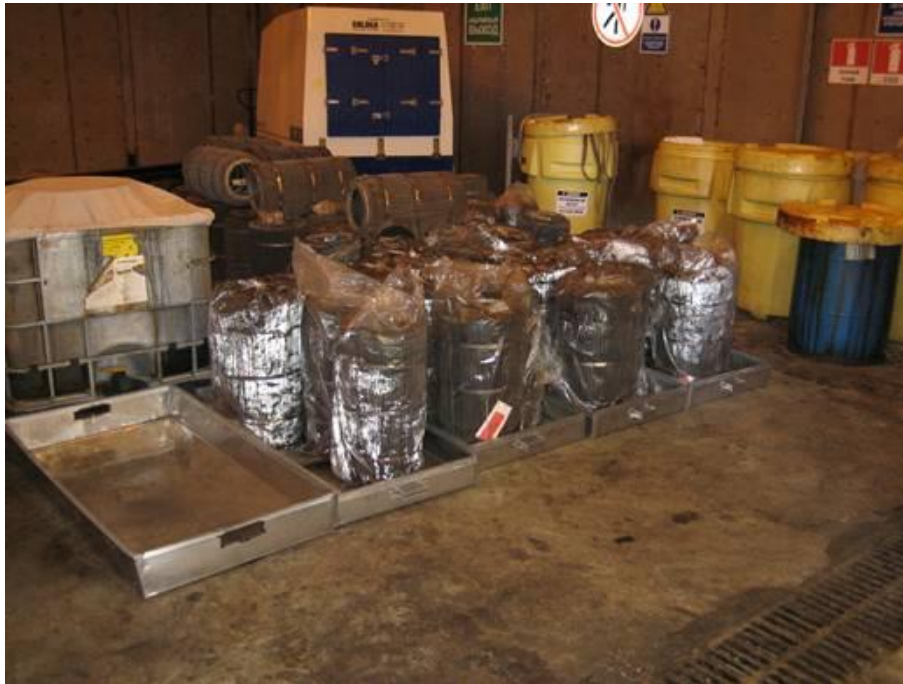
Photo 3 MEG filter cleaning area, OPF

The MEG filter cleaning room is equipped with waste water collection drains, and filters are placed in drip trays while not being cleaned (Photo 3). However the floor appeared stained, suggesting that the containment trays are not always effective.

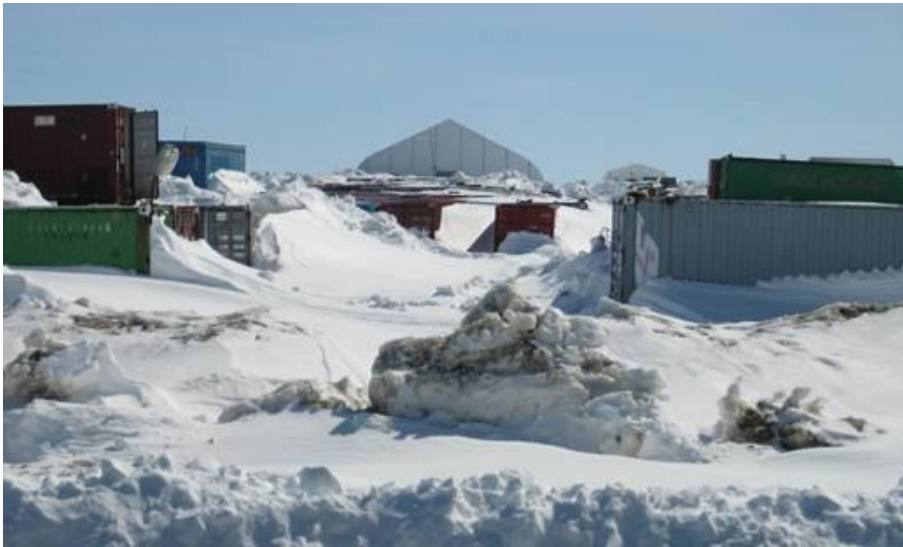
Photo 7 OPF Legacy waste containers, buried in deep snow

Approximately 540 shipping containers, most of which are 40 feet in length, are located in various open fields at the OPF site (Photo 7). Reportedly, the containers were left by Project contractor BETS and are now the responsibility of Operations. Initially, the contents of the containers were unknown. However within the last year the OPF maintenance department has been systematically opening and surveying the containers, and classifying the contents and structural condition of the containers themselves. The task was slowed down during the winter due to heavy snow accumulation around the containers in the open fields. The purpose of the task was to ascertain what content can be reused at the facility and what needs to be classified as waste and disposed of.

Each container was first examined for lifting integrity since they will need to be moved (and therefore lifted) either for disposal or for housekeeping purposes at the facility. Damaged containers will be emptied and cut up for scrap metal. Containers which are empty but sound will be given away at no charge when there is a request. To date, 540 containers have been examined for lifting integrity and 488 examined for content. Table 1 summarises the initial findings of the survey.

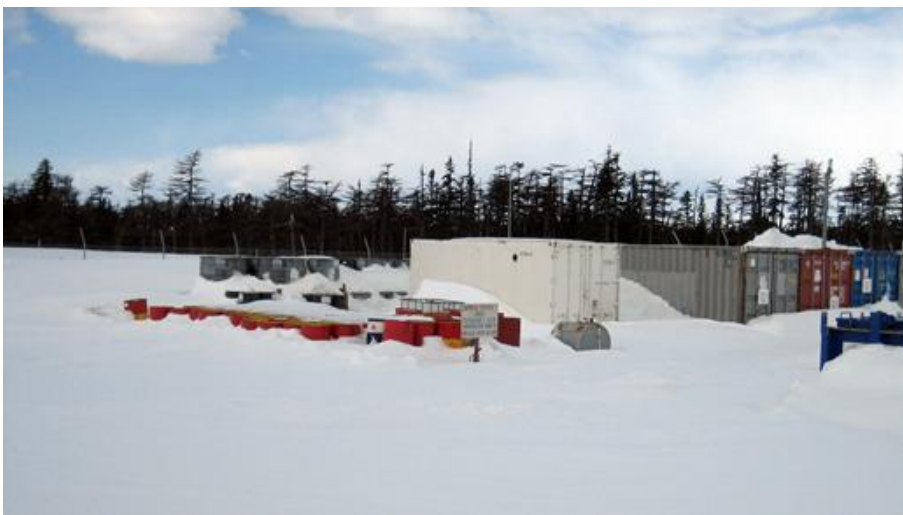
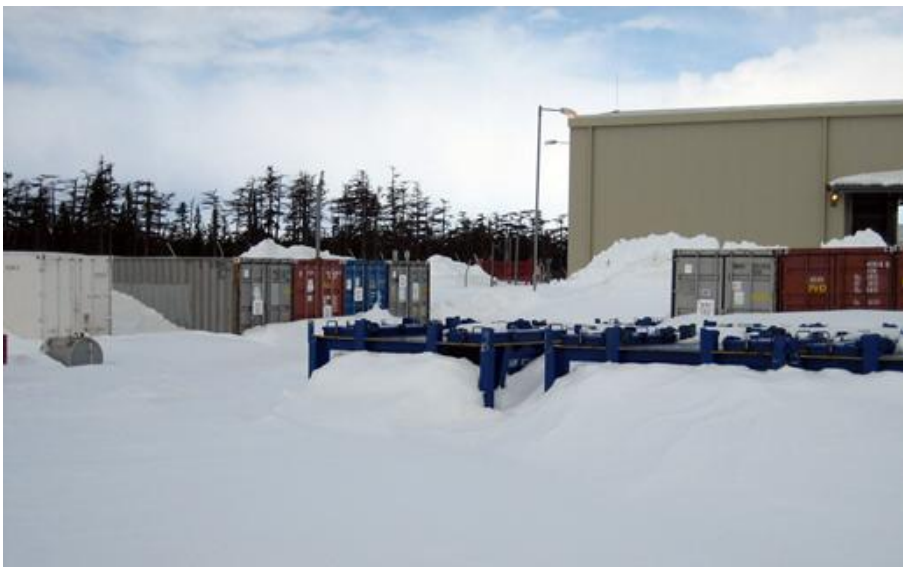
The chemical storage area is currently outdoors and was not accessible due to heavy snow drifts around the area (Photo 8 and Photo 9). During the visit it was observed (from a distance) that the area contained various drums, shipping containers, and various liquid storage containers.

All three areas are bunded. Heavy snow cover prevented a thorough investigation of the storage area. Reportedly a BETS fuel storage facility which was observed during the previous visit was dismantled.

Photo 8 OPF chemical storage area (1)

Photo 9 OPF chemical storage area (2)

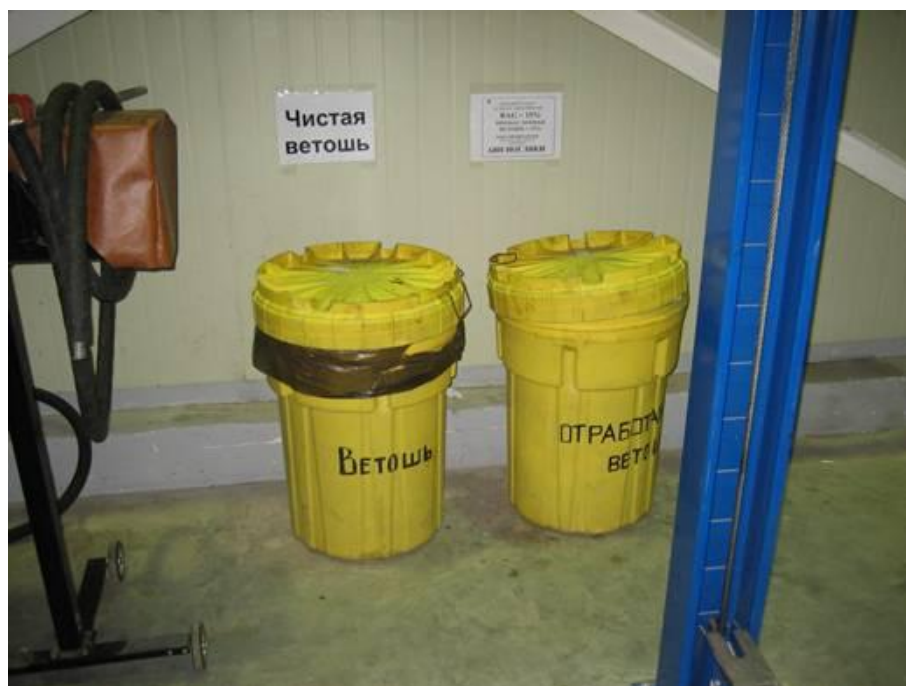
Photo 12 **Labelled waste containers, Nogliki OPF**

In general, housekeeping at the OPF was found to be very good. Containers for waste and waste oils were well labelled (Photo 12 and Photo 13) and used correctly, and spills and small oil leaks were absorbed using the correct materials (Photo 14). However, as can be seen in Photo 13, some of the oil containers were observed to lack any secondary containment; the OPF HSE manager also noted this and made sure the situation was rectified immediately (Photo 15). Further discussion on site regarding the availability of drip trays showed that there had been a problem in obtaining these items in the past, but now the workshop on the site makes them to order, so every oil, grease or glycol container should be able to have secondary containment to prevent the minor spills.

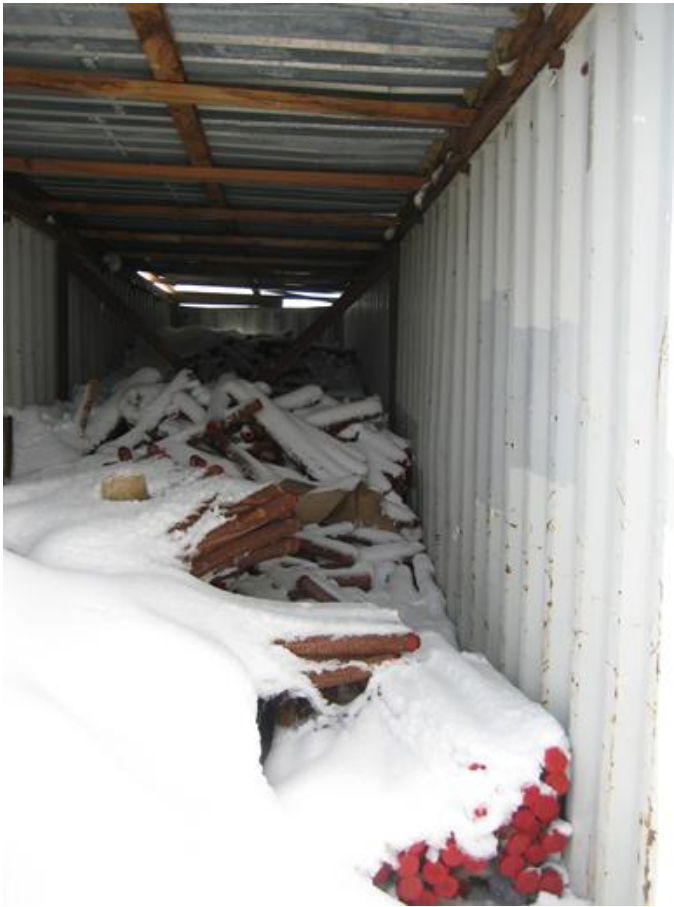
Photo 16 OPF waste storage area, exposed to the elements

The overall standard of housekeeping at the existing waste transit facility was not as good as previously observed in November 2008, however the station is mostly exposed to the elements and this visit was conducted shortly after a heavy snow storm (Photo 16). Moving waste handling to the newly built station in the near future will go a long way towards solving the housekeeping issues.

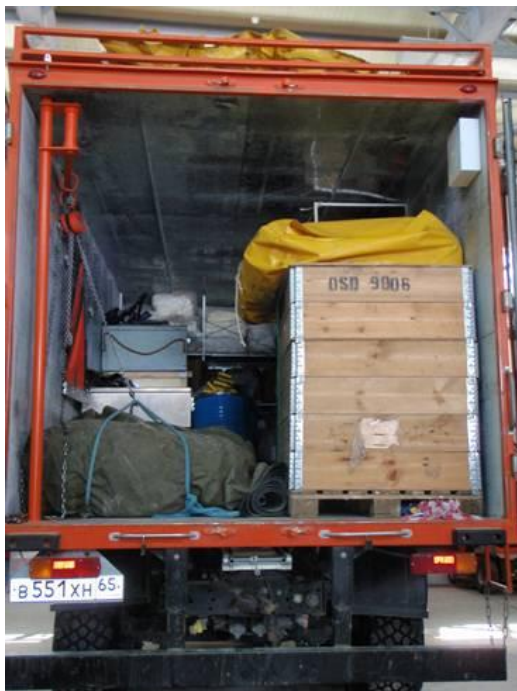
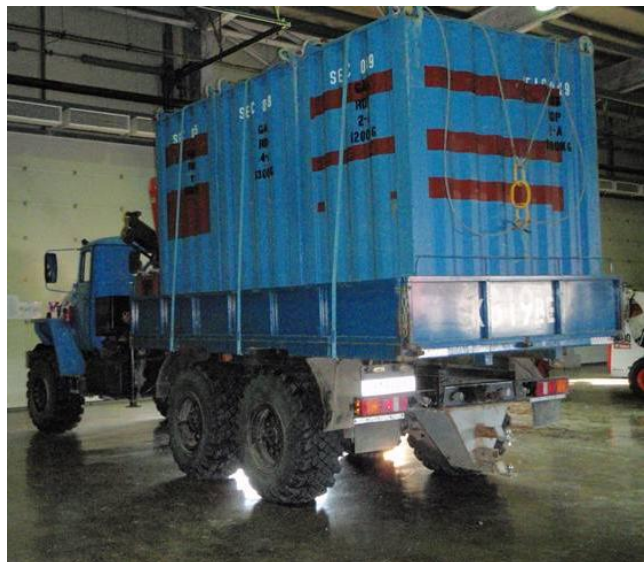
Photos 19 **OSR trucks pre-stocked with equipment, OPF and Gastello PMDs**

OSR vehicles are stored pre-loaded with key first-response equipment, ready to be quickly deployed (Photos 19). Inventories on container doors showed that the contents were regularly checked. Gastello personnel explained that different equipment is used for summer and winter conditions (for example winter pumps provide steam) therefore these pre-stocked containers are swapped seasonally – Gastello PMD was just changing from ‘winter’ to ‘summer’ equipment containers.

Wherever possible, vehicles were parked indoors to avoid exposure to the elements. Floors around the large vehicles were clean and free from spills and debris, and in particular OSR vehicles were facing roller doors in readiness (Photos 19). Areas housing smaller vehicles (e.g. A300 Bobcats), generators and ice saws were also seen; these were stored in a tidy manner with only small spots of staining were noticed on the ground (Photo 21).

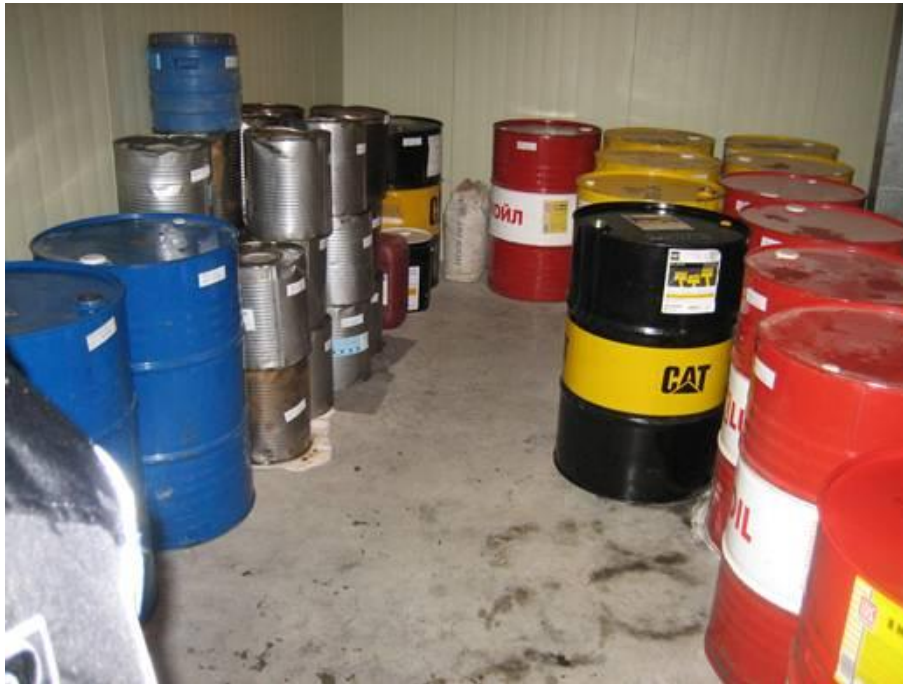
Photo 26 Drums in fuel storage area, without secondary containment, Nogliki PMD

The storage space available for fuel drums and other chemicals used one-site is limited. While large fuel drums were not stacked, and reportedly never would be, smaller containers were stacked four-high (Photo 26). Stacked containers (particularly dented containers as shown) may fall, presenting a greater potential for damage, spillage and also personal injury.

Very few drums/containers had secondary containment, which is not good practice. This was of particular concern at Nogliki as the room itself had no drain/interceptor or bunding, so spills would not be contained and could potentially run directly to unmade ground. AEA recommends that secondary containment for fuel drums is provided by way of drip trays at all PMDs as a matter of urgency, particularly where no further groundwater protection is provided, as at Nogliki.
