Intended for
Sakhalin Energy Investment Company Limited

On behalf of
Sakhalin-2 Phase 2 Project Finance Parties

Date
March 2019

SAKHALIN-2 PHASE 2 LENDERS' INDEPENDENT ENVIRONMENTAL CONSULTANT MONITORING REPORT SEPTEMBER 2018

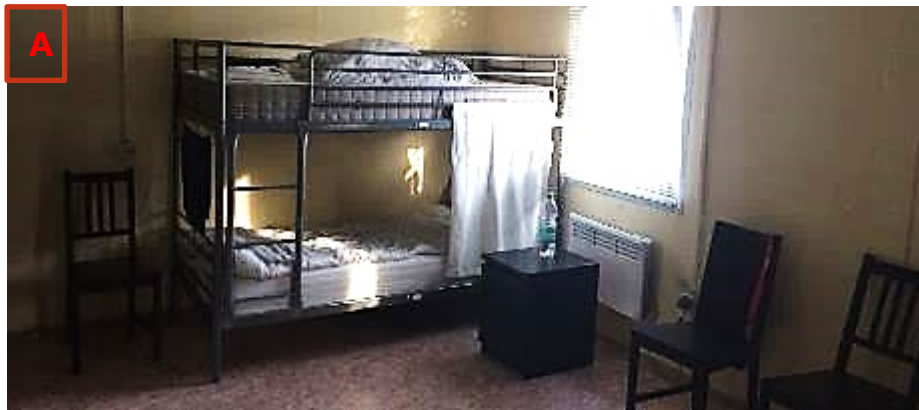
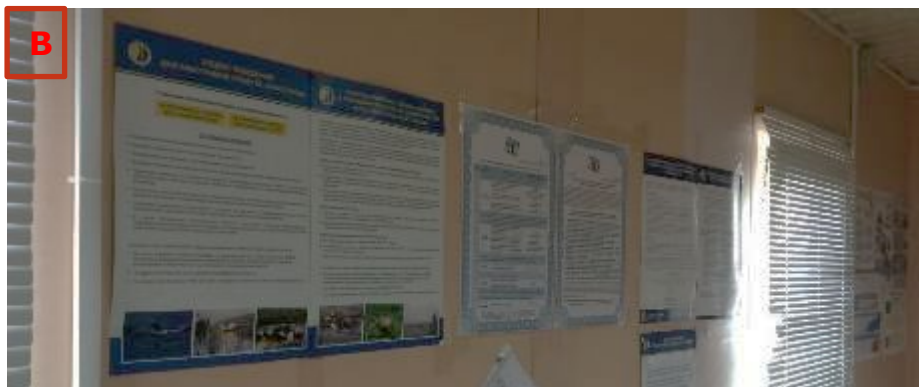
The Fly camp currently accommodates 360 employees. The camp is currently undergoing the process of refurbishment, which is expected to be completed by the end of 2018 or in early 2019. The camp is found to be managed in line with the Petrofac's Welfare Policy and Plan. In particular, the Fly camp provides:

- Sufficient space per person in each room (circa 18-20 m² per a 4-bed room);
- Internet and cellular connection;
- Adequate toilet and shower facilities;
- Adequate laundry facilities;
- Equipped and staffed medical facility;
- Opportunities to be informed of the applicable policies and grievance mechanism.

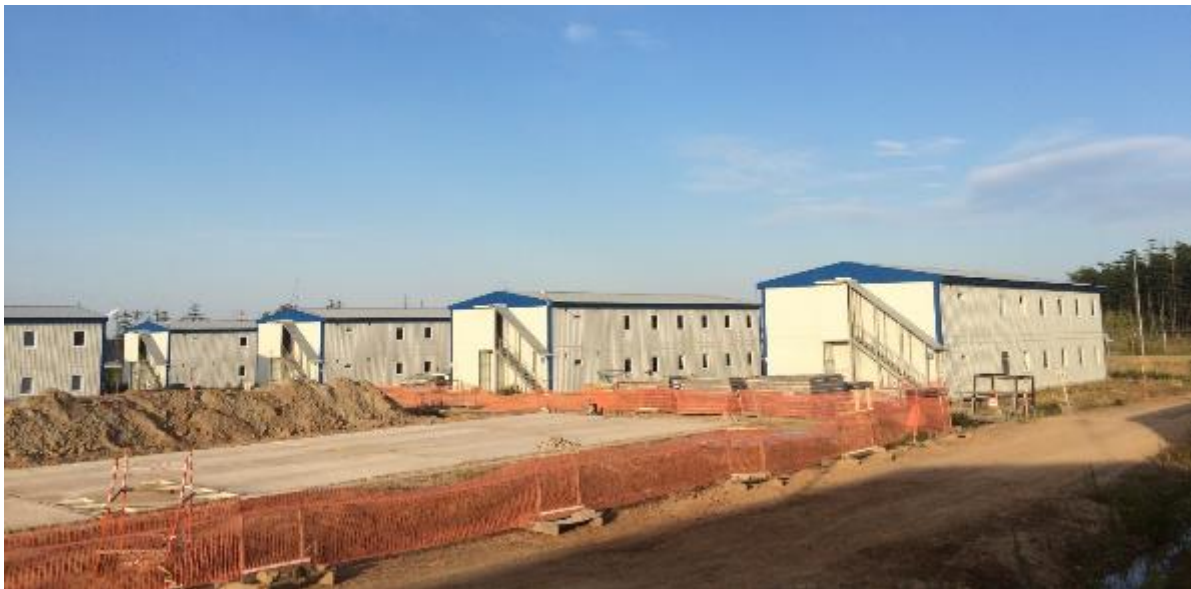
Figure 2.2 Fly camp refurbishment and main camp construction area

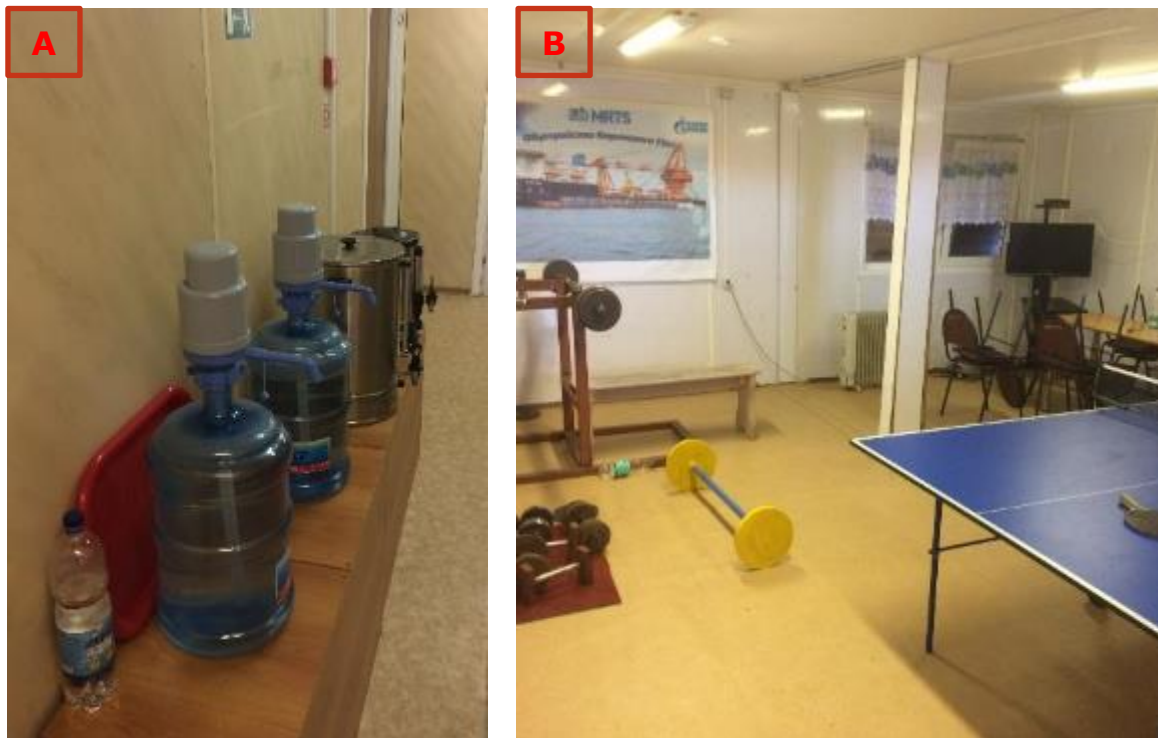
During the visit, Ramboll observed that the camp now has a check-in system in place, a medical professional is available, and the leisure opportunities are improved at the camp premises. As discussed previously, a concern had been raised due to lack of drinking water; this grievance was successfully resolved by Petrofac: the camp tenants are provided with a sufficient amount of bottled water, as observed by Ramboll.

Figure 2.3 MRTS Camp: A) Drinking water available B) Gym and a common area

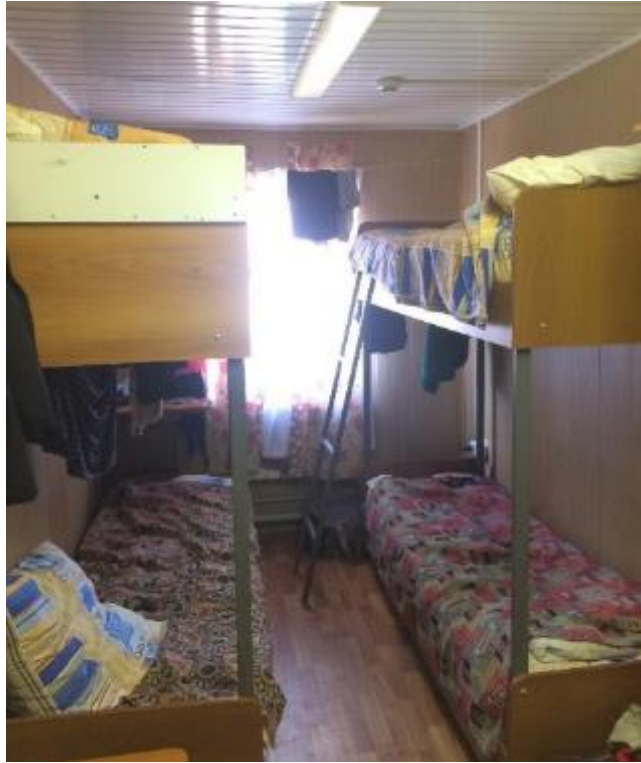
Some of the non-compliances, however, remain relevant. For example, the camp does not provide enough opportunities for leisure activities due to the lack of internet connection. As noted by Ramboll, not all providers' cellular network is well-functioning. The rooms' area is found to be in contradiction with the Petrofac's Welfare Policy and Plan as 3 m² are allotted per person. The rooms are observed to be under-furnished and small.

Figure 2.4 A sleeping room at the MRTS Camp

FINDING: *The MRTS and SU-4 accommodation camps are non-compliant with applicable standards, including the IFC/EBRD "Workers' Accommodation: Processes and Standards" and the Welfare Policy and Plan of Petrofac. Actions need to be taken in order to ensure adequate living conditions, leisure/communication infrastructure and safety (fencing/stray animals prevention) and in accordance with recommendations provided by Petrofac in their inspection reports.*

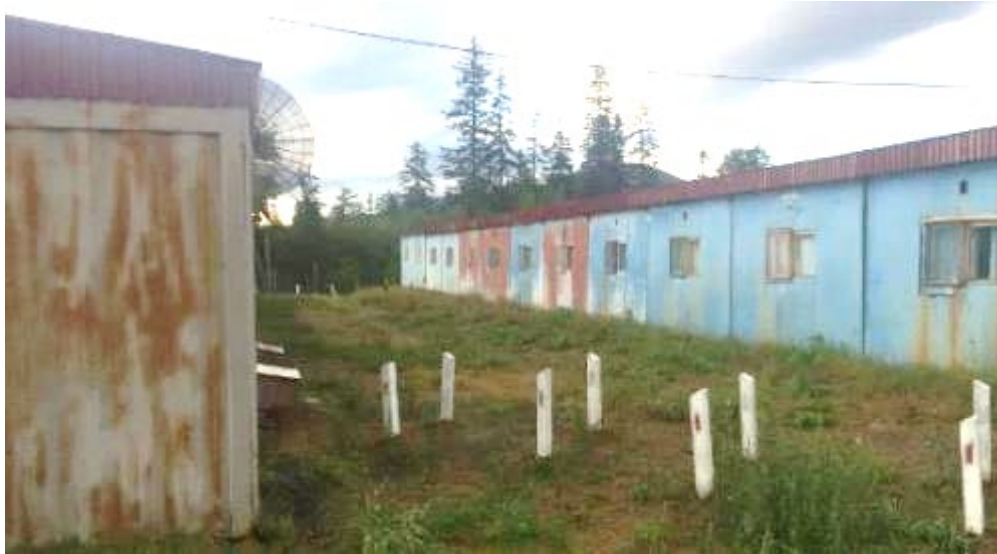
The SU-4 accommodation camp, with a capacity of 110 beds, accommodates 103 workers and is also operated by an external party. The camp consists of two dormitory modules constructed in early 2000's and is currently in a dilapidated condition.

Figure 2.5 SU-4 Camp dormitory module

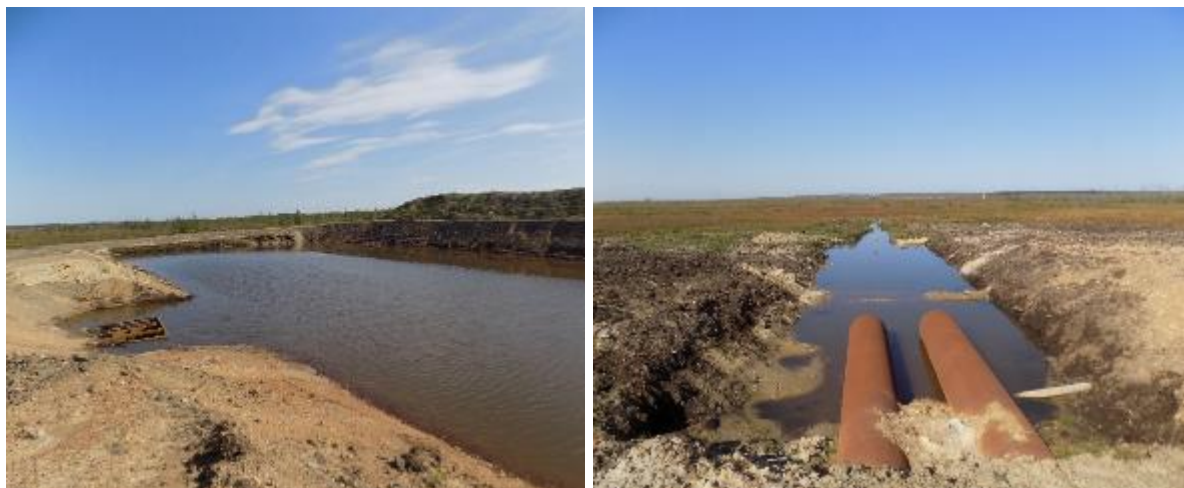
In 2016, Ramboll visited the proposed location of the peat storage area prior to any peat deposition. Ramboll then revisited the site in 2017 once peat storage had begun and made some comments on it which formed 2017 OFI #28. Essentially, the storage of peat by Sakhalin Energy has been extremely ordered and in line with Russian Federation requirements. The height of the peat piles exceeds those previously used by Sakhalin Energy, but this has been addressed previously by Ramboll. During the site visit, a new settlement pond and recently permitted discharge point to the peatland habitats north of the site were observed, along with a very effective system of drainage channels taking water from the peat piles to the pond.

Figure 2.7 – Peat Storage Area Settlement pond and Discharge point

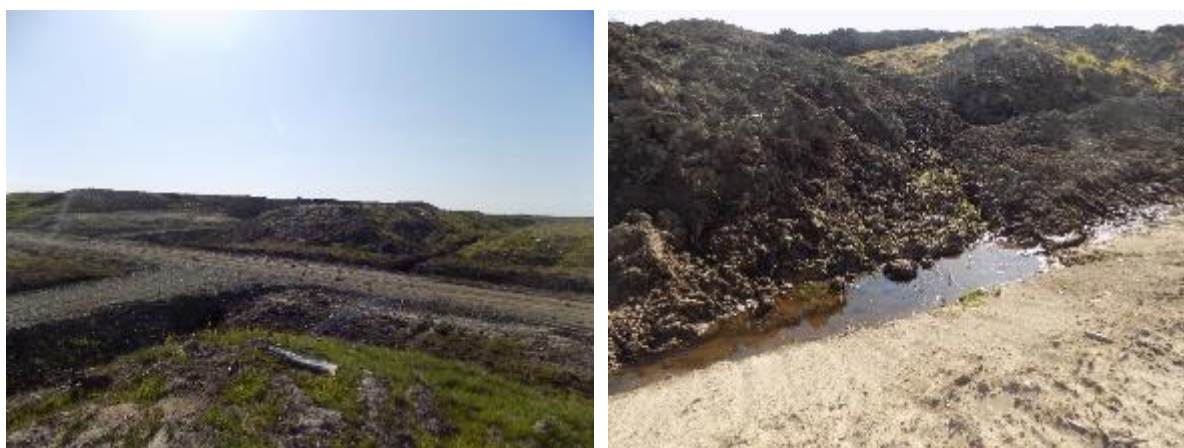
Those peat piles which have been in-situ from last year were seeded with a simple neutral grassland seed mix to stabilise them. Newer peat piles were still in the process of being created. It was clear from both types of pile that the material being deposited is not 100% peat with some non-peaty soils also mixed in. The peat has also lost all of its structure.

Figure 2.8 – Peat Storage Area showing seeded and vegetated piles and non-peaty soils

The peat is being stored for restoration of the OPF-C site following its decommissioning and removal. Only a small part of the stored peat will be required for that restoration. The majority of the peat will remain in-situ in the peat storage area in perpetuity. The area upon which the peat is stored was an area of natural habitat (as defined in IFC PS6) and under that standard, the aim is for no net loss of natural habitat. As such, Ramboll suggests that there may be actions that could be completed within the peat piles that might help to soften the area and allow natural vegetation to recolonise the area.

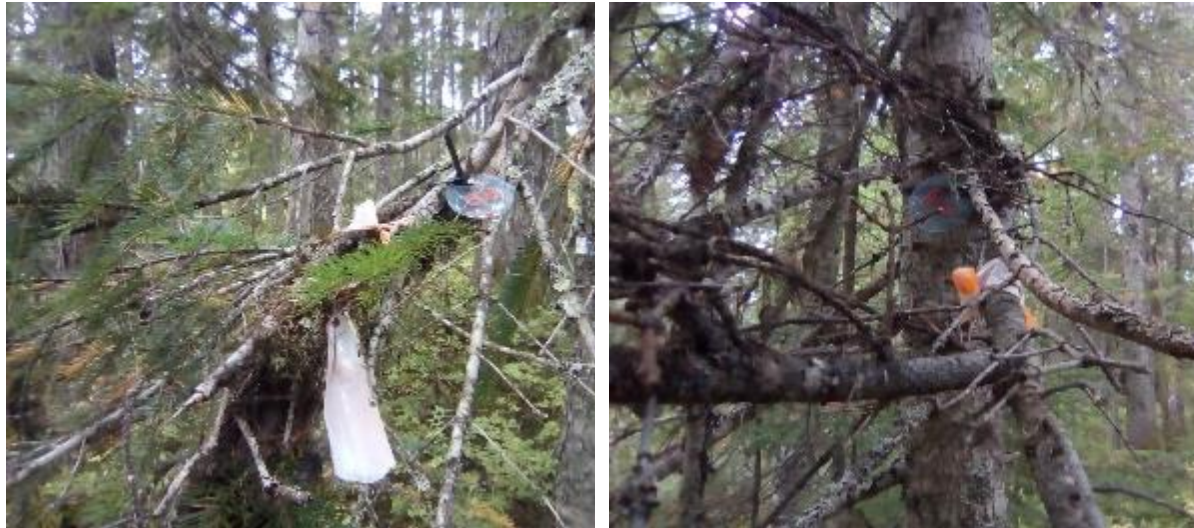
Lichen translocation was undertaken in 2016 and Ramboll was on site to meet the experts undertaking the work. After inspecting one of the receptor areas in 2017, we returned this year to monitor progress further, with the caveat that lichens are extremely slow growing and changes from year are not expected to be great. The lichen translocation was considered to be completed to a high standard and the translocated specimens are well labelled to allow revisits. Of the labelled specimens seen by Ramboll, all appeared to be healthy.

Figure 2.9 – Translocated Lichens

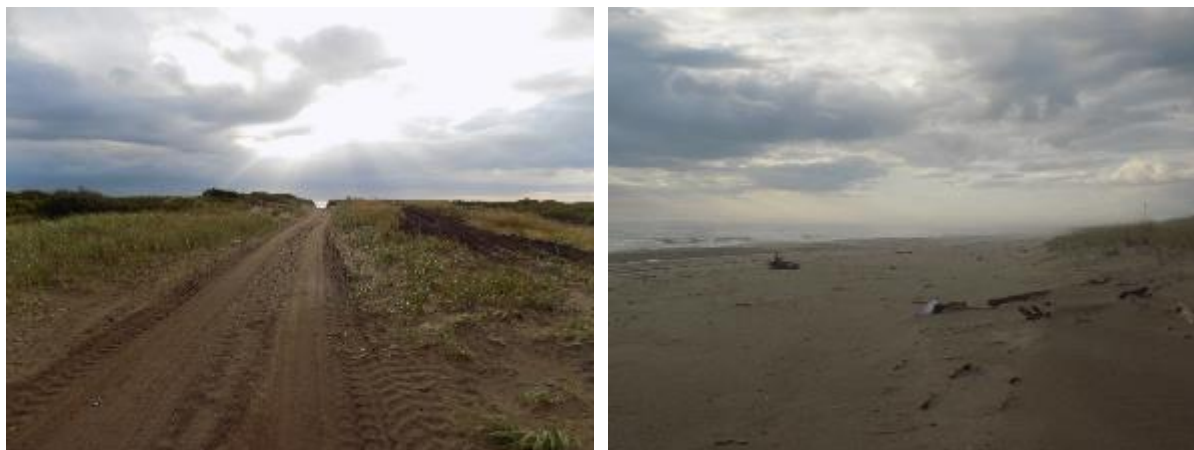
The equipment for the OPF was previously delivered by barge at the same location as that which will be used for the OPF-C. With the exceptions of a gap in the dunes and a track leading to the beach, there is little sign of those previous activities.

Figure 2.10 – Track and gap through dunes, current beach conditions

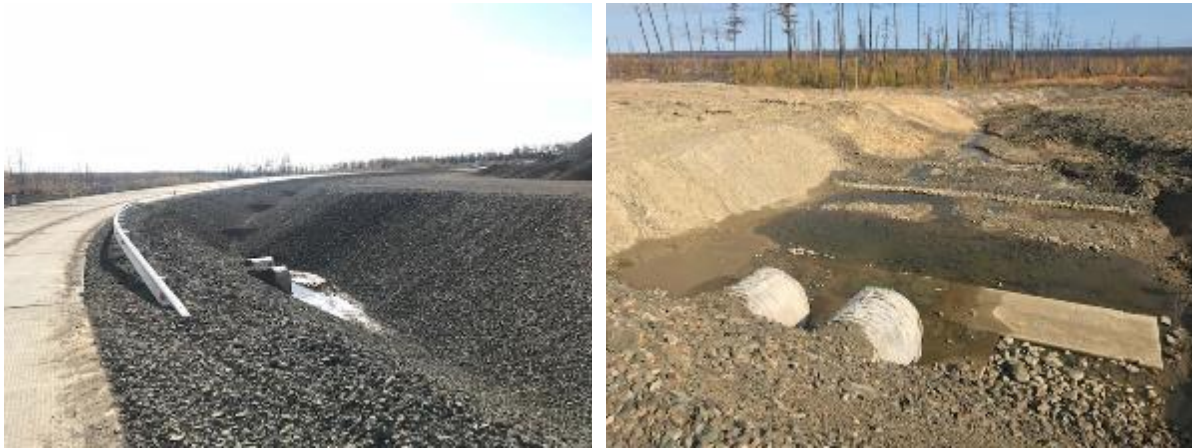
During the 2017 visit to the OPF-C site, Ramboll identified concerns with the on-site surface water management, particularly within the construction area itself as opposed to the camp area. In particular, an outflow from the north-eastern corner of the construction area had clearly allowed sediment to be deposited onto the natural peatland habitats beyond the construction area. In relation to 2017 OFI #22, new measures have been installed on-site to improve the situation. These were seen to be very good and an improvement. Ramboll has made one further suggestion to Sakhalin Energy regarding the possibility to increase the height of measures designed to prevent sediment reaching the habitats at the outflow with a view to the closure of the OFI.

Figure 2.12 – Improved on site water management (photos courtesy of Sakhalin Energy)

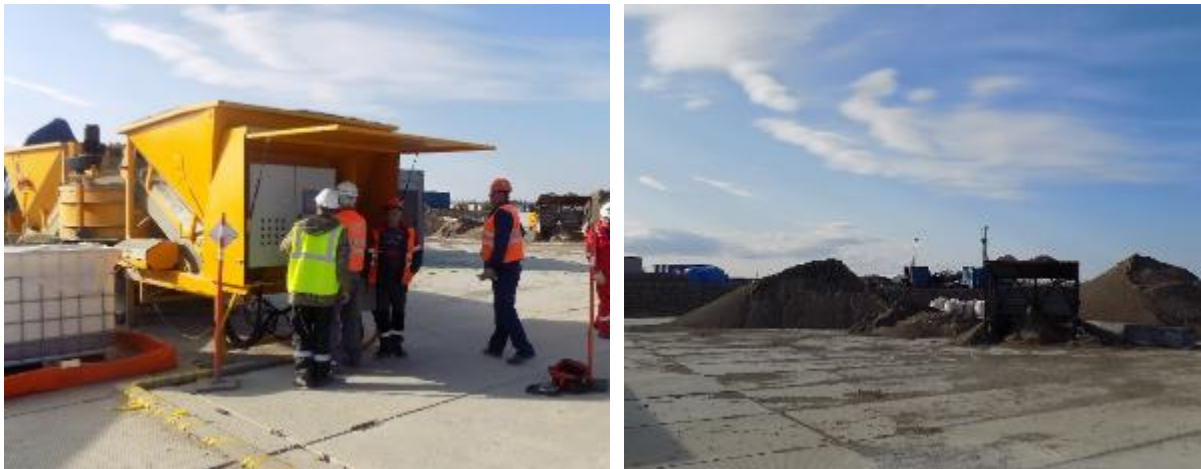
Activity on the construction site was limited at the time of the visit. Test piles have been completed, however, only one main pile had been completed and further piling works were not ongoing. As such, limited amounts of equipment or materials were seen on the site. The main feature was a small concrete batching plant and associated materials the area around which was neat and tidy.

Figure 2.13 – Concrete batching plant and associated storage area on Construction site

As can be seen in the photos of the batching plant (Figure 2.13 above), secondary containment for all liquid storage observed on site had been provided in one form or another. Chemicals were stored within a sealed container and all other camp materials were similarly well stored in a separate container.

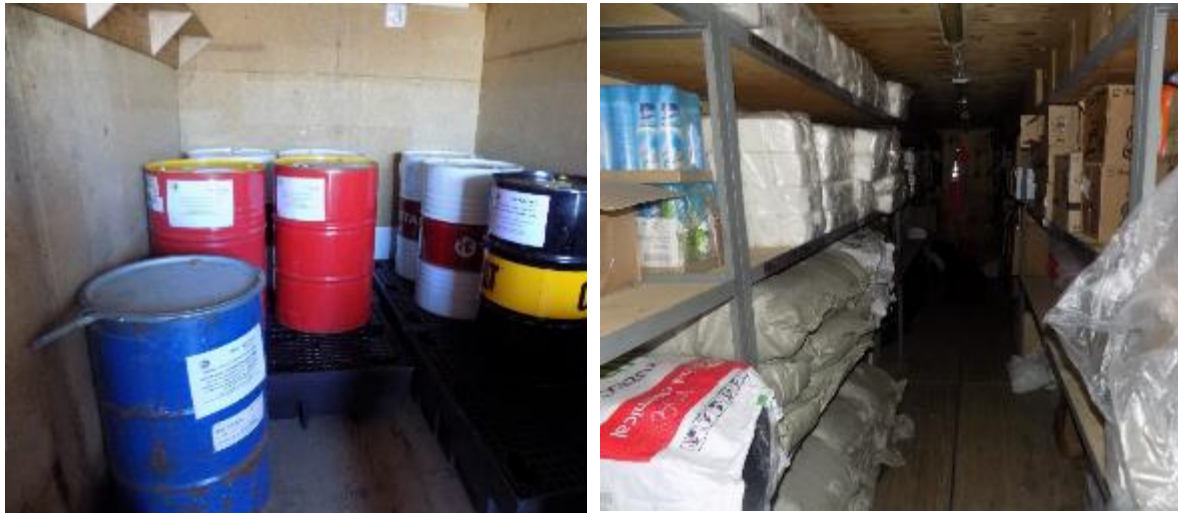
Figure 2.14 – Chemical and material storage. Liquid Barrels banded (oily rags in blue barrel)

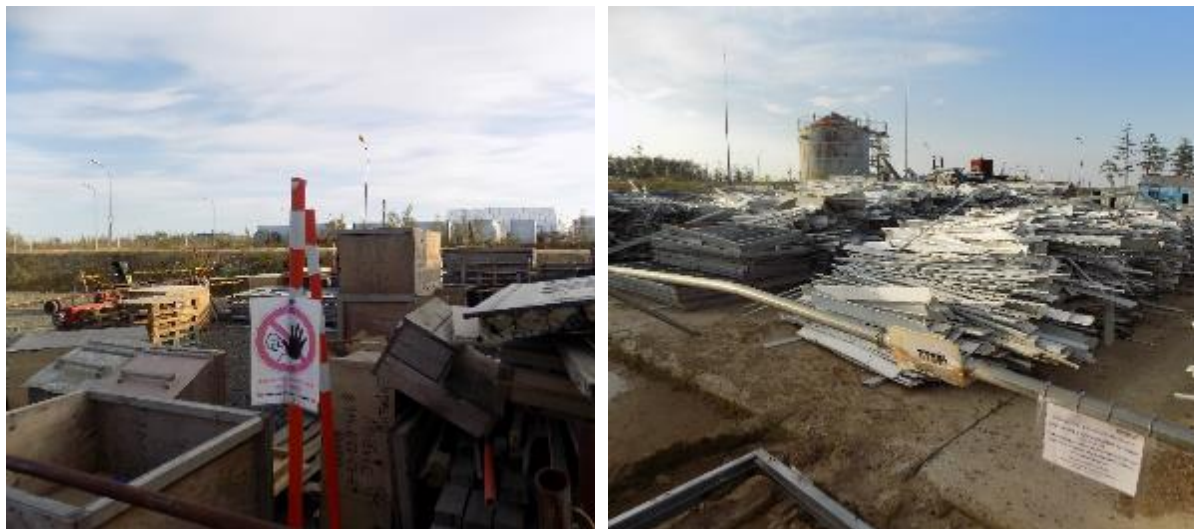
The Company reported that a Waste Management Plan has been implemented for the OPF-C Project and that adequate segregation and storage arrangements are in place at the construction site. All waste from the OPF-C construction site is currently being removed to the camp area each day. During the site visit, storage of waste was found to be extremely well organised. Well managed segregation of waste was seen, with each area clearly signposted.

Figure 2.15 – Wood and Metal Waste Segregation at the OPF-C site

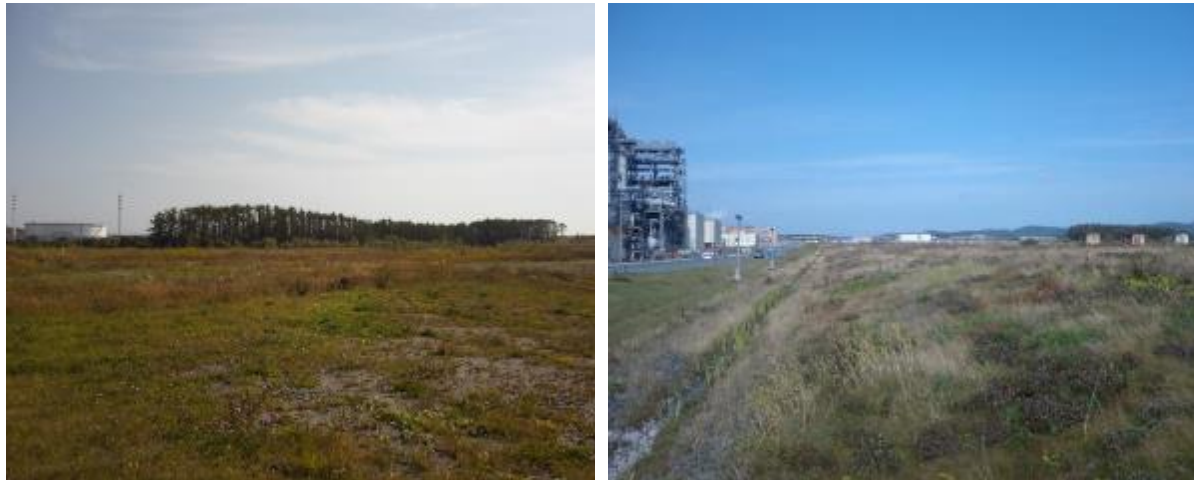
From the walkover, it is understood that although still vegetated, the onshore locations are essentially ready for the commencement of construction with only minor cable relocation works to be conducted in the main Train-3 production area.

Figure 3.1 - General views of the area earmarked for LNG Train 3 production facility, east of the existing LNG facility.

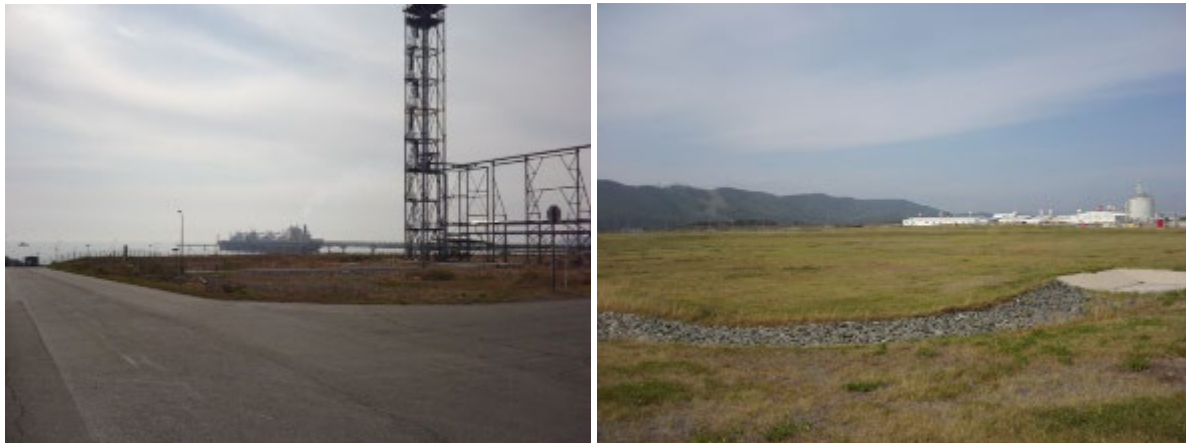
Figure 3.2 - View of the areas earmarked for new LNG loading Jetty (between the MOF and existing LNG loading jetty) and for the new bulk LNG storage tank.

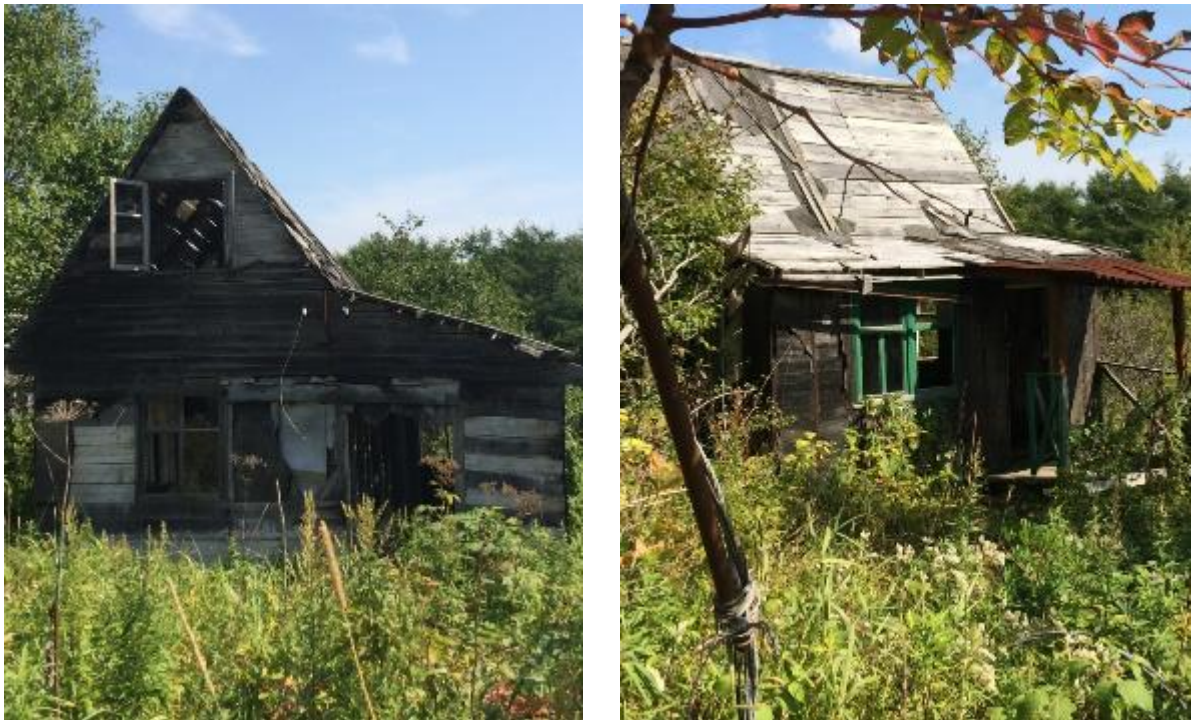
Figure 3.4 Abandoned houses in Stroitel

The dachas community obtained two new households over the few past years. However, the new households occupied previously-used land parcels; thus, the community is not expanding spatially. It is still noted that the number of tenants at Stroitel should be monitored as the empty land lots with legacy structures (previously belonging to fully-compensated persons) are now in possession of local administration and there is some potential for them to be re-occupied by newcomers. In such event, the stakeholder list shall be revisited by Sakhalin Energy.

Overall, it is understood that the Train-3 construction activities shall require additional Stroitel community engagement practices. To these ends, operation of Information Centres and the CLO office in Korsakov is viewed as critical. We recommend that the Company revisits the stakeholder engagement methods on a regular basis to ensure that they are sufficiently tailored to the needs and abilities of Stroitel dachas community.

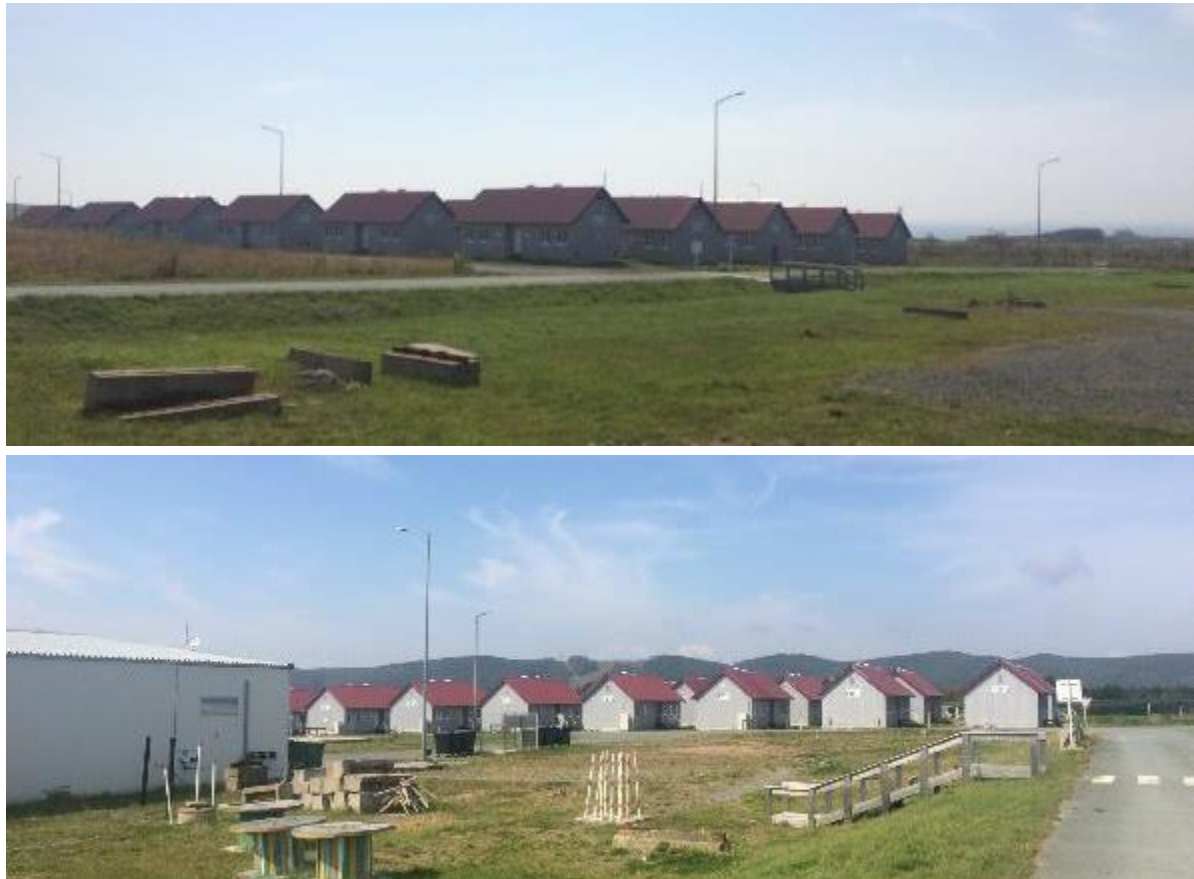
After the first load of cargo is dispatched from Train-3, the camp facilities will be relocated to a new area due to a change of SPZ (current location of Yunona camp will be within Train-3 SPZ). The location of this area is as yet unknown. It is recommended that the future Yunona camp relocation alternatives should aim to minimise the potential for physical displacement of local communities.

Figure 3.5 Yunona camp in its current condition

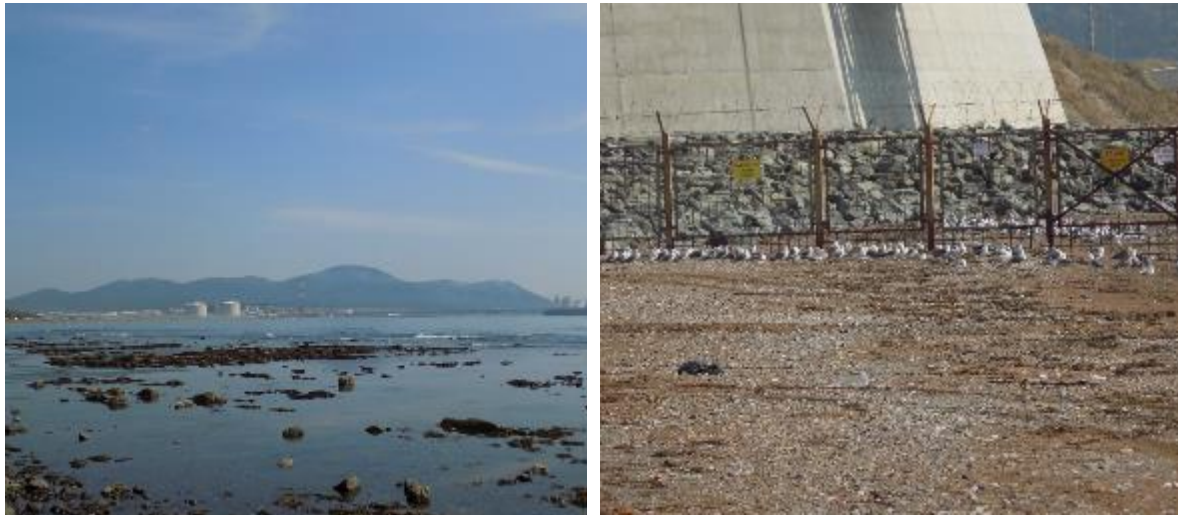
Figure 3.6 – Rocky shore west of LNG and gull roost adjacent to LNG

It was clear that Salmon Bay, which lies almost 20 km west of the LNG and not in a direct line of flight as it is north of Korsakov, provides the best coastal habitats for birds within the immediate area of the LNG. The tide was low at the time of the visit and abundant waders, herons and ducks were in the area along with various raptors. In contrast, the rocky shores east and west of the LNG (both c. 3 km) supported only occasional gulls and ducks. Notably, the largest gathering of gull species was recorded on the beach adjacent to the existing LNG jetty with small numbers of ducks swimming under the jetty and cormorants resting on the structure itself.

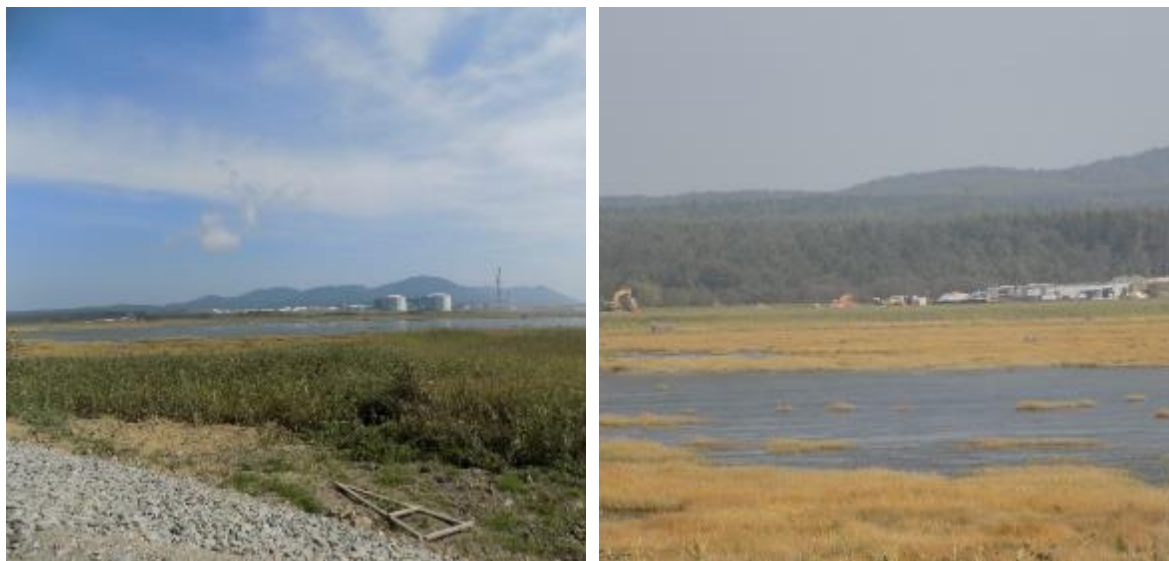
Figure 3.7 – Mereya Wetland, showing proximity to LNG and restarted bridge works

The Mereya wetland (less than 1 km west of the LNG) was also visited, and the waterbody was found to be entirely devoid of any birdlife. In discussion with the Sakhalin Energy ornithologist, it seems that the waterbody is only used infrequently by birds, not least as hunting still occurs there. Nonetheless, bird monitoring reports produced by Sakhalin Energy have identified the surrounding wetland as providing important breeding locations for species such as Latham's (Japanese) snipe *Gallinago hardwickii*. Works apparently restarting on the mothballed bridge across the Mereya will need to take account of that constraint.

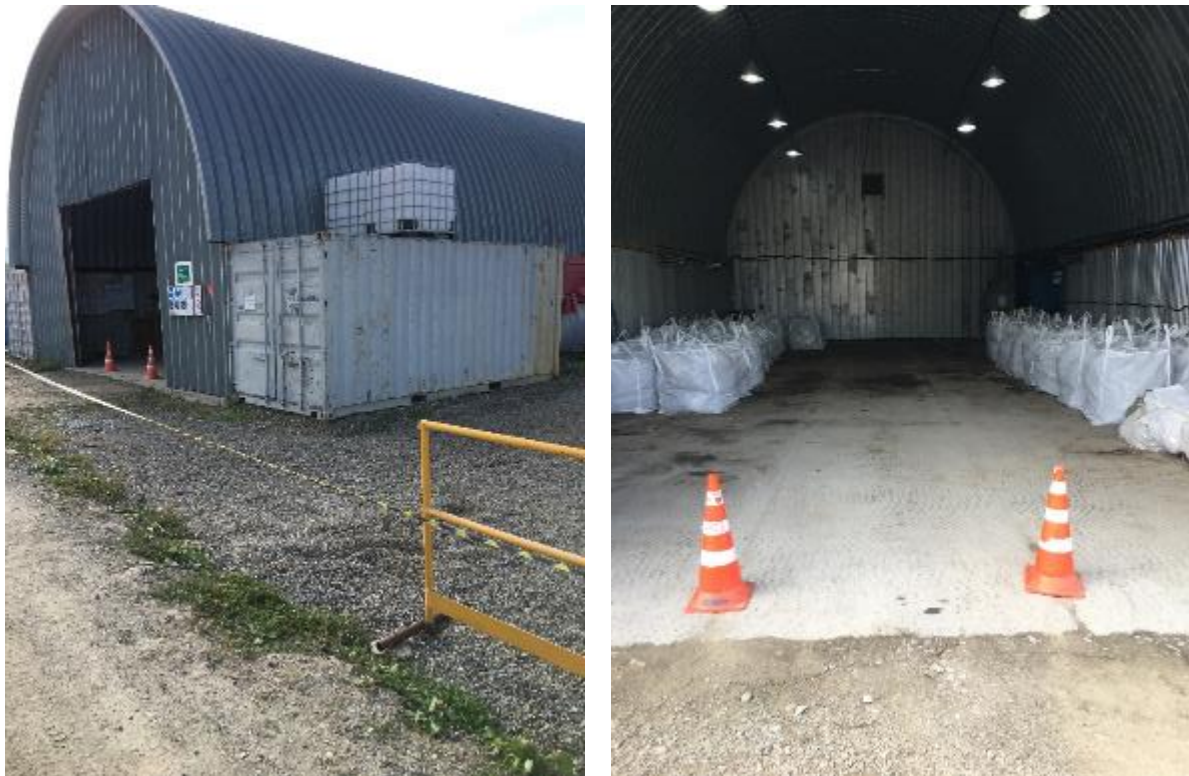
No obvious signs of leaks or spills of hazardous liquid wastes were noted by Ramboll during the brief walkover (e.g. ground surface staining, odour or distressed vegetation) and no significant incidents (fires or spills) were reported to have occurred.

Figure 4.1 - General views of the exterior and interior of the non-hazardous waste storage shed

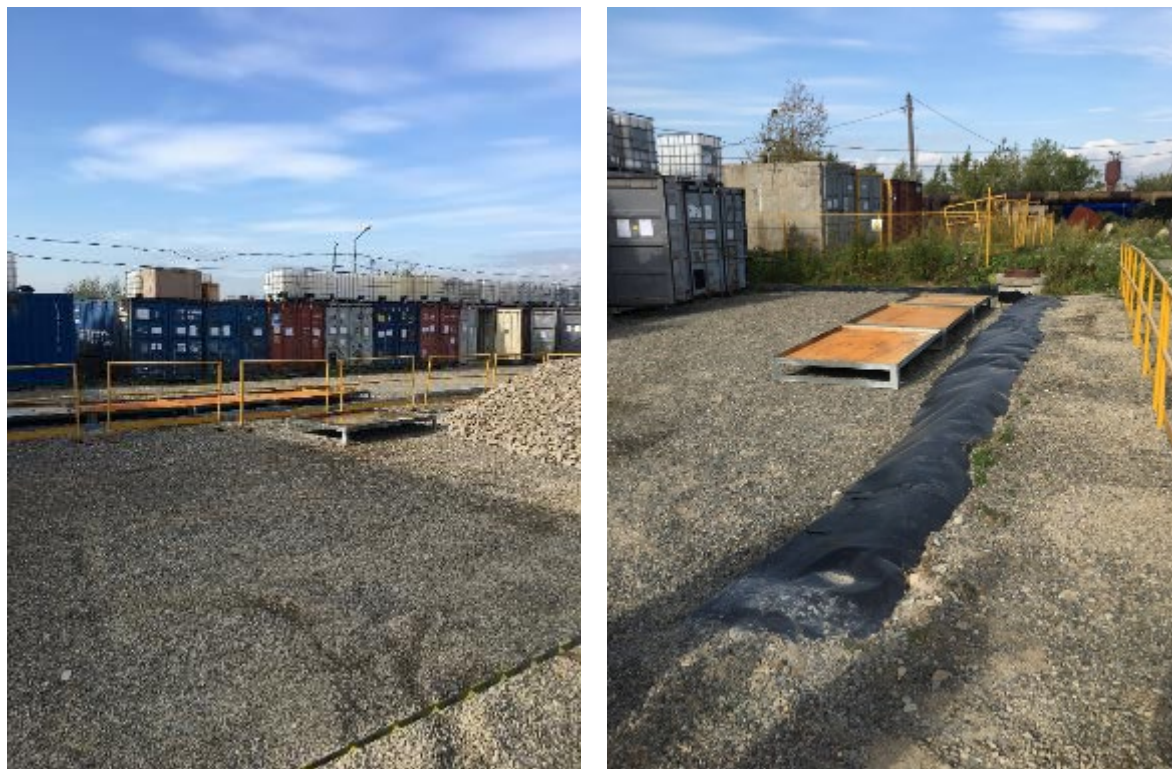
Figure 4.2 - Views across hazardous waste storage area (including trays for initial reception of drums and impermeable liner visible around the perimeter)
