Appendix 3 Individual RoW Descriptions

List of RoW Locations Visited			
KP	River / Location	Team	Date Visited
96	NOB-17	Northern	28/9/2011
109	NOB-19	Northern	28/9/2011
22.7	Khandusa River	Northern	29/9/2011
14	Sandy slopes / fault crossing #1	Northern	29/9/2011
36 – 38.3	Access route to Askasi River	Northern	29/9/2011
62	Dagi River	Northern	29/9/2011
67	Tomi River	Northern	29/9/2011

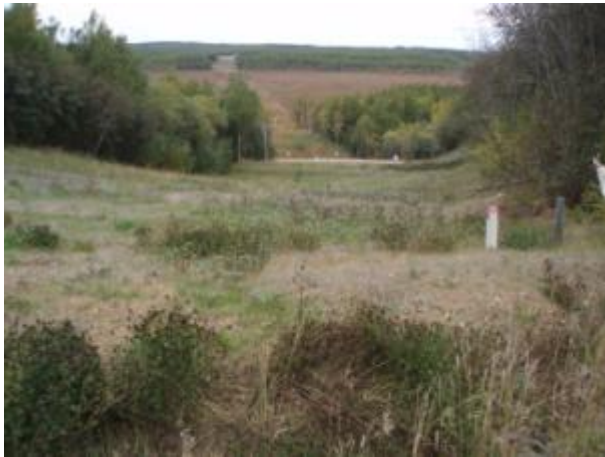
The RoW either side of the BVS generally re-vegetating well, although significant unwanted tree growth on the RoW was also identified (see Photo 1).

Photo 1 – Re-vegetation of the RoW (note unwanted tree growth)

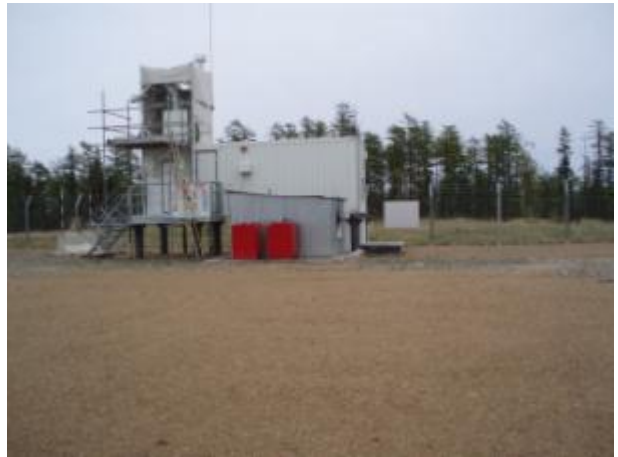
A temporary diesel power generator and associated fuel day were present at the BVS (see Photo 2). These were located within a rudimentary bund, although it appeared unlikely that this would provide sufficient containment to HSESAP requirements (110% secondary containment).

Photo 2 – Temporary diesel generator and fuel day tank (note rudimentary containment)

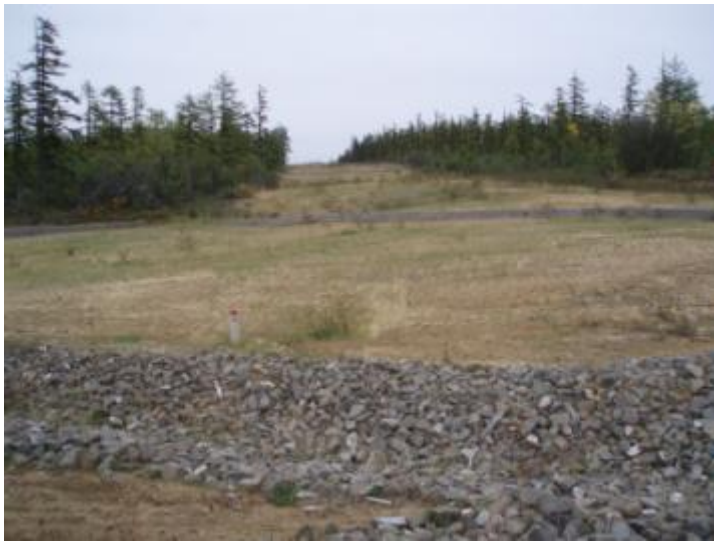
The RoW either side of the BVS generally re-vegetating well, and drainage controls are in good condition (see Photo 1).

Photo 1 – Armoured drainage ditch in good condition

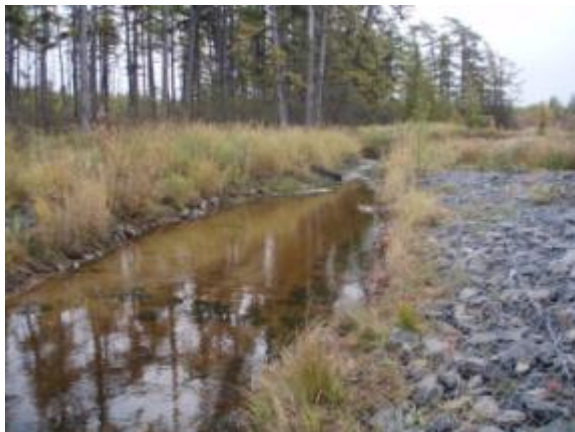
The river banks are protected by Reno matting which appears in good condition with some amount of growth through the matting starting to appear (Photo 1). The RoW slopes to the north show evidence of good vegetation, particularly on the lower slopes towards the river where the peat concentrations are higher, and the slope breakers appear to be functioning well. The southern bank appears to be more sandy and while limited re-vegetation is occurring in some areas and good use of Enkamat was evident (see Photo 2), some erosion/rillings was evident (see Photo 3). In places the erosion is becoming more severe with washouts behind slope breakers (Photo 4).

Photo 1 – Reno protection on the riverbank

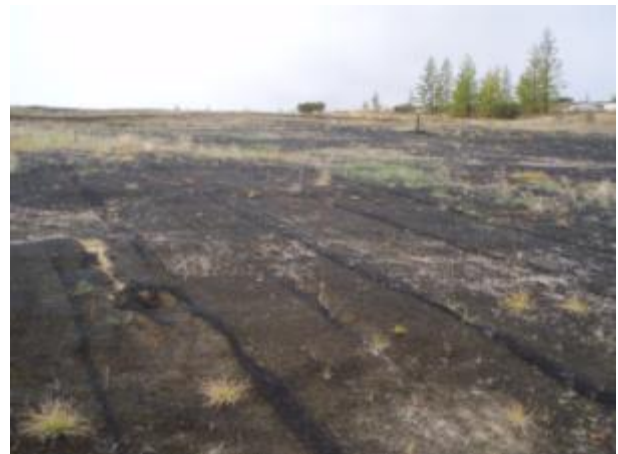
Photo 2 – Southern slopes with Enkamat

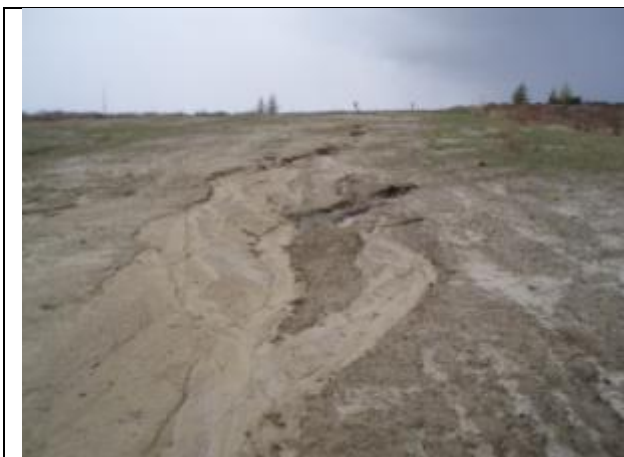
Photo 3 – Rilling on the Southern slope

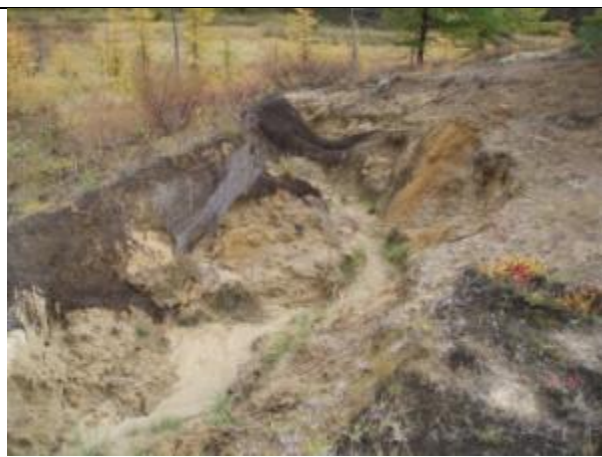
Photo 4 – Washout behind Slope Breaker

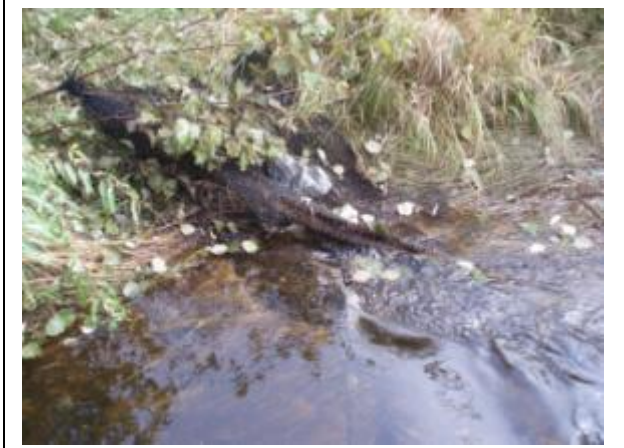
There was evidence that Enkamat installed by the Company for surface stabilisation on the RoW was found to have been pulled up and used as impromptu netting across the river, presumably for illegal fishing during the salmon spawning season.

Photo 5 – Enkamat in river

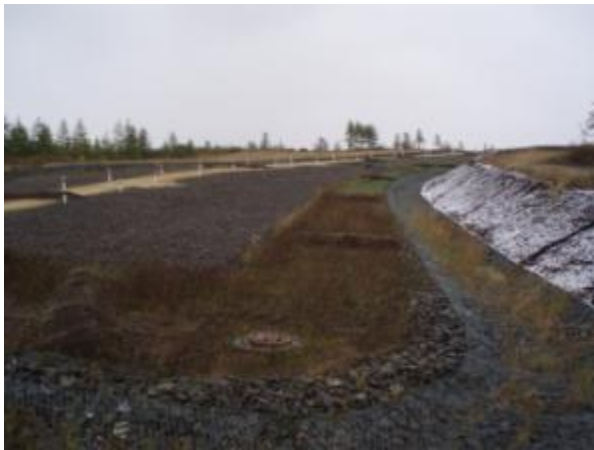
The fault crossing area is fenced off and was found to be in tidy condition, with the running track and drainage controls in generally good condition (see Photo 1). However, some of the side cuts at the edge of the fault crossing were seen to be failing and are in need of both redesign and repair (see Photos 3 and 4).

Photo 1 – Drainage channels running track

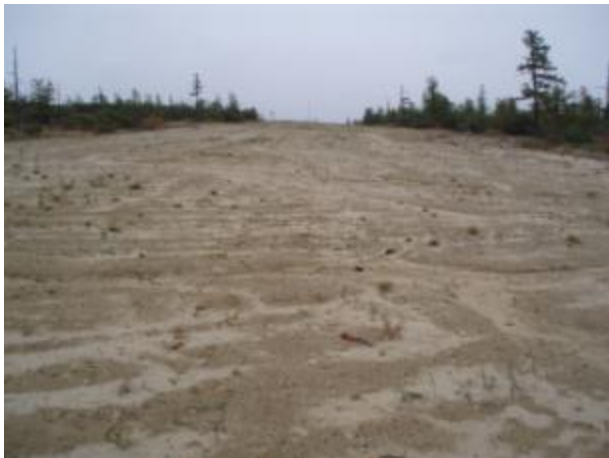
Photo 1 – lack of vegetation

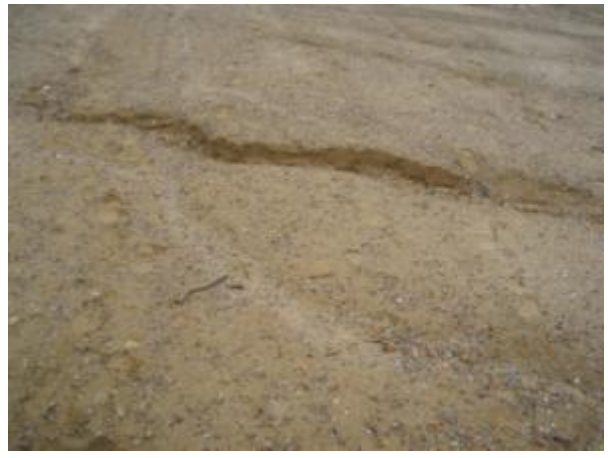
Photo 2 – Erosion rills forming

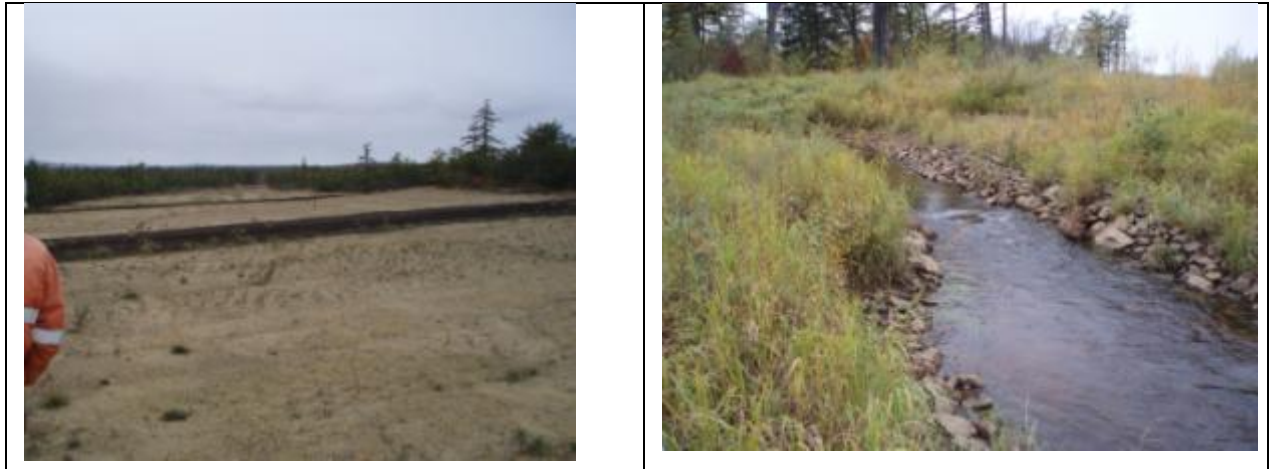
The upland slopes on the approach to the river itself, also show a lack of vegetation, although slope breakers have been installed to a good standard help reduced siltation effects (see Photo 3).

Photo 3 – Slopes breakers on the approach to the river

Photo 4 – Good revegetation of the riverbanks

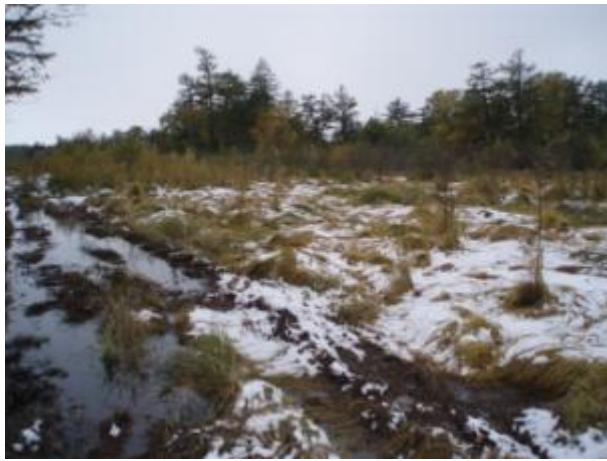
The northern approach to the crossing was very wet but appeared to be showing good signs of re-vegetation (snow on the ground at the time of visit limited the level of visual inspection that could be undertaken see Photo 1).

Photo 1 – Vegetation growth on the north approach

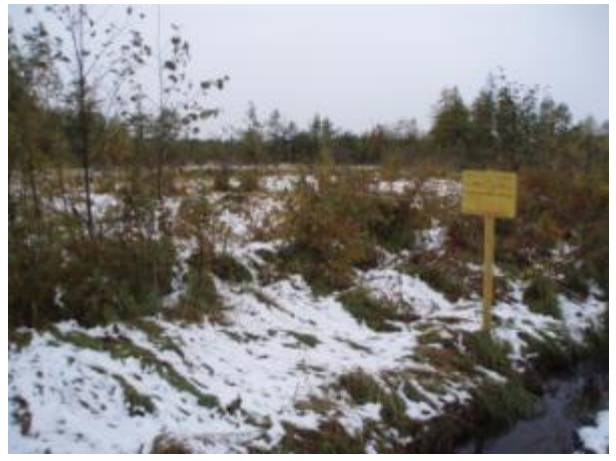
Good vegetation of the riverbanks was also identified, although significant tree growth was also identified that will require control.

Photo 2 – Riverbank re-vegetation (including tree growth)

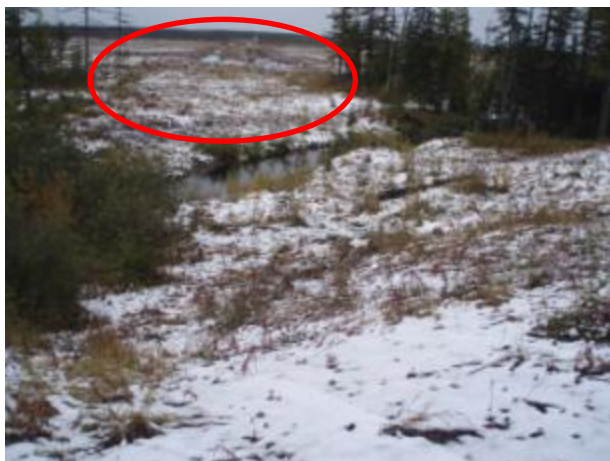
The riverbanks are protected by reno mats. These appear to be in reasonable condition with some vegetation now growing through the mats, although snow cover made visual inspection difficult (Photo 1).

Photo 1 – Bank protection and vegetation (note visible pipeline crowns)

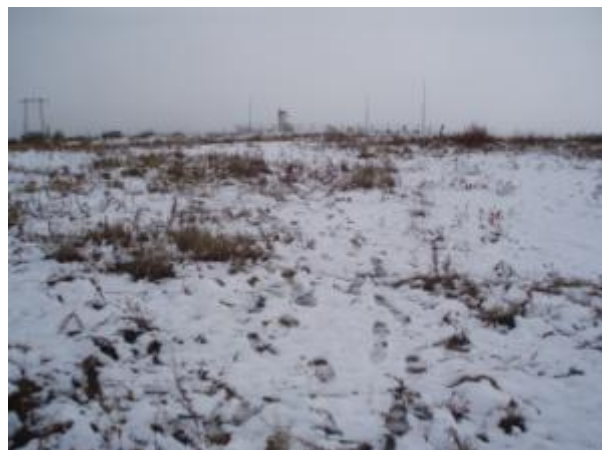
The southern approach to the river crossing area was snow-covered, although it appears, although re-vegetation was clearly visible through the snow, it was not possible to judge the overall level of recovery (Photo 2). A wetland area lies to the north of the river crossing. This area could not be accessed for close inspection, but even from a distance the crowns on top of the pipelines were clearly visible (see far side of river in Photo 1). We note that this wetland area is on the list of wetlands identified by Sakhalin Energy for ongoing recovery monitoring.

Photo 2 – Snow-covered RoW with some visible vegetation

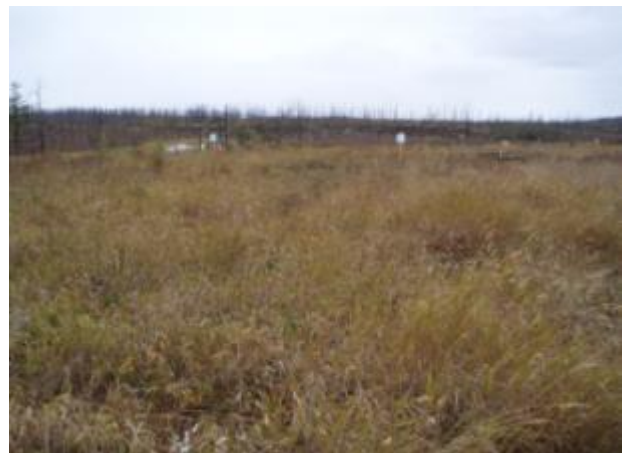
Vegetation at the top of the hill is sparse (Photo 1), although at this site there is no evidence of erosion features forming and the slope breakers are in place and in good condition (Photo 1). The vegetation growth improves further down the hill and is good in the river valley area where there is more peat and organic matter in the soil (Photo 2).

Photo 2 – Good vegetation in river valley

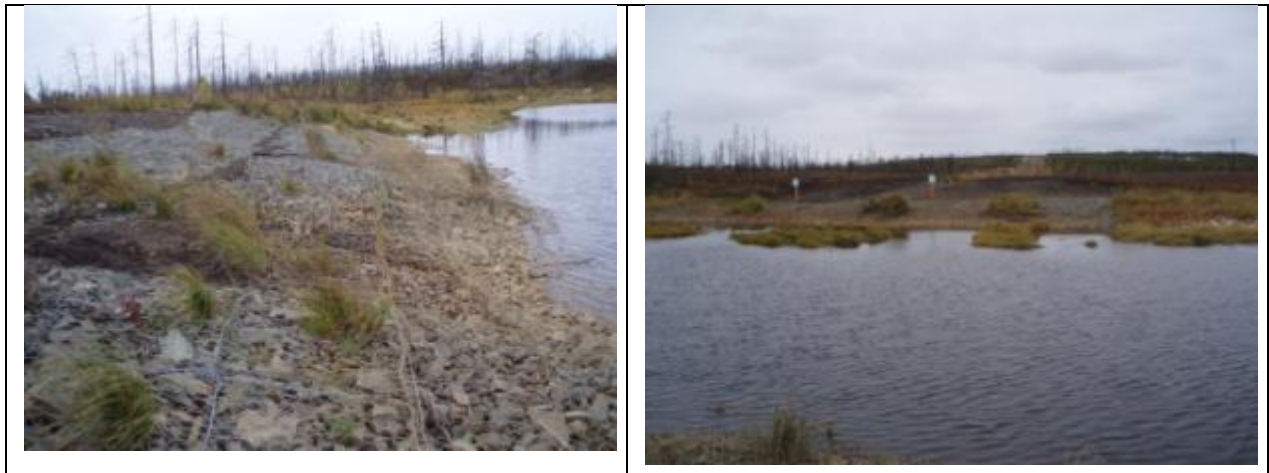
Reno mats are in place on both riverbanks and appear in good condition with vegetation growing through the mats (Photos 3 and 4).

Photo 3 – Reno mats on the southern riverbank

Photo 4 – Reno mats on the northern riverbank

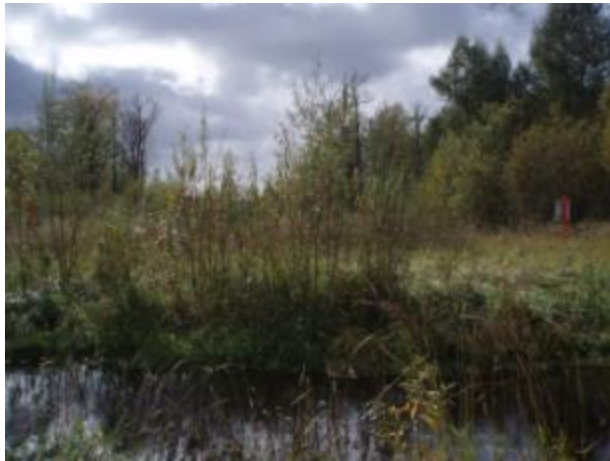
The river banks are in good condition with silting of the bank encouraging growth and bank stabilisation (Photos 1), the river bed appears clean and gravelled.

Photo 1 – Riverbank re-vegetation

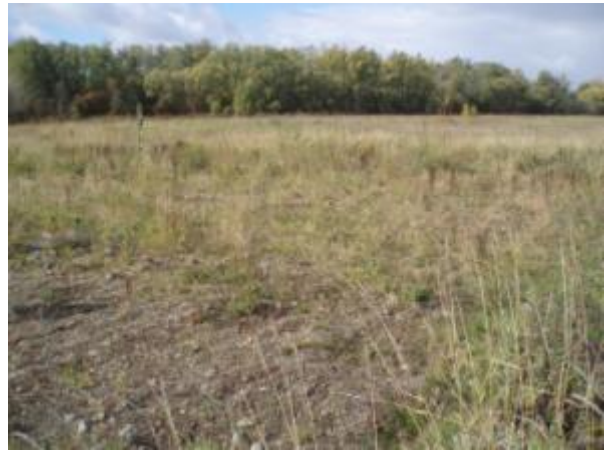
The approach to the river is partially re-vegetated with a reasonably healthy looking cover coming through (Photos 2). In some areas significant unwanted tree growth was identified (see Photos 1 and 3)

Photo 2 – Re-vegetation RoW

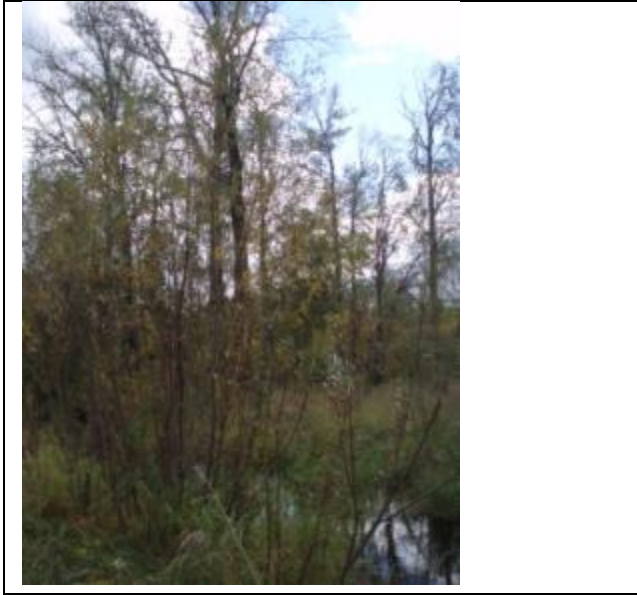
Photo 3 – Tree growth on the RoW

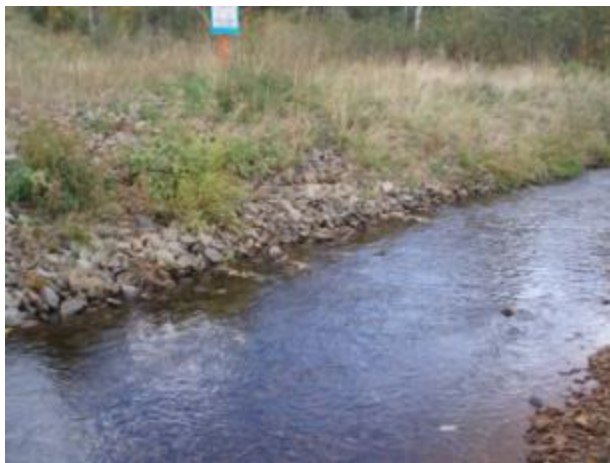
The river crossing is protected by rip-rap and was in very good condition, with natural re-vegetation growing through the rip-rap, and the river was seen to be running clean with no evidence of silting (Photo 1).

Photo 1 – Svetly Stream banks

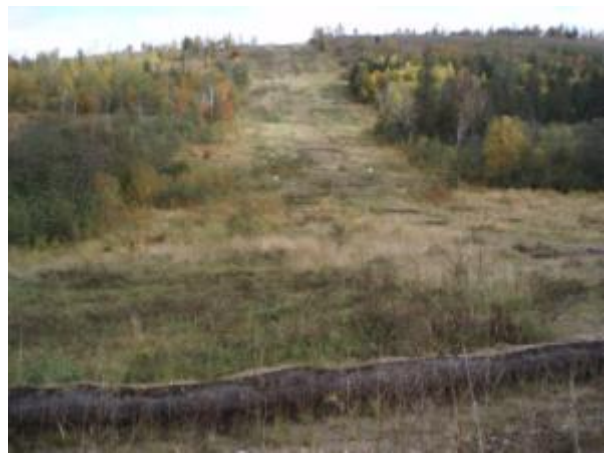
The re-vegetation is good close to the river on the lower slopes (Photo 2) and moderate on the upland slopes (Photo 3).

Photo 2 – RoW adjacent to river

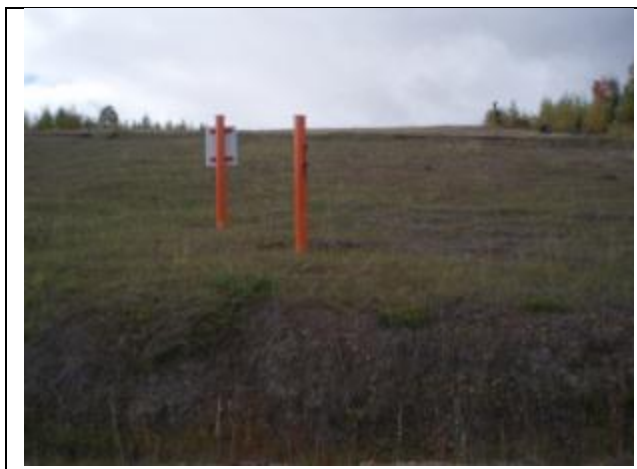
Photo 3 – Upland slopes above the river

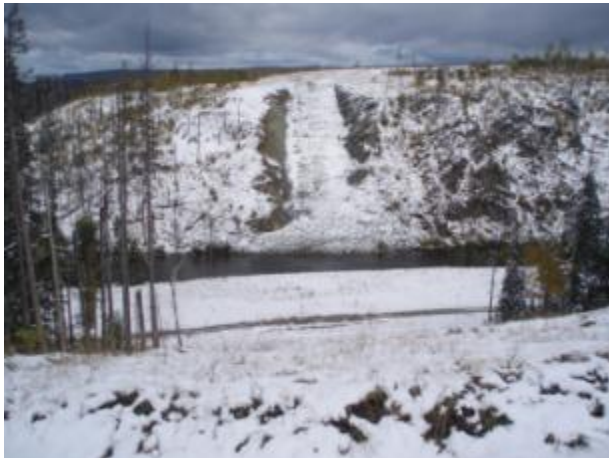
At the time of the site visit both the northern and southern slopes were snow covered, making visual observation of the condition of the RoW impossible.

Photo 1 – North facing Scree Slope

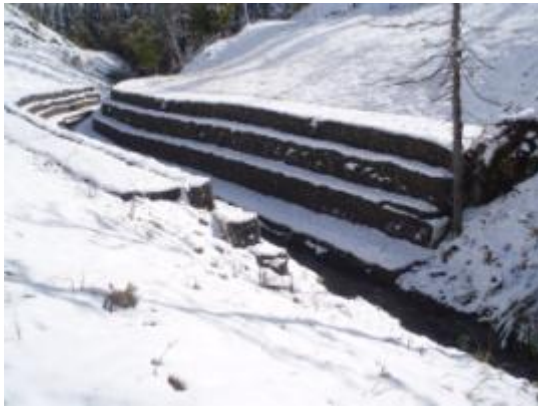
Due to the steep nature of the crossing and the problems of slope stability, the toes of slopes along the river are controlled through gabions (Photo 1). These all appear in good condition with the wiring holding well and no signs of movement at the toe.

Photo 1 – Gabion engineering at toe of slopes

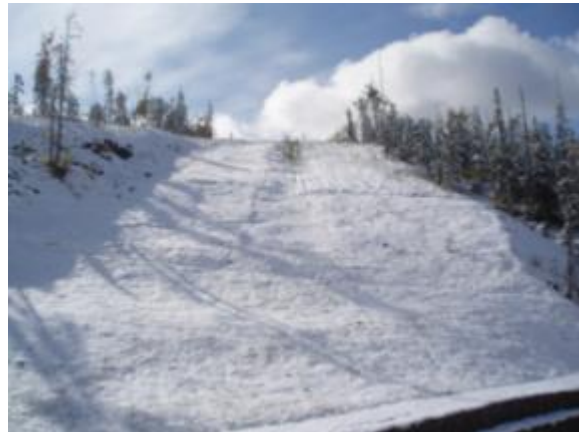
The slopes on either side of the river were heavily snow covered making visual observation of condition impossible (Photo 2).

Photo 2 – Snow covered slopes

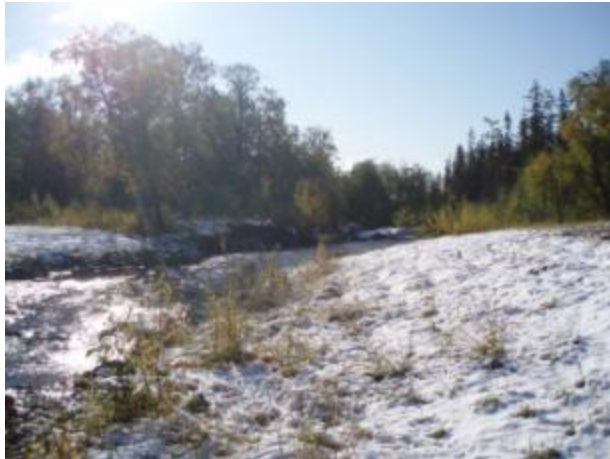
The river banks were in good condition on the RoW with Reno mats holding well with signs of growth visible along the bank despite snow coverage (Photo 1). The river appears clean and silt free and the riverbed at the crossing location comprised clean gravels of a similar nature to upstream areas (Photo 2).

Photo 1 – Reno mats signs of re-vegetation

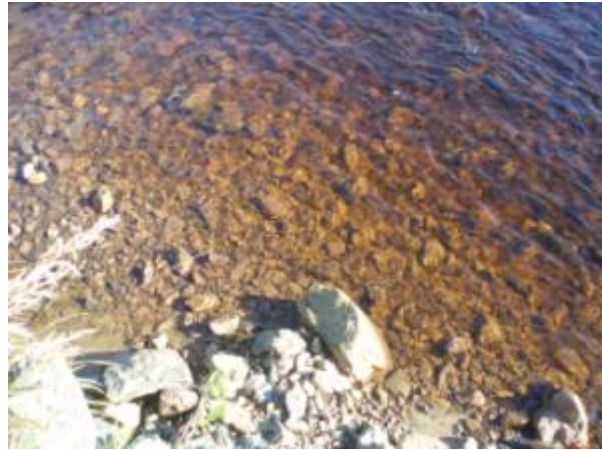
Photo 2 – Scour upstream on east bank

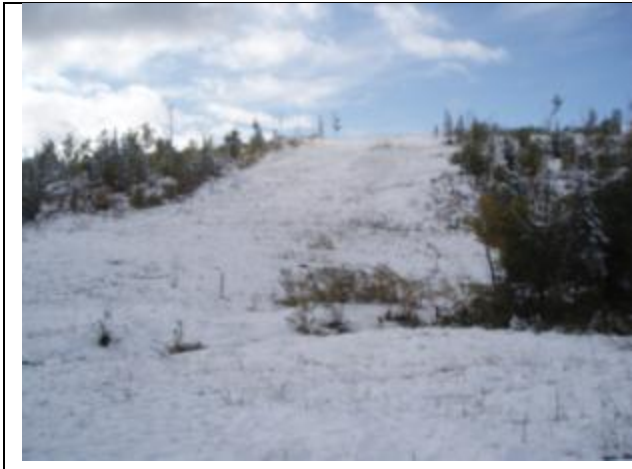
Snow cover on the adjacent slopes made visual inspection of the condition difficult, but it appeared that re-vegetation was likely to be sparse (Photo 3).

Photo 3 – Snow-covered RoW

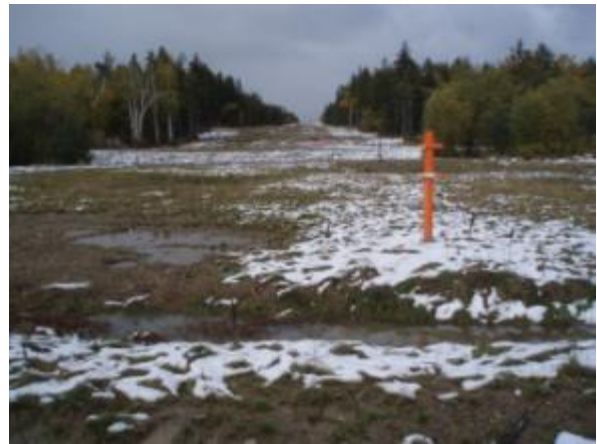
The RoW is showing sparse to moderate vegetation growth in the low lying areas (Photos 2 and 3) and this will require some attention in the form of continued fertilisation to ensure improved growth over the next few growing seasons.

Photo 2 – Moderate/sparse vegetation growth on the RoW

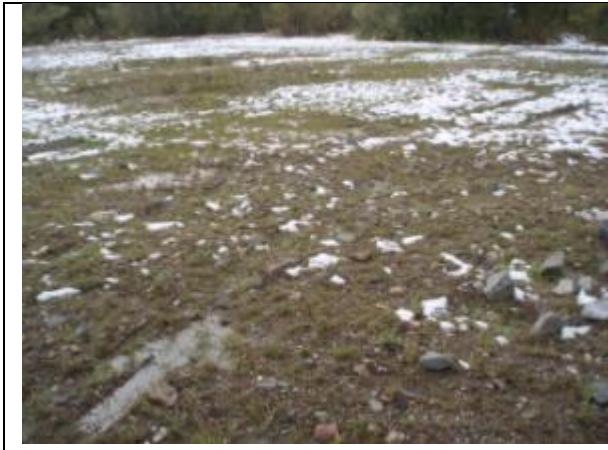
Photo 3 – Moderate/sparse vegetation growth on the RoW

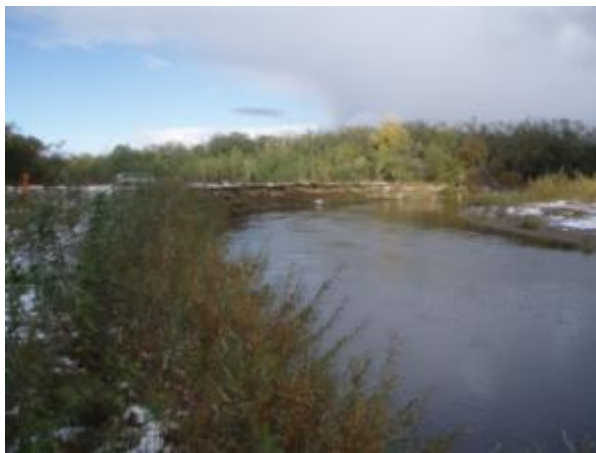
The northern bank of the river (outside curve of the meander) is protected by gabions, through significant vegetation is now growing (Photo 1). The southern bank has Reno matting now covered in silt and is also showing natural re-vegetation (Photo 2). At the time of the visit there were no concerns over the river bank condition at this crossing.

Photo 1 – Vegetation covered gabions on north bank

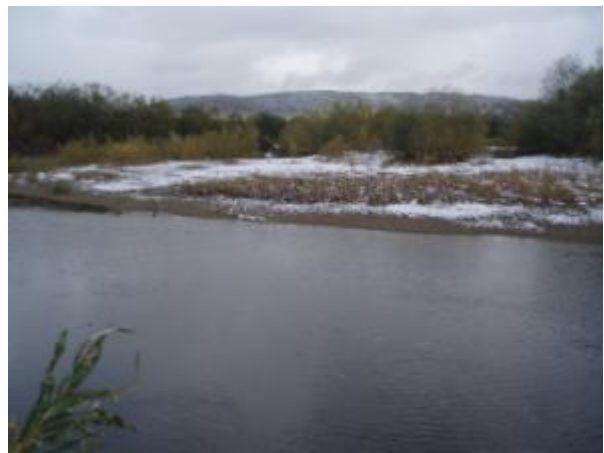
Photo 2 – View to south bank

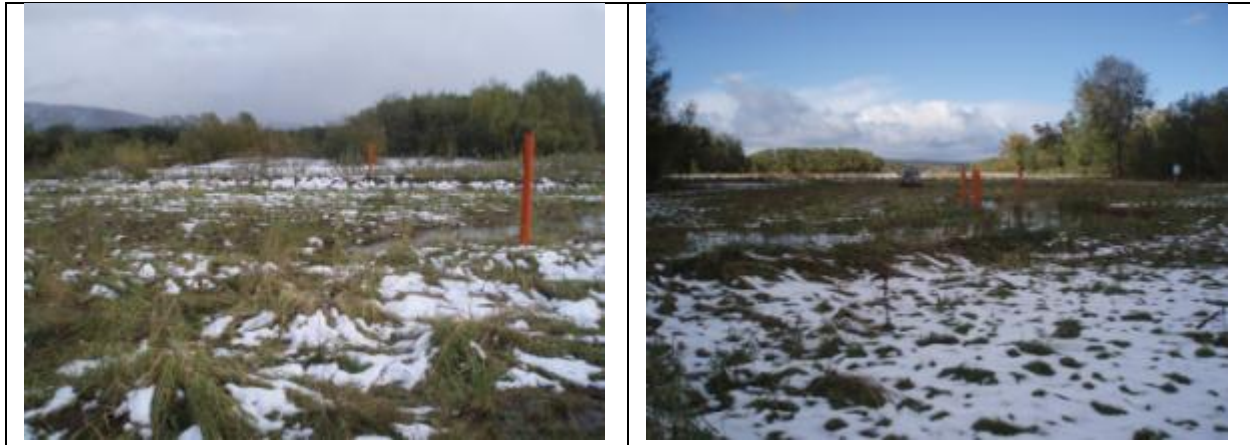
Re-vegetation along the RoW on the northern approach to the river is general good (Photo 3). Some tree growth was noted on the southern bank that will require control (Photo 1). Some pooling of standing water was identified over the pipelines (Photo 4).

Photo 3 – Re-vegetation on north approach

Photo 4 – Pooling over the pipeline north of the river

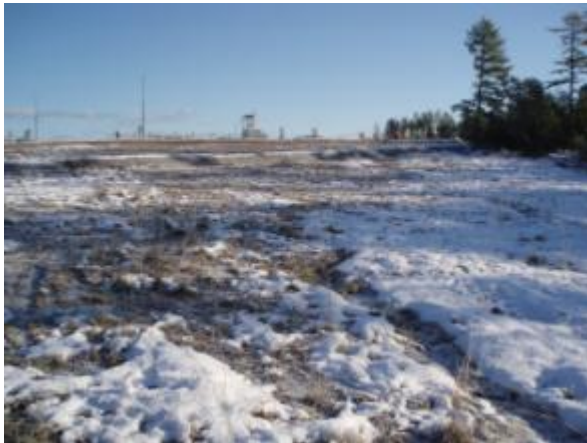
This area had been a problem during the construction period with wash-outs and erosion difficult to control. It was noted during this visit that the slopes had held up reasonably well with the slope breakers still in place but only moderate signs of vegetation growth under snow coverage (Photos 1 and 2). However, in common with the other sandy areas visited, there

Photo 1 – Slopes looking north to TOB-1

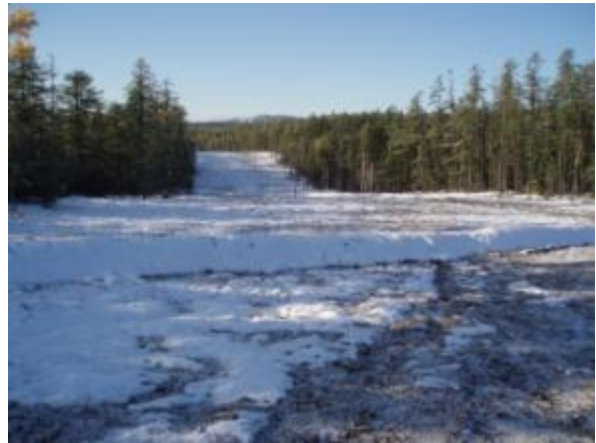
Photo 2 – Photo looking south

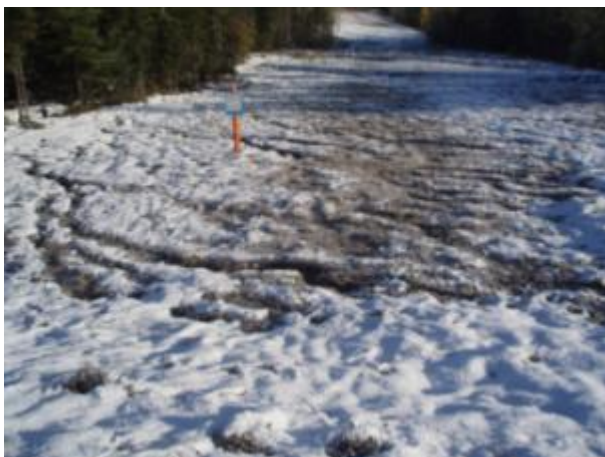
was evidence of erosional features with erosion rills formed in areas of barren growth (Photo 3), and silt and sand build up behind slope breakers (Photo 4).

Photo 3 – Erosion rills in barren soil

The sparsely vegetated areas of the slopes will need further re-seeding and fertilisation to try and create a long-term solution to the erosion, while in the short-term repairs and maintenance will be required for the engineered areas of the slope.

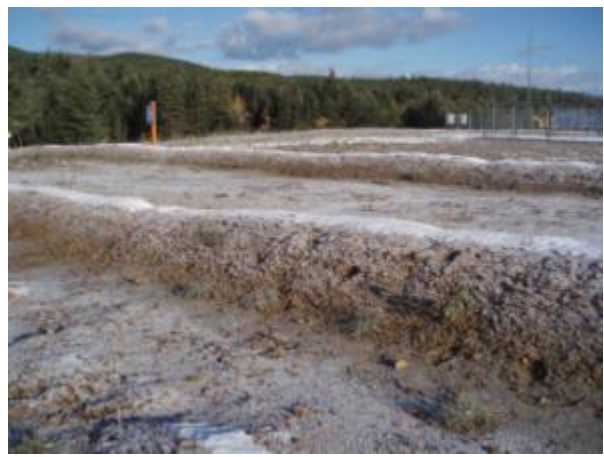
Photo 4 – Slope breakers with evidence of siltation

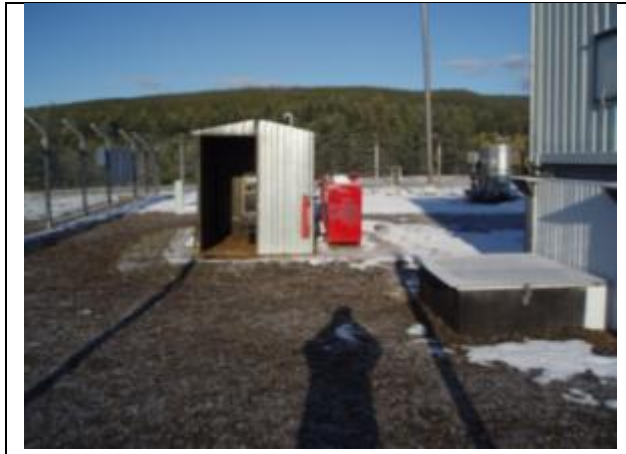
A temporary diesel power generator and associated fuel day were present at the BVS (see Photo 5). These were located within a rudimentary bund, although it appeared unlikely that this would provide sufficient containment to HSESAP requirements (110% secondary containment).

Photo 5 – Temporary generator at TOB1

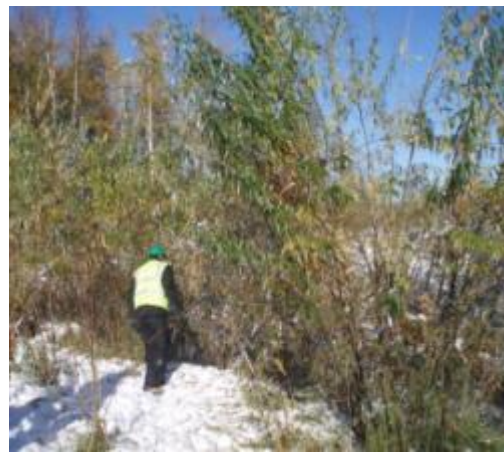
Heavy snow coverage made visual inspection of the RoW into the river difficult, but significant re-vegetation was identified (Photo 1). However, this include tree growth, including some very tall growth that had evidently taken multiple seasons to grow and which is in urgent need of control (Photo 2).

Photo 2 – Significant tree growth on RoW

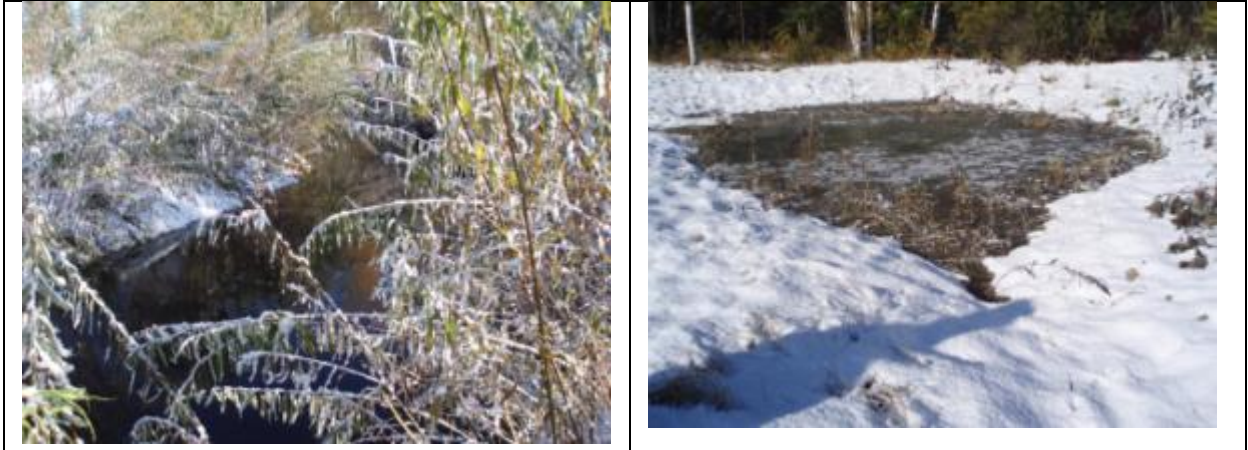
The river crossing was in good condition with both banks showing vegetation over the Reno mats placed during construction (Photo 3). The crossing was in good condition. Some water pooling was identified over the pipeline on the southern approach to the river and this will require monitoring (Photo 4).

Photo 3 – Re-vegetation of river banks

Photo 4 – Water pooling of the pipelines

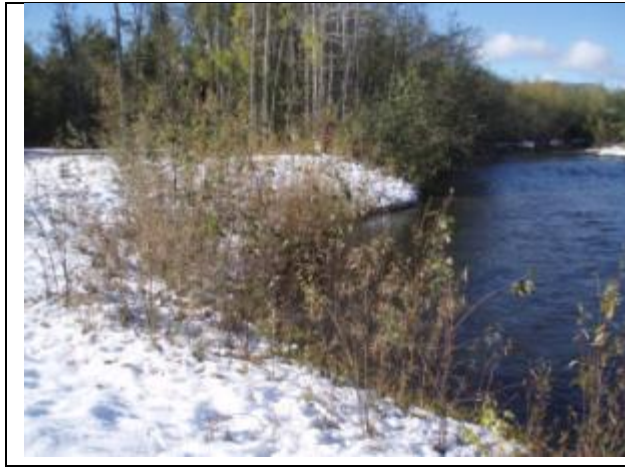
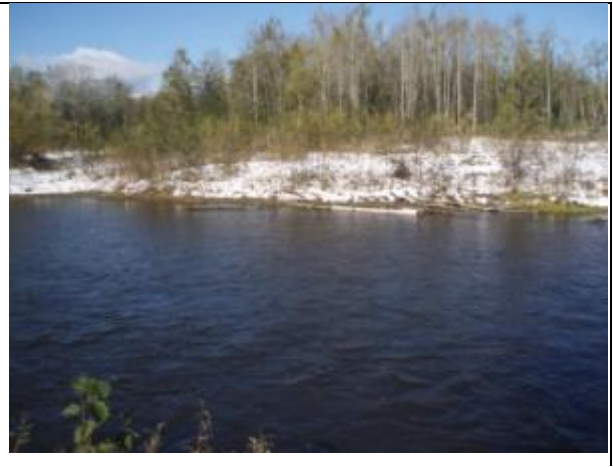
The river banks were both in good condition with the Reno matting holding well and starting to show signs of natural re-vegetation showing through, although control of tree growth is required (Photos 3 and 4). The river was running clean and the river bed looked to be in good condition.

Photo 3 – Northern bank re-vegetation

Photo 4 – View to southern bank

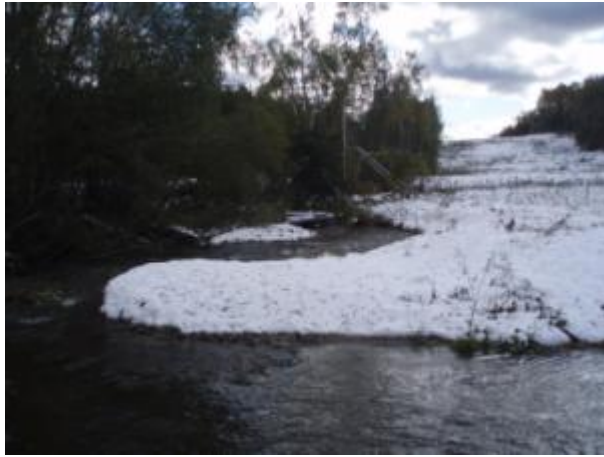
The RoW crosses the river just upstream of a small meander, shown in Photo 1. Both banks are protected with Reno mats – these are in good condition although remain largely unvegetated at present. Vegetation on the southern slopes is patchy although visual inspection was hampered by snow coverage (Photo 2). Vegetation on the slopes north of the access road appeared to be of a similar level (Photo 3).

Photo 1 – Meander, towards southern bank

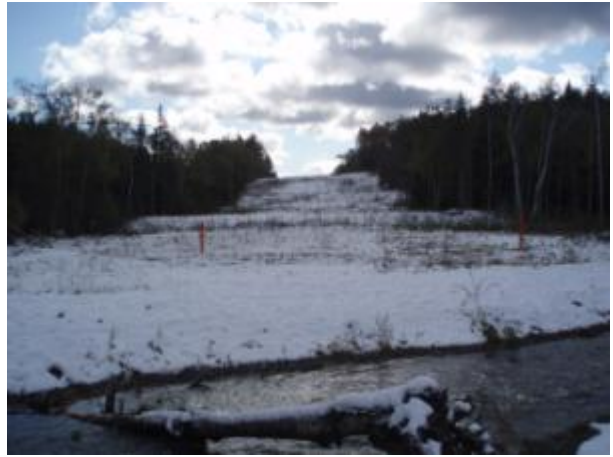
Photo 2 – Southern slope

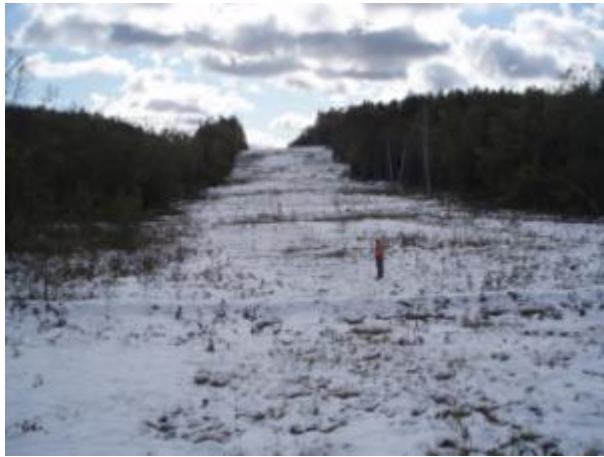
Photo 3 – Slopes north of access road

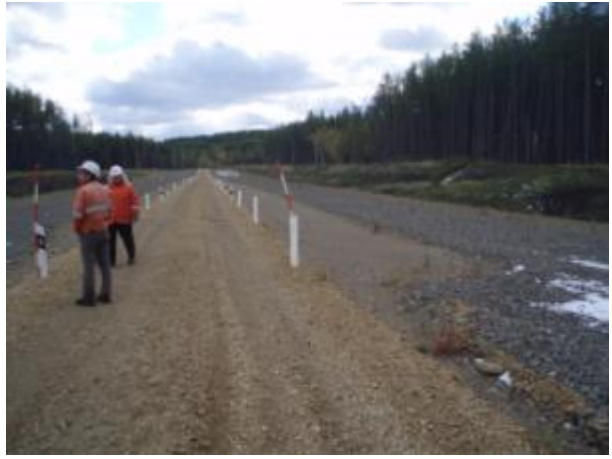
The fault crossing area was found to be in generally good condition, including the running tracking and drainage controls (Photo 2). The side cuts are thought to have previously been hydro-seeded, and evidence of old and new vegetation was noted (Photo 1).

Photo 2 – General view of fault crossing

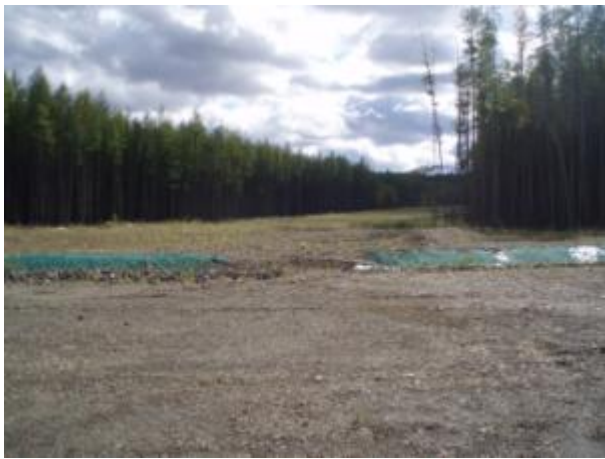
The original (re-routed) RoW (Photo 3) was very sparsely vegetated, with very poor topsoil and only a few shoots. We understand that this area will be reforested back to its former state by the forestry authorities.

Photo 3 – Re-routed RoW

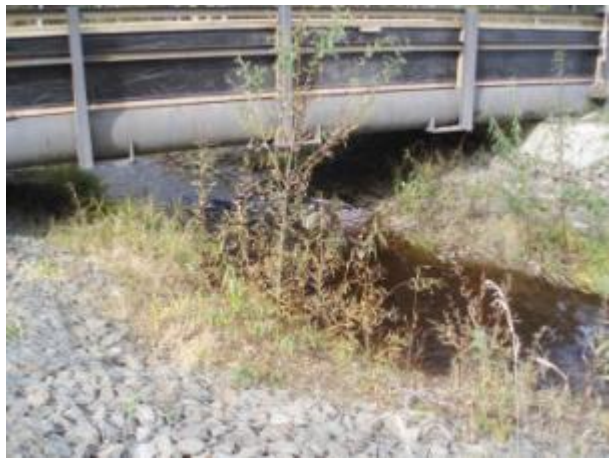
The river Porvotnaya was found to be in good condition, as was the bridge over the river (which leads to the BVS) which included good sediment control (Photo 4).

Photo 4 – River Porvotnaya and bridge

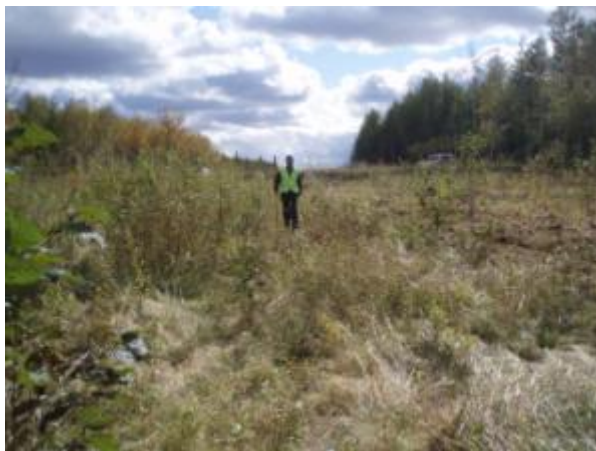
Revegetation of the southern approach to the Pobedinka River was seen to be very good (see Photos 1 and 2).

Photo 1 – Established vegetation along RoW

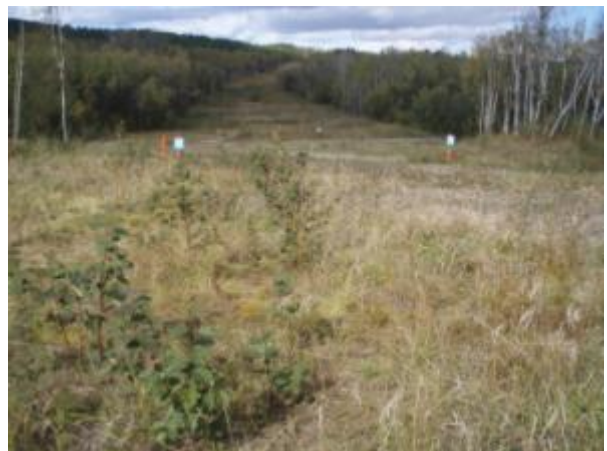
Photo 2 – Established vegetation along RoW

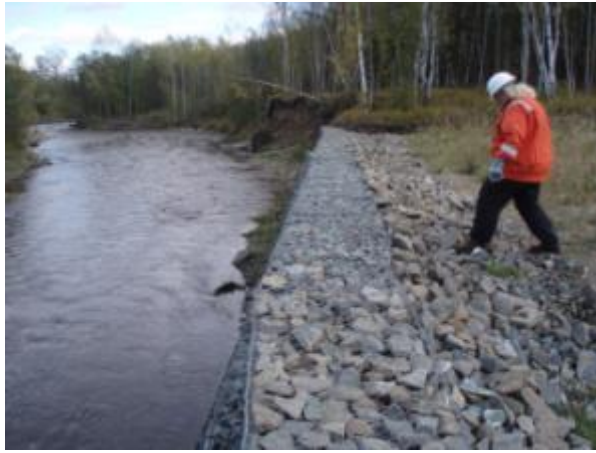
The southern bank of the Pobedinka River has been recently re-engineered following damage during the spring flood and the works appear to be of a good standard (Photo 3). Substantial new rip-rap has been installed upstream of the gabions in an attempt to prevent future undercutting of the gabions. We note that the rip-rap is of a substantial size (Photo 4), but nonetheless ongoing monitoring of the stability of the bank will be required. Significant bank undercutting is visible downstream of the gabions (Photo 5) and potential impacts on the gabions will also require ongoing monitoring.

Photo 3 – Gabion wall

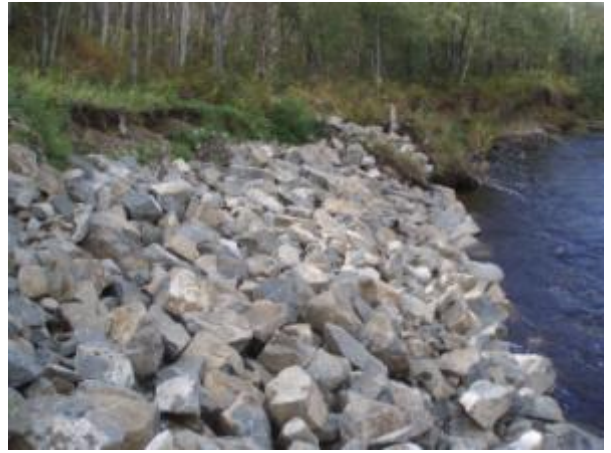
Photo 4 – New rip-rap installation

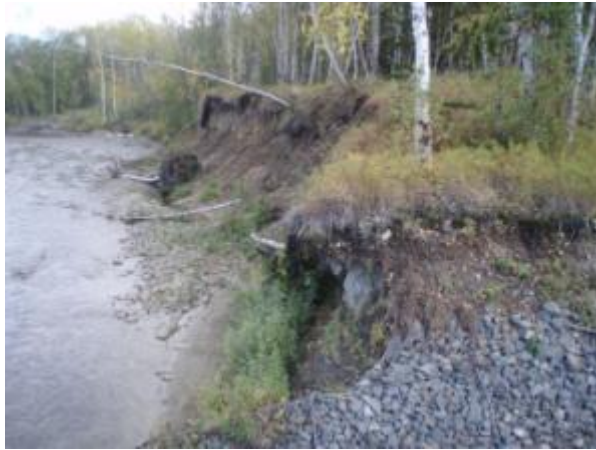
Photo 5 – River undercutting outer bank

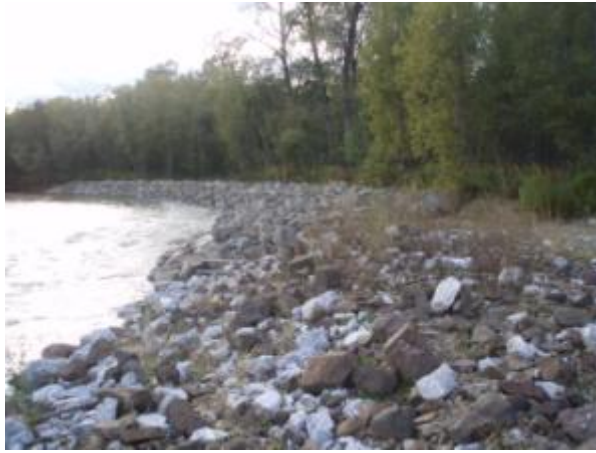
The Leonidovka underwent major engineering works in 2011 during which the western eroding bend was afforded new rip-rap protection (Photo 1). The rip-rap used was found to be of a substantial size (Photo 2) and was place on both failing reno mats and beyond the edge of the RoW to prevent future back-cutting of the renos. A gabion wall is installed on the southern, which is set back from the river edge and appears to be in good condition. A tributary to the river on the western side of the river crossing has been protected by rip-rap and appears to be in good condition (Photo 4).

Photo 1 – New rip-rap installation

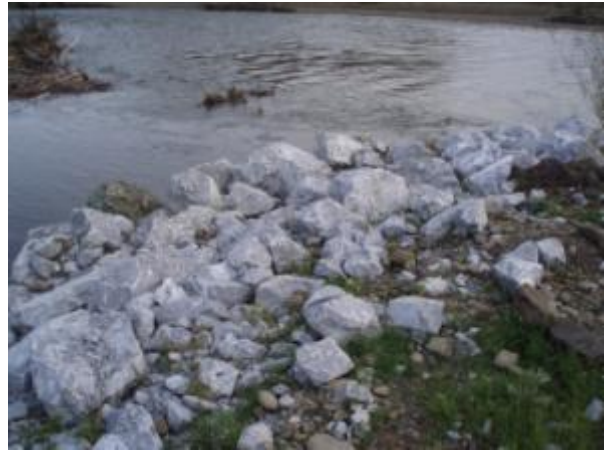
Photo 2 – New rip-rap installation

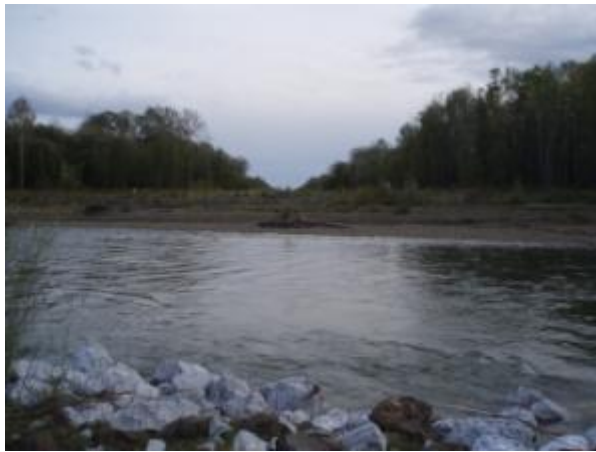
Photo 3 – Southern riverbank with gabion wall

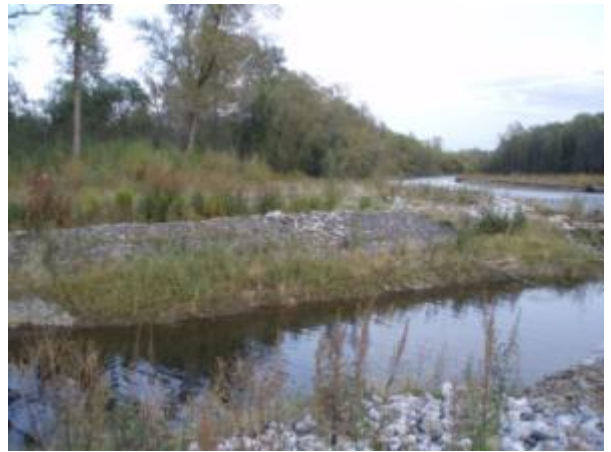
Photo 4 – Rip-rap protection of tributary

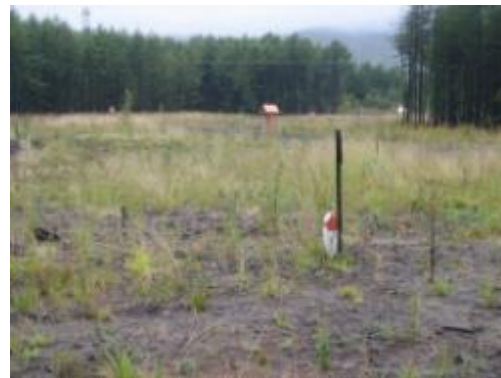
The block valve station was visited to view the operation conditions of the temporary power generator and fuel day tank. Currently there are several of these among the block valve stations due to failure and subsequent replacement of the dedicated gas operated Ormat power generation units. During the 2010 visit it was observed that the temporary units did not have secondary containment for the fuel day tanks and leak protection for the generators. During the current visit it was observed that the fuel tank had secondary containment and that the generator was situated above drip trays (Photo 1). The RoW at the vicinity of the block valve was re-vegetated however thin in spots (Photos 2 and 3).

Photo 3 – View to north showing vegetated RoW

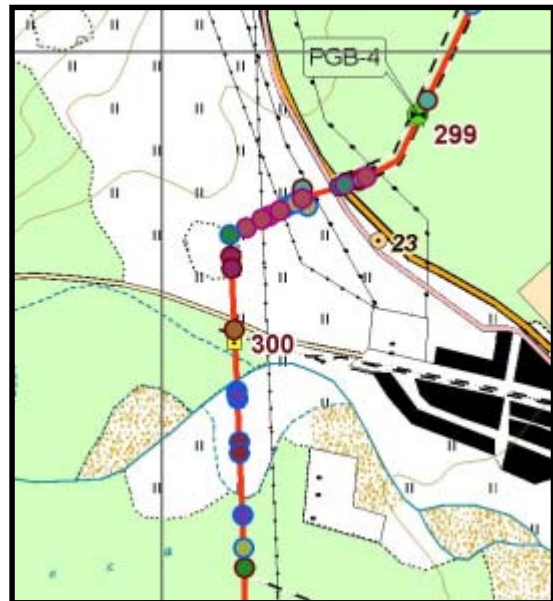
The Gastelovka river is a high energy braided river with multiple channels. The river banks experienced damage during the 2009 typhoon season and were repaired. Since then, the channels did not require further repair. The bank of the northern channel (currently the minor channel) is well fortified against the RoW to the north with Reno mattings which are in good condition (Photo 1). Further south the larger main channel is also fortified with Reno matting on the south bank (Photo 2). The Reno matting on the southern channel appears intact. It was not possible to cross the river to view the southern channel in more closely. The RoW north and south of the river is well vegetated (Photos 2 and 3).

<p>Photo 1 – View of the Reno matts on the north bank of the northern channel.</p>  	<p>Photo 2 – View across the river showing Reno matts on the south bank.</p>  
<p>Photo 3 – View north from Gastelovka River showing well vegetated RoW</p>

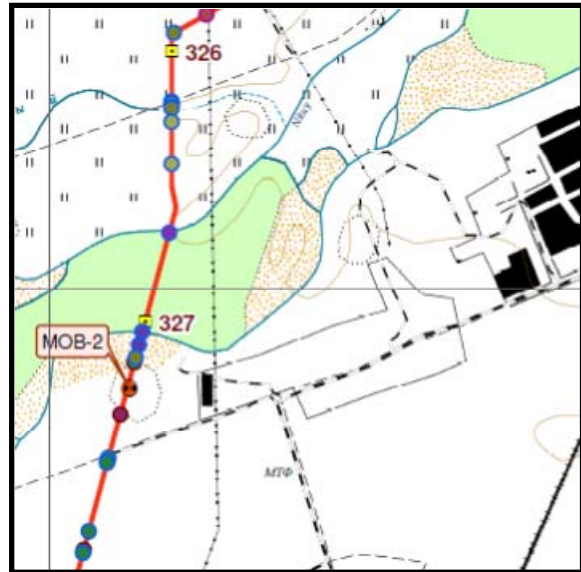
From a distance it was possible to see only the top of the substantial bank fortification on the main northern channel (Photo 1). The overall braided river character of the Nitui River could be seen from an elevated terrace east of the crossing (Photo 3). The RoW north and south of the northern most channel showed very good re-vegetation of grass and other plants (Photos 4 to 6).

Photo 1 – View south at the bank fortification on the main northern channel
