Appendix 3 Individual RoW Descriptions

List of RoW Locations Visited			
KP	River / Location	Team	Date Visited
96	NOB-17	Northern	28/9/2011
109	NOB-19	Northern	28/9/2011
22.7	Khandusa River	Northern	29/9/2011
14	Sandy slopes / fault crossing #1	Northern	29/9/2011
36 – 38.3	Access route to Askasi River	Northern	29/9/2011
62	Dagi River	Northern	29/9/2011
67	Tomi River	Northern	29/9/2011

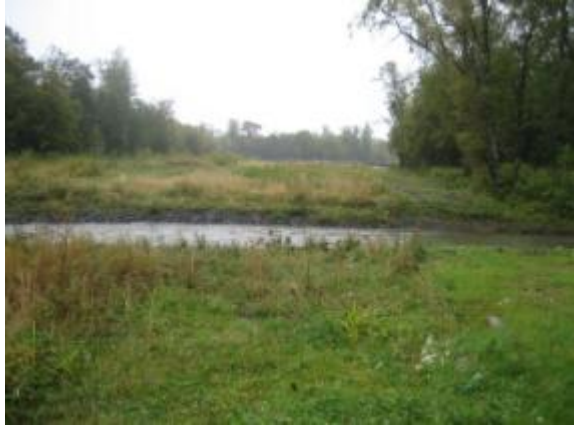
The Nitui River is a high energy, multi channel braided river. The river banks suffered damage and erosion during the 2009 typhoon season – see June 2010 visit report. Since then the banks protection had been repaired. At the time of the current visit to the north boundary of the channel it was possible only to reach a minor channel at the north end and to view the main channel only from a distance. The northern most channel showed good bank protection consisting of Reno matting in good condition and good re-vegetation on the banks (Photos 1 and 2).

Photo 2 – Close up on the south bank showing Re Reno matting in place and re-vegetation.

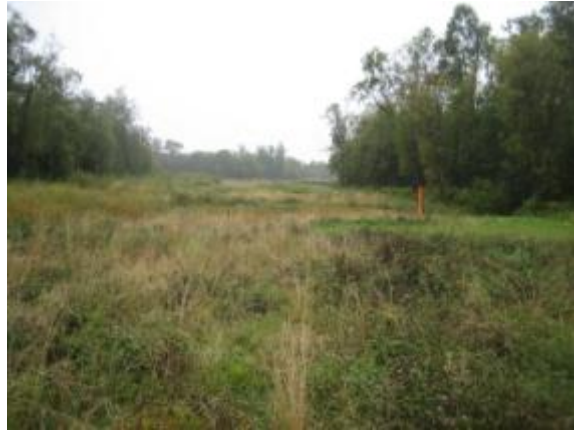
Photo 5 – Close up of re-vegetation on the RoW

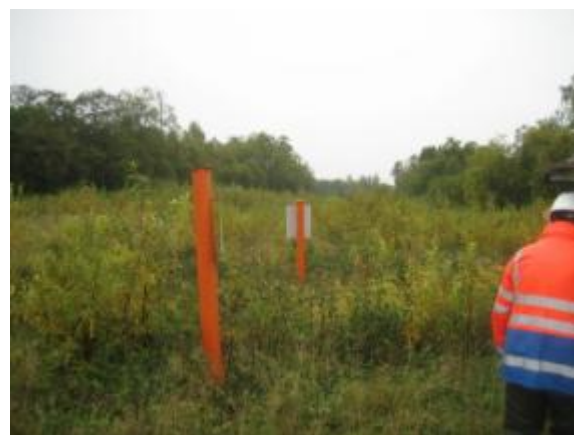
Photo 6 – View of a RoW slope north of the Nitui with good re-vegetation

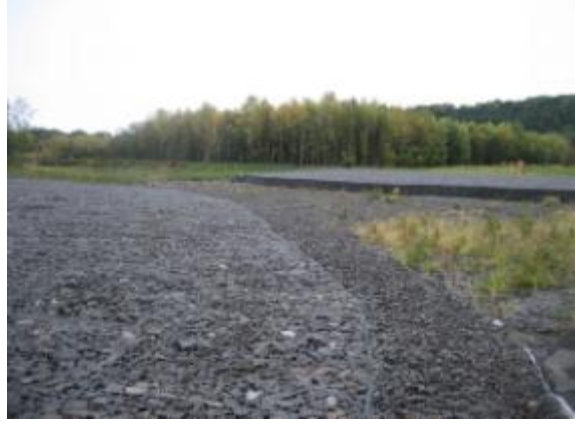
The crossing itself appears intact and the south bank is protected by a gabion wall (Photo 3). During the current visit significant change in vegetation on the RoW was observed. In the 2010 visit there was a sparse vegetation cover on the RoW. However during current visit there was mostly dense vegetation cover of grass, bushes and tree saplings (Photos 3 and 4). The saplings are reportedly Alder and form a dense ground cover. However the presence of the saplings will need to be addressed in the near future.

Photo 3 – View to the south showing gabion wall protection and very dense vegetation of saplings on the slope across the river.

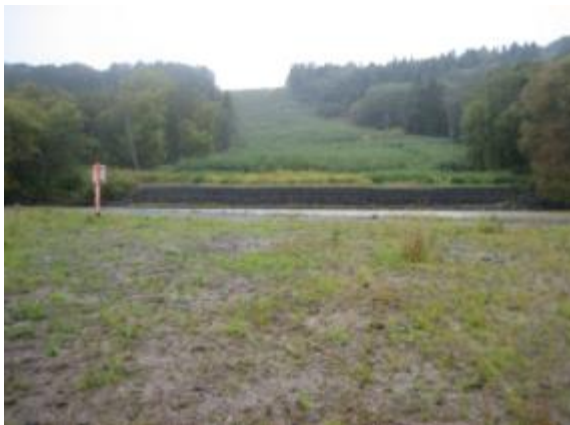
Photo 4 – View of the RoW north of the crossing showing dense coverage of saplings.

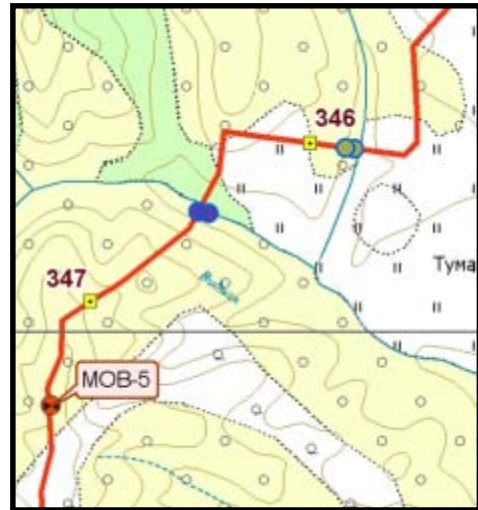
A previously used access track along the centre of the slope which previously was used to provide access from the top ridge to the bottom of the slope is now well protected with fortified slope breakers and with a beginning of re-vegetation (Photos 1 and 3).

Photo 1 – View to the north of the re-vegetated RoW with fortified slope breakers.

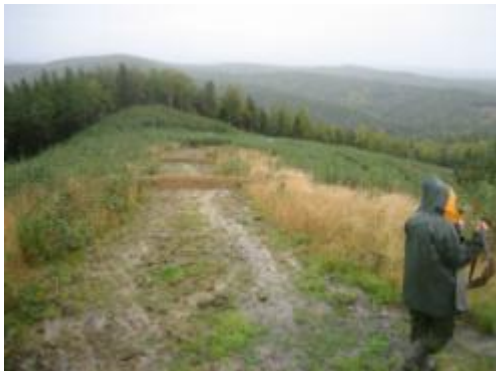
Photo 2 – View to the north showing a dense coverage of tree saplings

The presence of dense coverage of tree saplings will need to be addressed by SEIC in the near future.

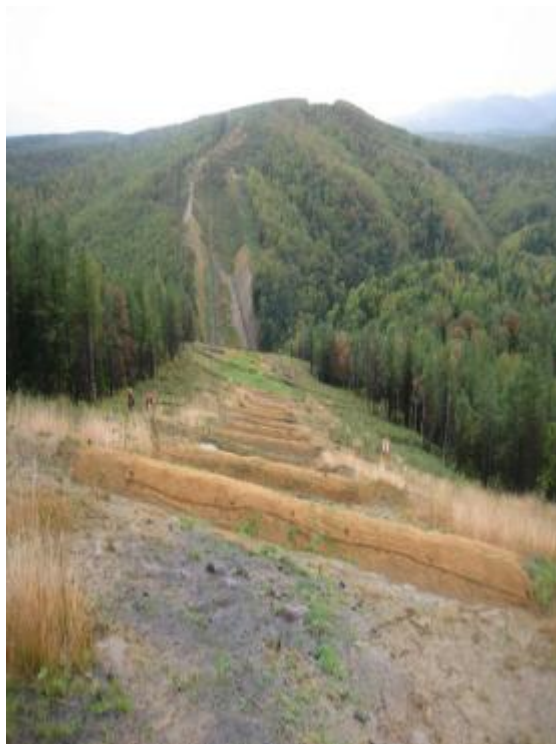
The Gar River slopes were observed from the north Slope only due to weather concerns and access road condition. The Gar crossing was damaged during the 2009 typhoon season but has since been repaired. The north Slope appeared to be in good condition and reportedly the river crossing itself held well during the last spring and summer. The slope was well vegetated with grass and saplings and access track from the last repair activity had been protected with fortified and reseeded slope breakers (Photo 1). On some of the slope breakers there is already good evidence of re-vegetation. The southern slope was also observed (short of the very bottom portion) and appears to hold well in the central and upper portions. A recent daily report that was provided by SEIC indicates that there was a slope movement on the oil and the gas pipe trenches at the lowest most part of the southern slope and that it was repaired. The southern slope is only partially vegetated and there is a need to continue seeding slope and seeding and protecting the side cuts (Photo 2).

Photo 2 – View to the south showing a partially vegetated south slope. The slope is covered in green vegetation and brown soil, with a road visible in the foreground.

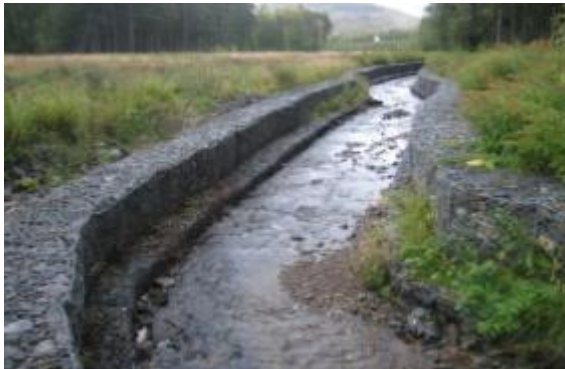
The Solyanka River approaches the crossing with the RoW in parallel to the RoW. SEIC constructed gabion lined channel to protect the RoW eastern edge (Photos 1 and 2). Since last year's visit more work was performed to strengthen the upstream edge of the protection channel. Heavy riprap was added upstream of the gabion wall (Photo 2).

Photo 2 – View to upstream of the river channel prior to the crossing where the protective gabion walls start. The heavy riprap is a new addition.

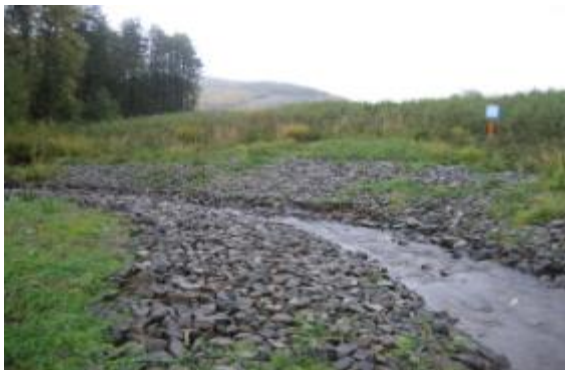
Photo 4 – View south towards the MOB 8 block valve showing good re-vegetated.

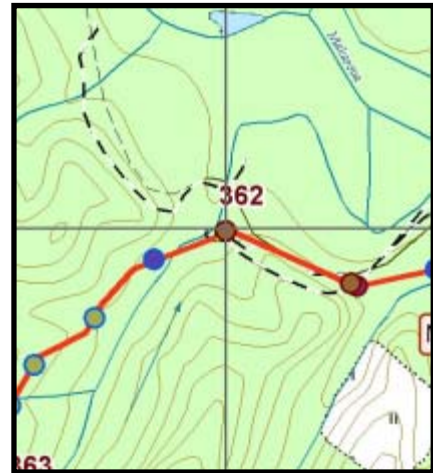
The Sosnovka River crossing includes the river and adjacent tributary to the north. The tributary crossing is protected with riprap and is currently heavily re-vegetated. The banks at the river crossing are protected with gabion walls and Reno matting which appear in good conditions.

Photo 1 – View downstream showing Reno matting, gabion walls and the dense vegetation.

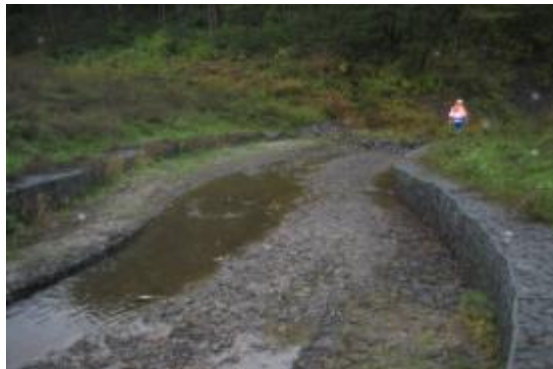
Photo 2 – View to the upstream showing Reno matting and gabion walls.

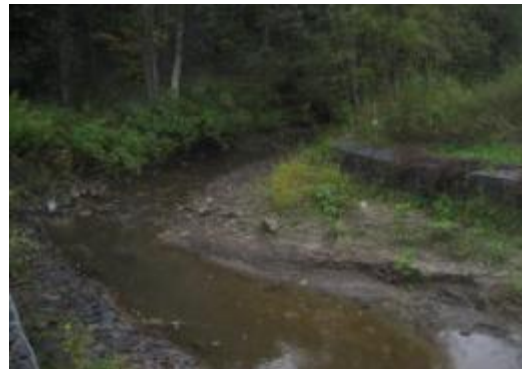
The RoW north and south of the crossing is densely re-vegetated with grass and other plants – some of which reach a meter or more in height.

Photo 3 – View to the south along the RoW showing dense and tall vegetation.

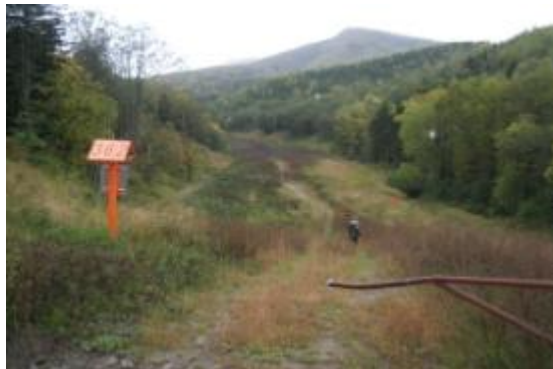
Photo 4 – View to the north along the RoW showing dense and tall vegetation.

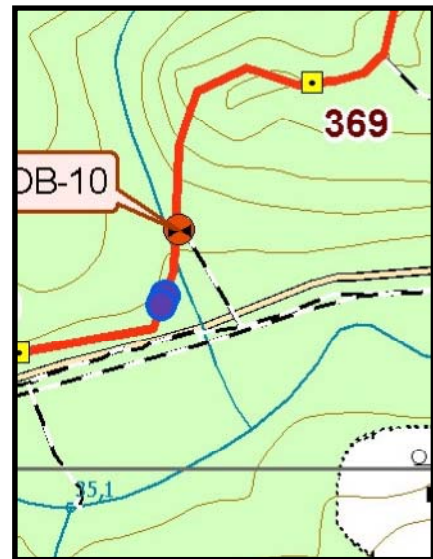
The Pegas River crossing banks are protected by Reno matting and gabion walls, and silt fencing is intact (Photos 1 and 2). The RoW on each side of the crossing is densely re-vegetated (Photos 3 and 4). The slope above the river and MOB 10 block valve is also very well vegetated (Photo 4) as compared to last year.

Photo 1 – View upstream showing Reno matting and gabion walls. Also note the dense vegetation.

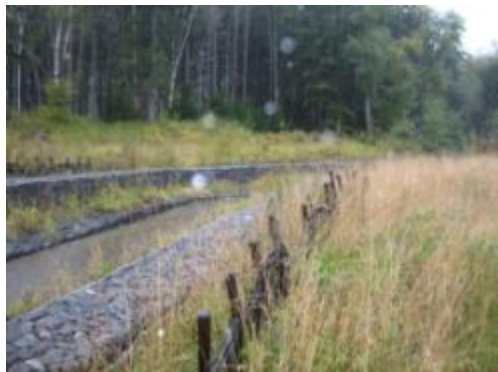
Photo 2 – View downstream showing Reno matting, gabion walls, and dense vegetation.

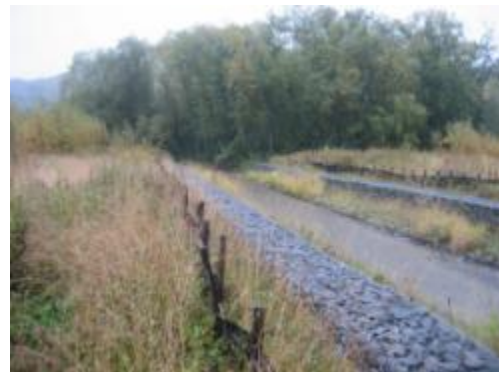
Photo 3 – View of RoW to the south of the crossing showing dense re-vegetation.

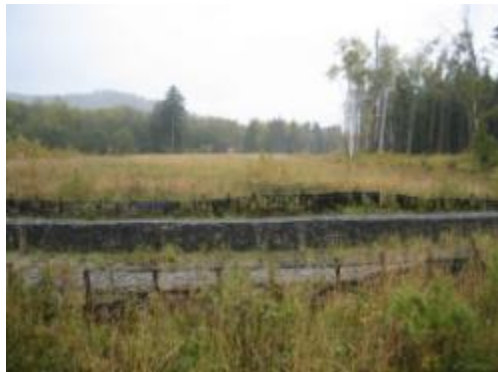
Photo 4 – View north at the slope above the Pegas showing good re-vegetation.

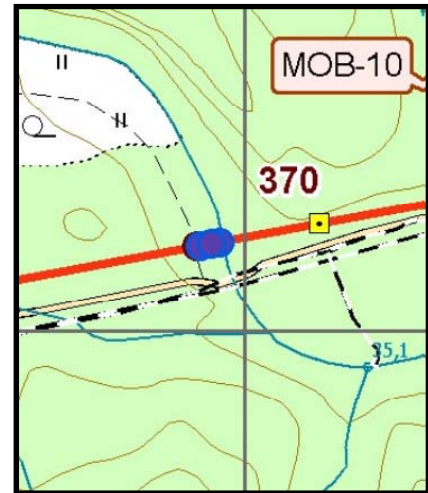
The Lasnaya 1 River crossing is protected by Reno mattings and a gabion wall on the north bank. The south bank consists of natural river gravel deposits on top of Reno matting. The RoW on both sides is densely vegetated.

Photo 1 – View of the river crossing to the upstream showing Reno matting and a gabion wall on the north bank. The south bank consists of natural river gravel deposits on top of Reno matting. Dense vegetation is visible on the north bank.

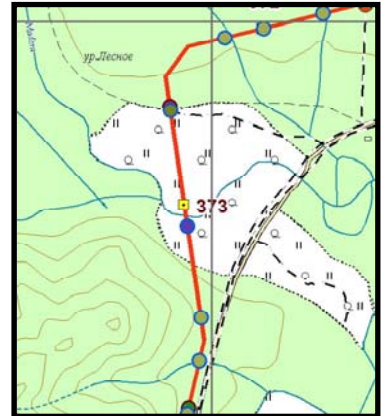
The river crossing is protected by gabions on the south bank and Reno matting on the north bank. During the 2009 Typhoon season the bank protection was damaged but since then repaired and appears in good condition (Photos 1 and 2).

Photo 1 – View upstream showing Reno matting on the north bank and gabions on the south bank.

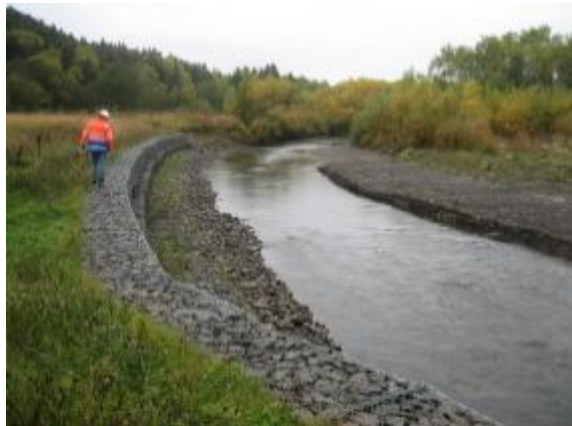
Photo 2 – View downstream showing Reno matting on the north and gabions on the south.

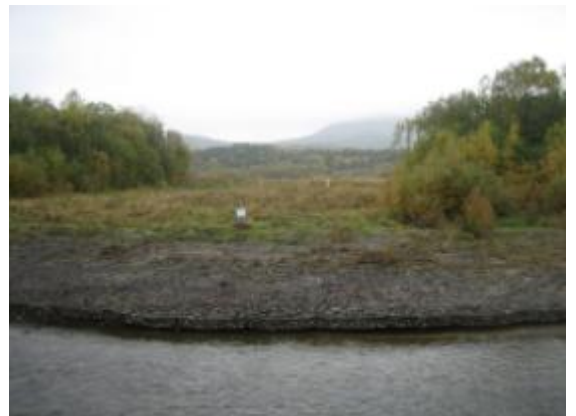
RoW along the road in Lasnaya Valley has a very good vegetation cover.

Photo 1 – View to the north east of the RoW along an access road in Lasnaya Valley. Note the good vegetation cover.

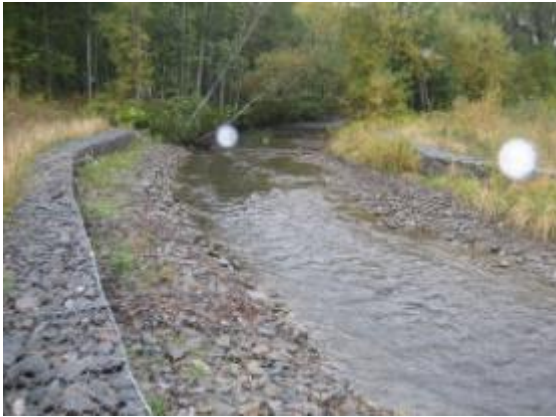
Photo 2 View downstream of the river crossing showing Reno matting and gabion walls.

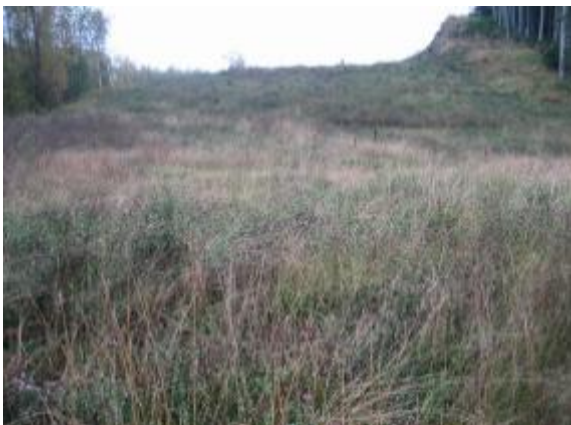
Photo 4 – View of the RoW north of the crossing with very dense vegetation cover.

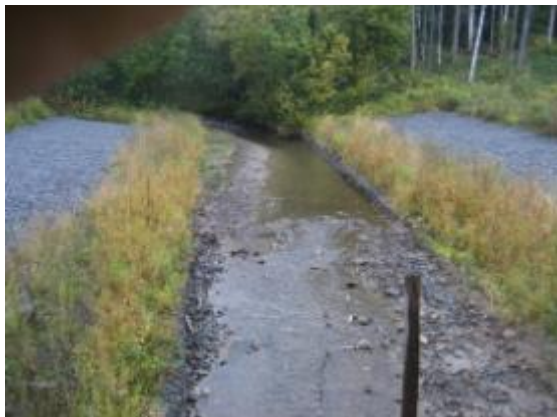
Photo 2 – View to the north showing dense vegetation cover.

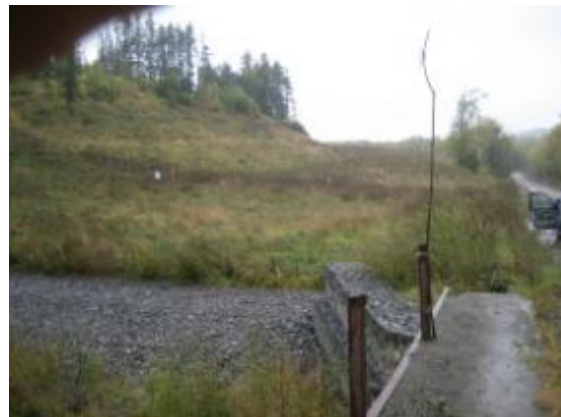
Photo 3 – View to the south showing dense vegetation cover.

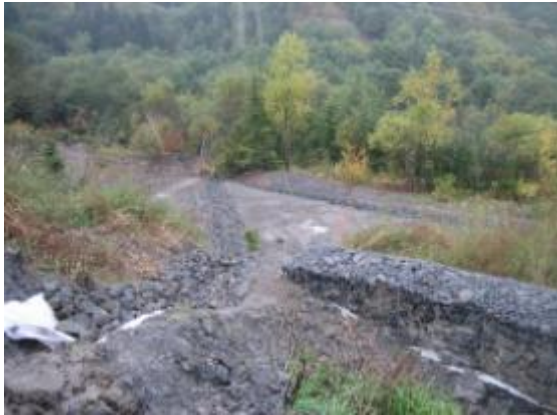
Recent landslide at KP 382 on the west side of the RoW is currently being repaired. The project is classified as Category 3 repair work and is executed directly by SEIC. The works include stabilization of the side slope using gabion walls and geotextile and construction of a drainage system (Photos 1 to 3).

Photo 2 – View of gabion wall and drainage channels

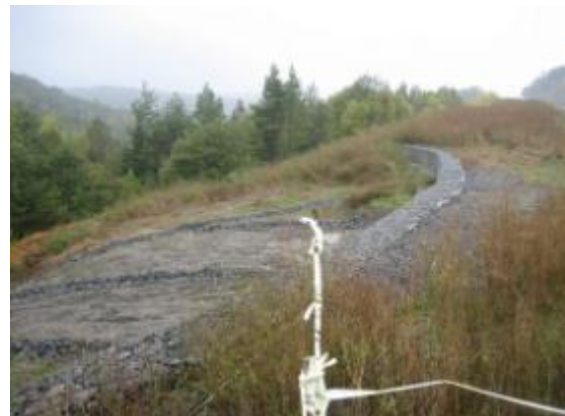
Photo 3 – View of terracing and geotextile during on going work.

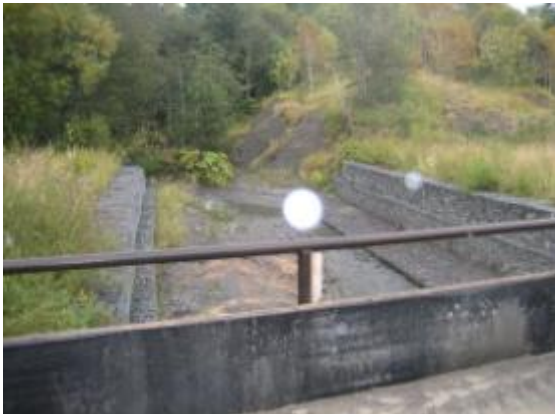
Photo 2 – View to the north showing slope with good vegetation cover.

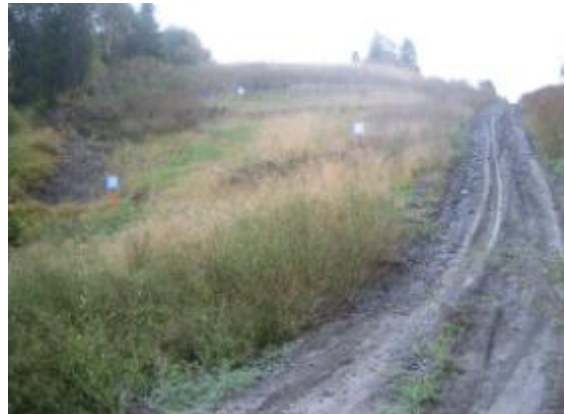
Photo 3 – View across the river showing the RoW on both sides with good vegetation cover.

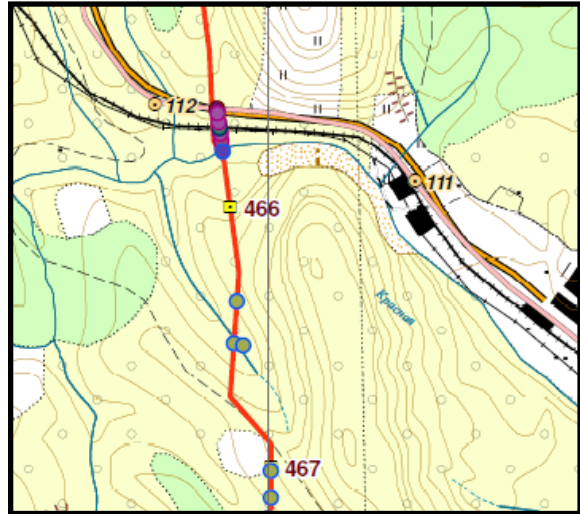
The Krasnaya River crossing has a long steep slope which is protected by slope breakers on the south side and Reno matting protection on the banks. At the time of the visit, the slope appeared to be well vegetated and in tact (Photo 1). The RoW on the north side of the river and north of the railroad and federal highway is also well vegetated (Photo 2).

Photo 1 – View to the south showing well vegetated slope and river crossing

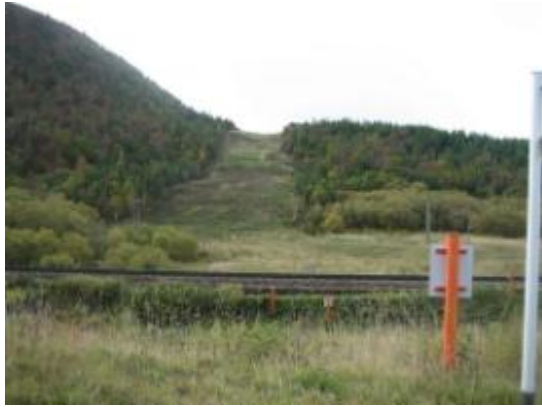
Photo 2 – View to the north showing well vegetated RoW.

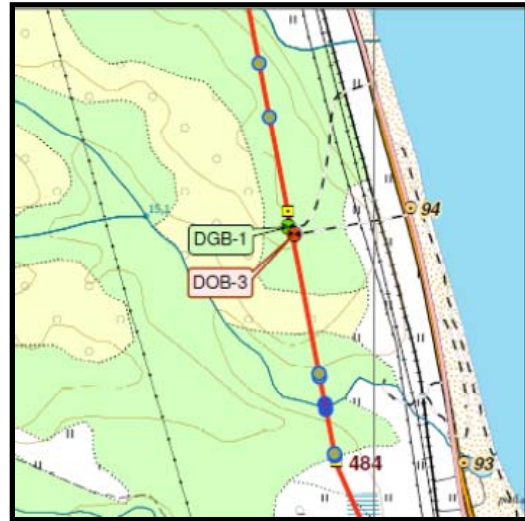
The Primorskaya River banks are protected with Reno matting. The river banks are partly vegetated and a silt fence on the south bank is in need of repair. The south slope is heavily protected with fortified slope breakers but is still poorly vegetated (Photo 1). The north slope is mostly vegetated (Photo 1). The RoW south of the river and north of MOB-4 is poorly vegetated (Photos 2 and 3). Although there is a marked improvement since last year's visit, more needs to be done in this area in order to improve the bio-restoration.

Photo 1 – View north showing mostly vegetated north slope and poorly vegetated south slope.

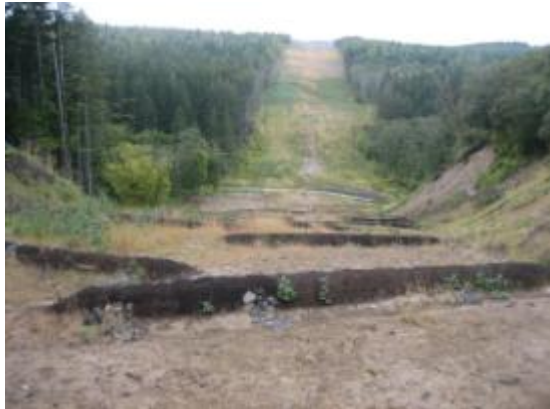
Photo 2 – View north showing poorly vegetated RoW and repaired slope breakers.

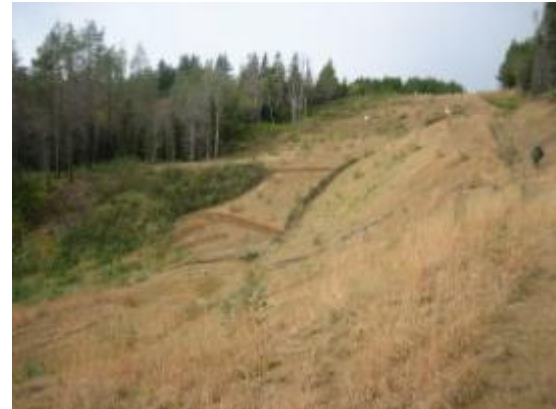
Photo 3 – View north showing minor drainage crossing and partially vegetated RoW.

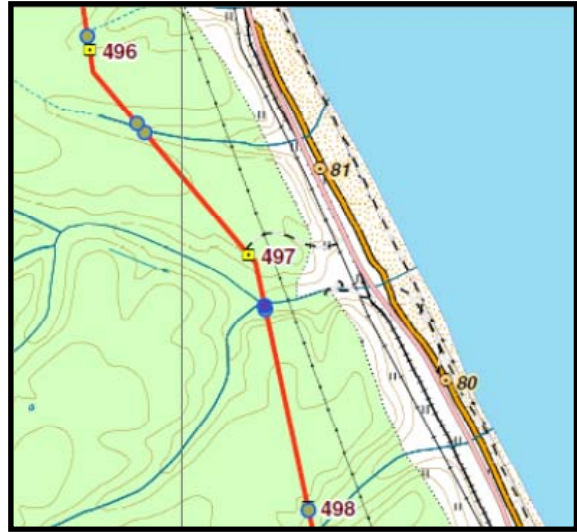
The Listvenitsa River crossing is located south of Fault Crossing No. 17. The river banks are protected by Reno matting and are well vegetated (Photo 1). The RoW to the south has a dense vegetation cover. The slope to the south is also well covered but shows an erosion channel next to the east side cut (Photo 2). Reportedly, this feature is already on the repair list.

Photo 1 – View of the river channel showing good bank vegetation and Reno matts.

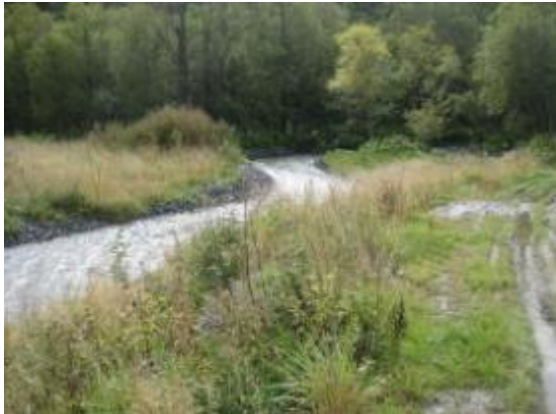
Photo 2 – View south showing vegetated south slope with an erosion channel on the east side .

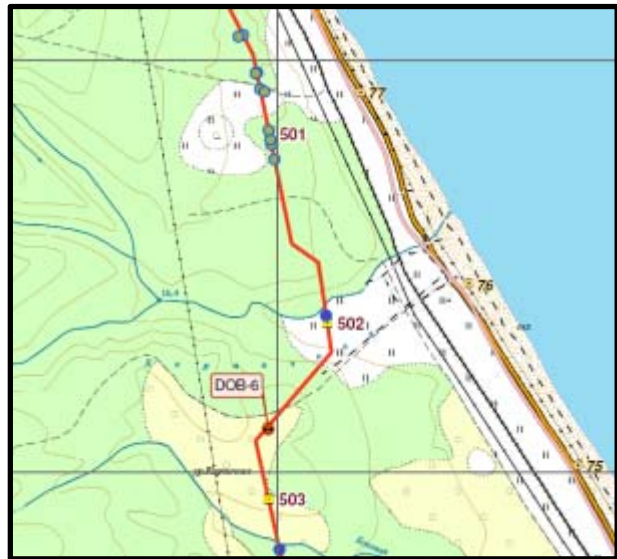
The Kirpichnaya River crossing is well protected with Reno mats and the banks are very well vegetated (Photos 1 and 2). The slopes on both sides of the river are well vegetated and appear to be holding well. A meander of the river on the downstream side is impacting the RoW on the east side and is under observation by SEIC.

Photo 1 – View upstream showing good vegetation on the Reno matting covered banks.

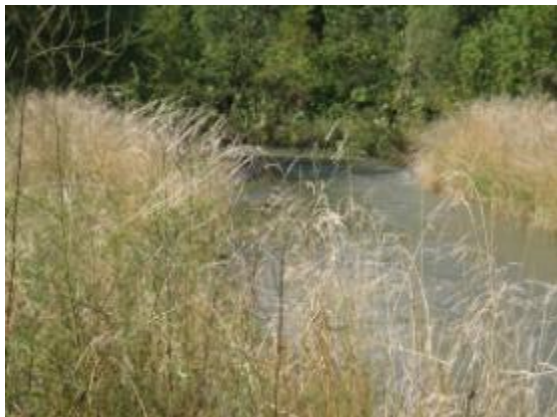
Photo 2 – View to the north showing vegetated slope.

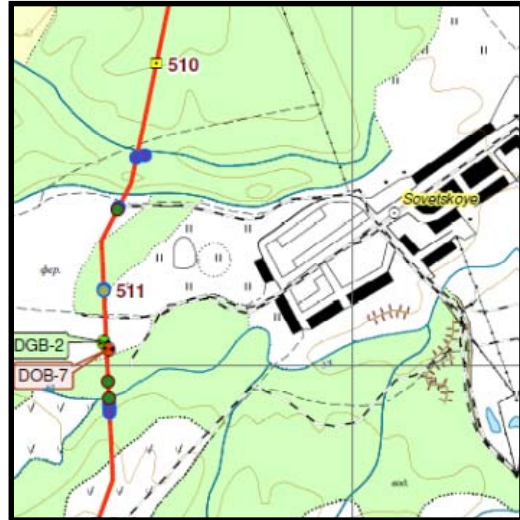
The Sovietskoy Ridge had soil stability problems during construction. Since then, a specific soil drainage and slope stability design was implemented using a specialist contractor (Photos 1 and 2). During the last two years the ridge appears to be holding well. The Ai River Valley which extends between Sovietskoy Ridge and the Ai River channel is very well vegetated and is being used as a pasture for live stock (Photo 3).

Photo 1 – View of the ridge slope with good vegetation and slope breakers

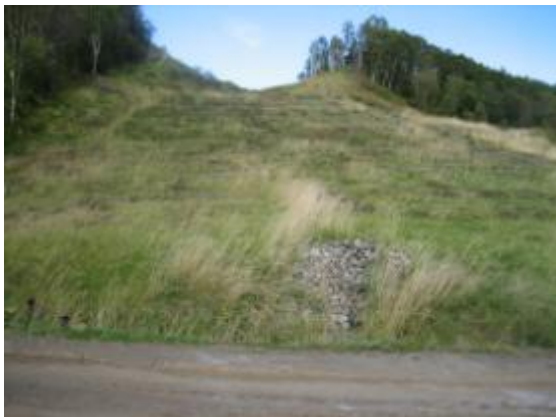
Photo 2 – View of the ridge with a drainage outlet at the base.

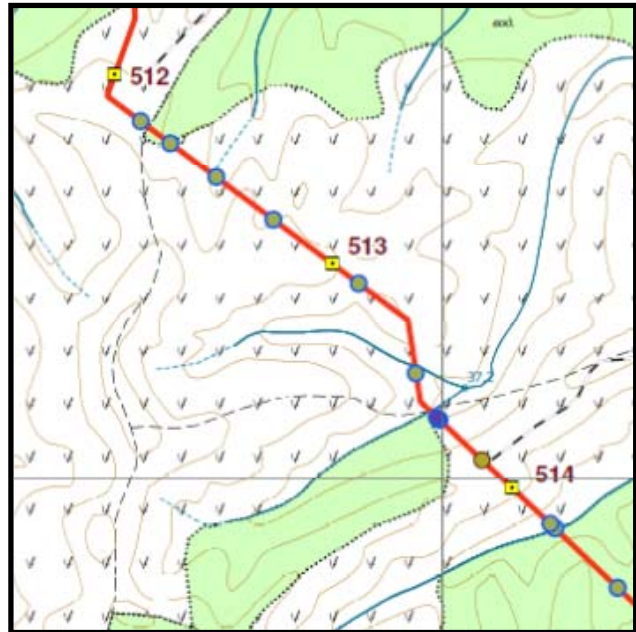
The sandy slopes between the Ai River and Fault Crossing Number 19 show an improvement over observations from last year. Vegetation is denser but in places there is partial or no vegetation at all. The slope breakers which were installed along the sandy area mostly function well but in places need increased in frequency. The sandy area will need surface preparation and re-seeding for improved bio-restoration.

Photo 1 – View to the north along the RoW

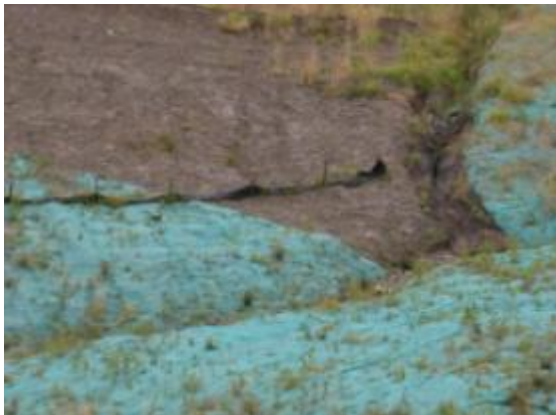
Photo 4 – View of a slope with very sparse vegetation

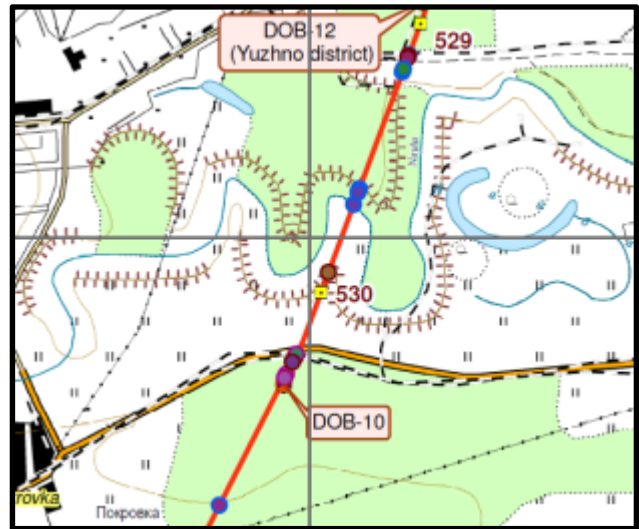
The RoW crosses the Dolinsk Wetlands from north to south approximately 2 km west of Dolinsk. Since construction ended the main issues were the presence of large quantities of timber logs partly submerged in the peat material and poorly levelled RoW. The logs were used as access road foundation during construction. In addition, there was scattered concrete debris. During the current visit, the RoW was observed only from the road and from the block valve station. From these vantage points (Photos 1 and 2) it appears that the RoW is well vegetated with a pronounced improvement over last year.

Photo 1 - View to the north along the RoW

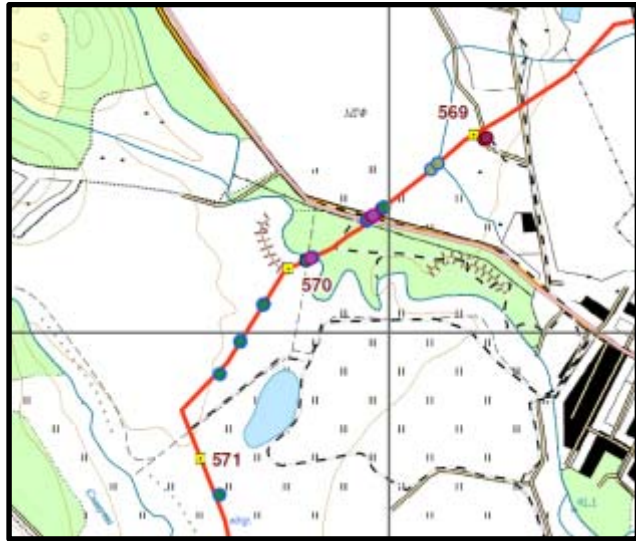
The Vladimirovka River crossing is protected by Reno matting and riprap (Photo 1). In addition the meander on the upstream of the crossing has been fortified by heavy riprap in the last winter (Photo 2 and 3). The work was conducted to prevent the river from cutting into the RoW upstream of the crossing. The RoW on each side of the crossing is well vegetated.

Photo 1 – View of the crossing with Reno matting and good vegetation

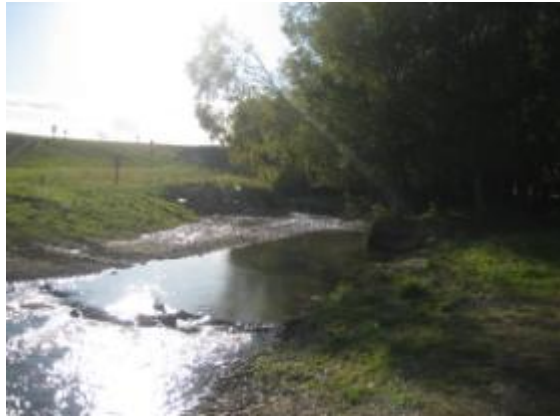
Photo 2 – View of the fortified meander upstream of the crossing

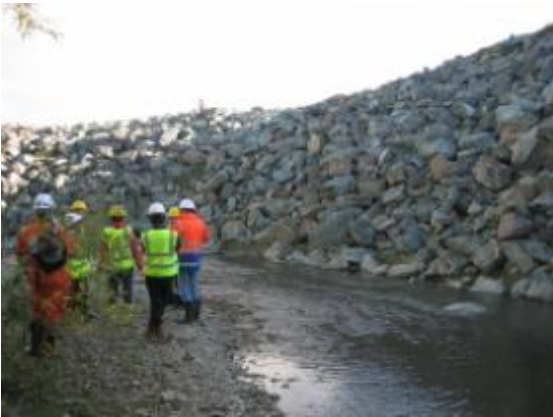
Photo 3 – View of the fortified meander upstream of the crossing

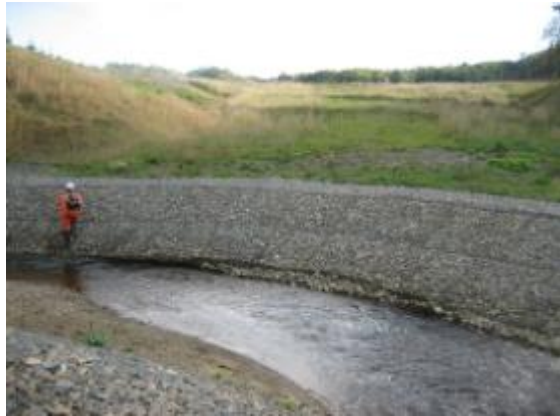
The Mayakovskoga River crossing is protected by Reno matting and riprap (Photos 1 and 2). The Reno matting was replaced last winter when debris from previously placed bridge was removed and the banks were reshaped and covered. The RoW on each side of the crossing is well vegetated (Photos 3 and 4).

Photo 2 – View to the upstream showing the crossing with Reno mats on the banks.
