**KP 370.2 Lasnaya 1 River**

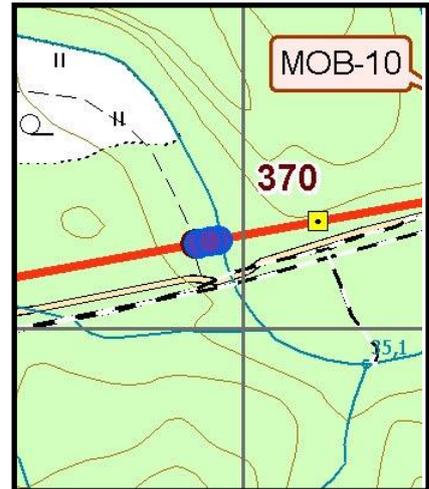
The Lasnaya 1 River crossing is protected by Reno mattings and a gabion wall on the north bank (Photo 1). The south bank consists of natural river gravel deposits on top of Reno matting. The RoW on both sides is densely vegetated (some tree saplings are appearing that need to be removed). An armoured drainage ditch within the gabion wall appears to be functioning well (Photo 3).

**Photo 1** – View of northern bank gabion walls. Also note the dense vegetation.

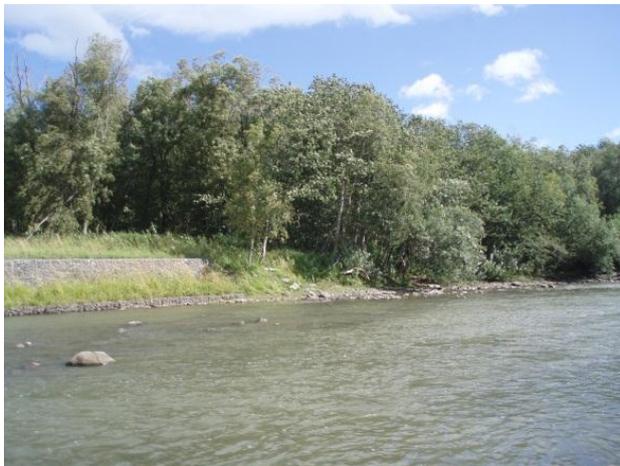
**Photo 2** – View of dense vegetation on southern bank.

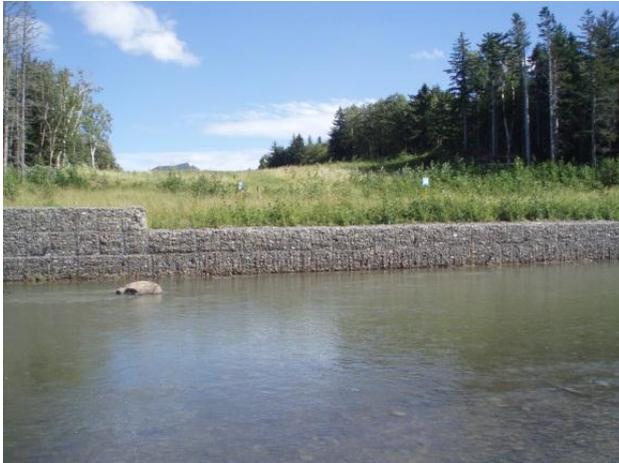
The Lasnaya 2 River crossing is protected by Reno mattings and a gabion wall on both banks (Photos 1 and 2). Some erosion and damage to the gabion wall was visible at either end of the northern bank gabion wall (Photo 3).

**Photo 2** – View of southern bank gabion walls.

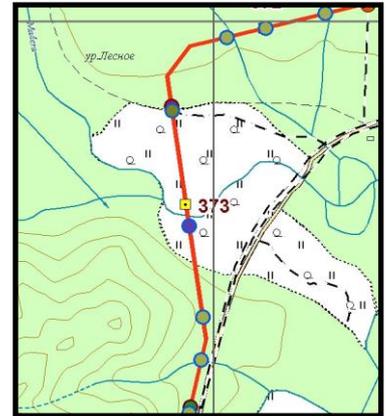
The river crossing is protected by gabions on the south bank and Reno matting on the north bank (Photo 1). The placement of the reno matting on the northern bank has noticeably narrowed the river compared to the river width up- and down-stream (Photo 1), and this is leading to some under-cutting of the matting. Erosion of the upstream southern bank has occurred but this is protected by good size riprap at present (Photo 2).

**Photo 1** – View downstream showing Reno matting on the north bank and gabions on the south bank. Visible narrowing of the river is seen on the northern bank.

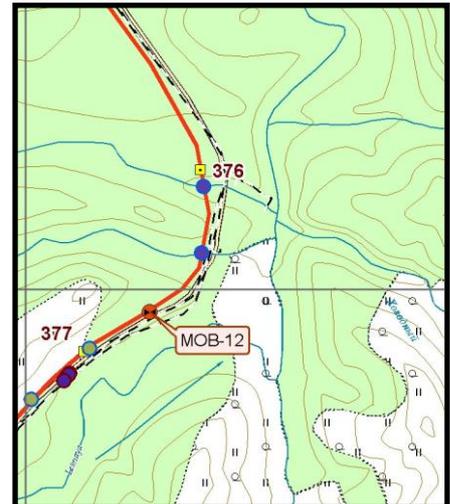
The Zhelezhnyak River crossing was damaged during the 2009 Typhoon season and was since then repaired. The banks are protected by gabion walls and Reno matting and appear in to be good condition (Photos 1 and 2).

**Photo 1** – View upstream of the river crossing showing Reno matting and gabion walls.

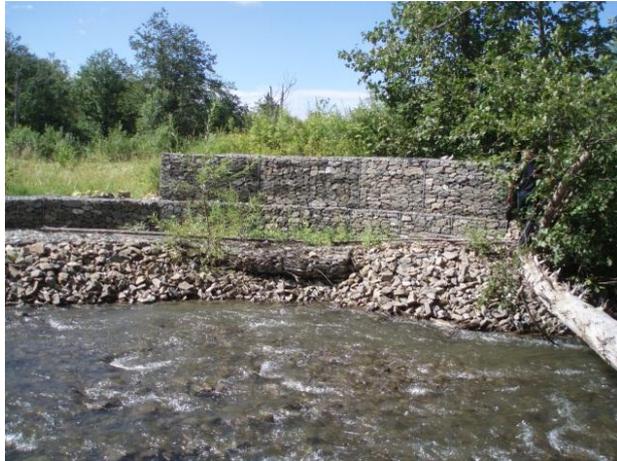
**Photo 2** View downstream of the river crossing showing Reno matting and gabion walls.

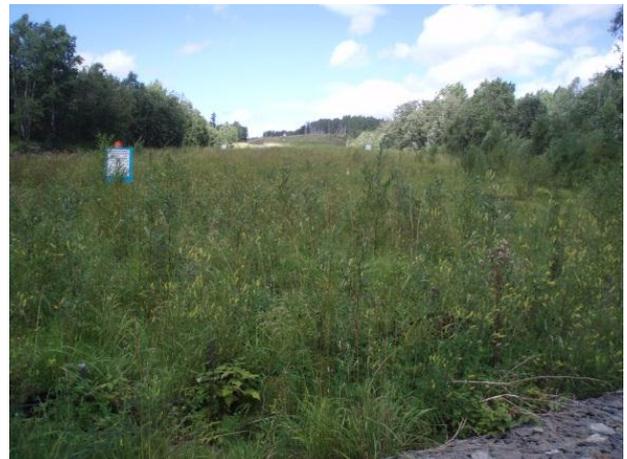
The RoW on the north side of the crossing has good vegetation cover (Photo 2). The south slope is also well vegetated but with partially bare side cuts (Photo 3). The silt fencing on the south side is damage and in need of repair (Photo 3).

**Photo 3** – View south showing the south slope with generally good vegetation cover, but bare side slopes and silt fencing in need of repair.

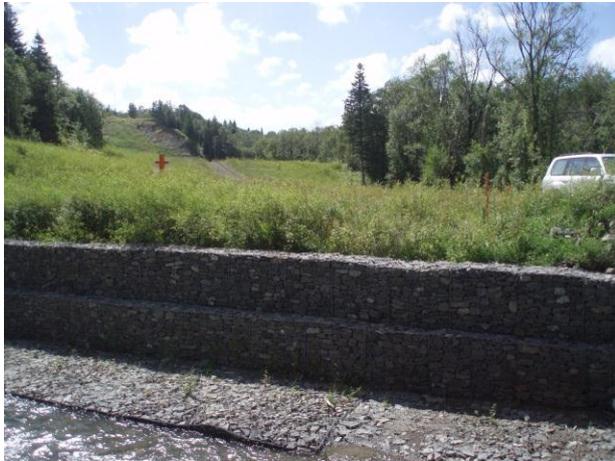
**Photo 2** – View to the north showing slope with good vegetation cover.

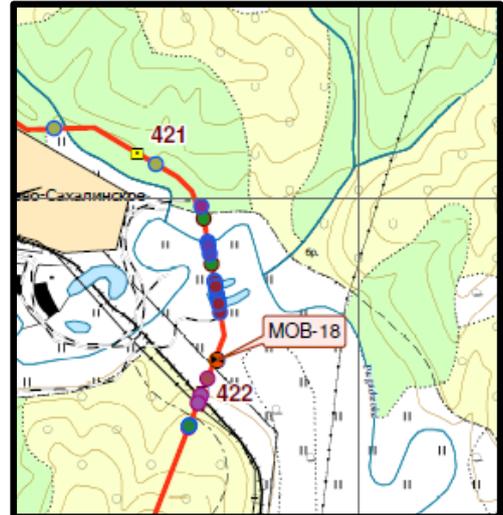
The Pugachevka River is surrounded by flat RoW on either side, with the area to the south classified as wetlands. The riverbanks are protected by reno matting on the southern bank (Photo 1) and riprap on the north bank (Photo 2), all of which appears to be in good condition. The river divides within the width of the RoW and the riverbanks at the divide appear in good condition (Photo 3). Spawning salmon were seen in the river at the time of the inspection.

**Photo 1 – Reno matting on southern bank**

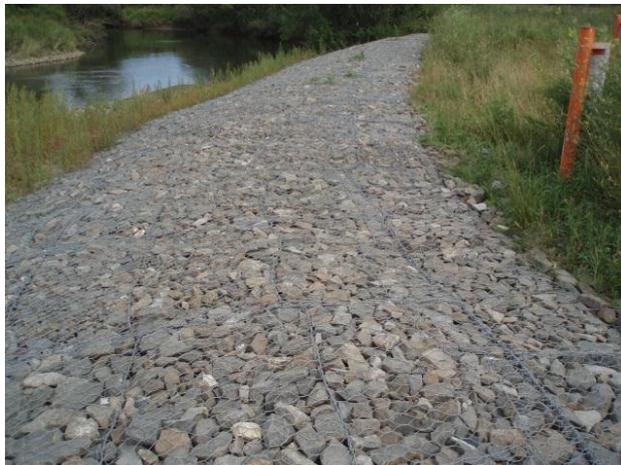
**Photo 2 – Riprap on northern riverbank.**

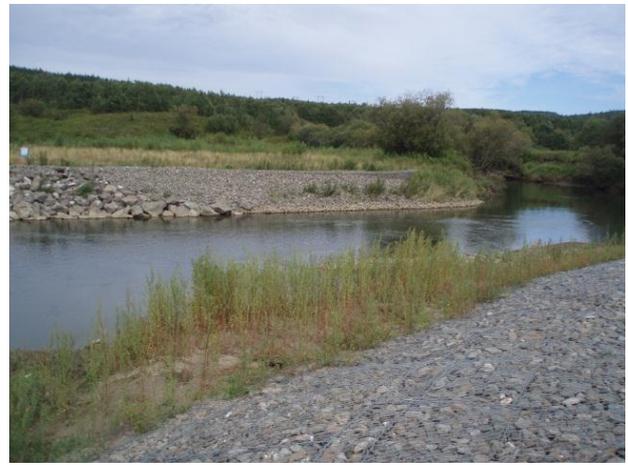
**Photo 3 – River divide at edge of RoW**

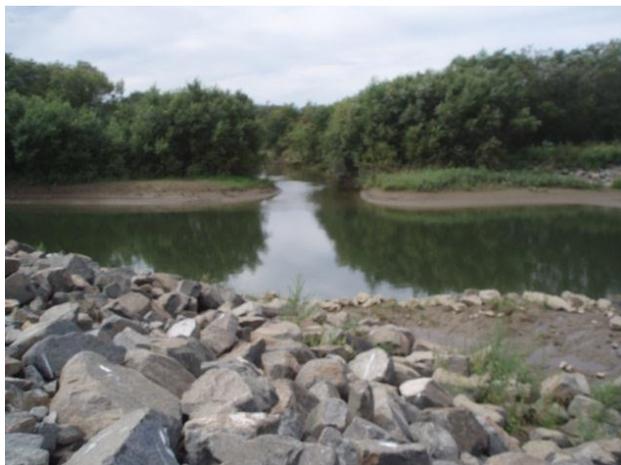
**Photo 4 – River divide at edge of RoW**

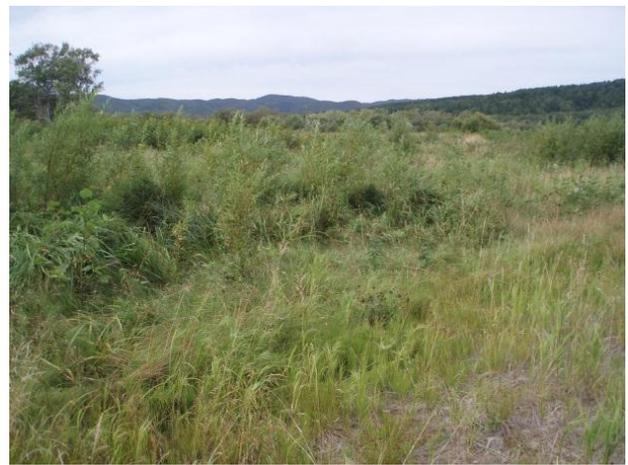
The wetland was well vegetated, but the soils were found to be dry and no evidence of wetland were found either on the RoW or in adjacent areas. A slight depression over the FOC was evident.

**Photo 5** – Dry soils in area classified as 'wetlands'

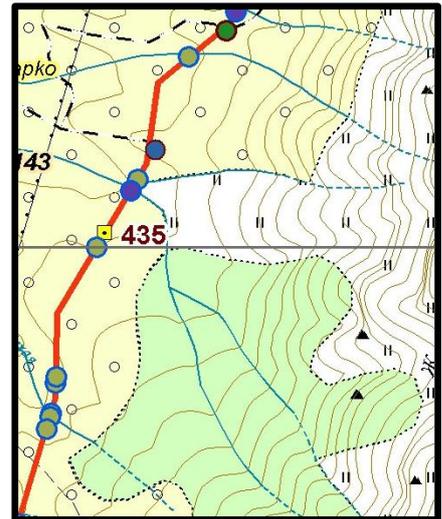
The RoW crosses a minor tributary (to the north) and the main channel (to the south) of the Travyanaya River. The minor channel is protected by reno matting, through which a good level of vegetation has grown through (Photo 1).

**Photo 1** – Reno matting and vegetation on northern tributary

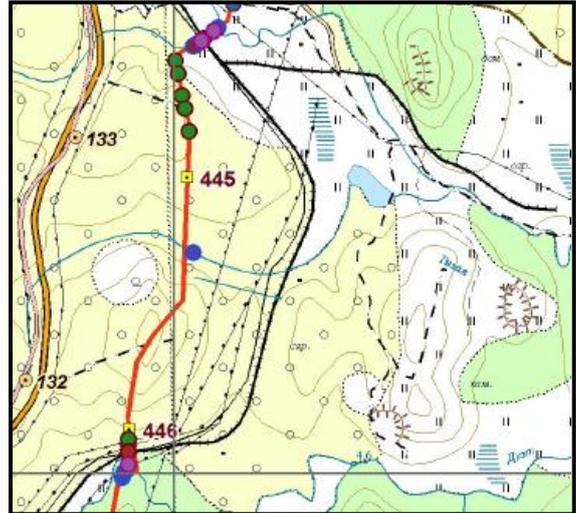
The Tikhaya River flows adjacent to the railroad and both were crossed using a horizontal thrust boring method. This resulted in undisturbed river banks which can be seen in their natural state in Photos 1. The river valley was disturbed by the excavation for the thrust boring and pipe trenches but it is graded and mostly well vegetated. As Photo 2 shows, the vegetation on the slope to the south is limited.

**Photo 1 – View of riverbanks**

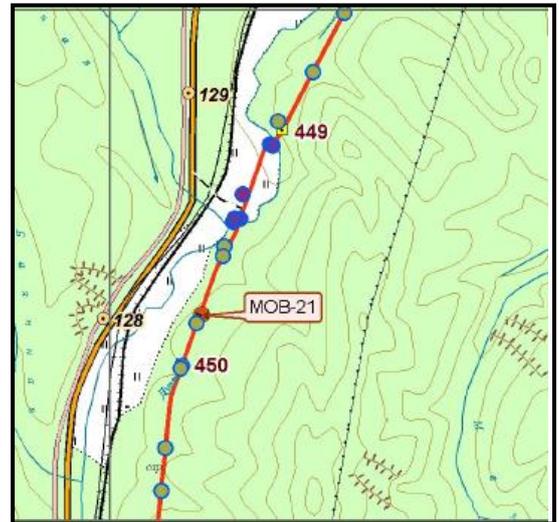
The Duet 3 River crossing is situated at the southern edge of valley, and the river flows along the RoW to the Duet 2 crossing. The river banks are protected with Reno mats and are well vegetated (Photo 1).

**Photo 1** – View of re-vegetation of banks

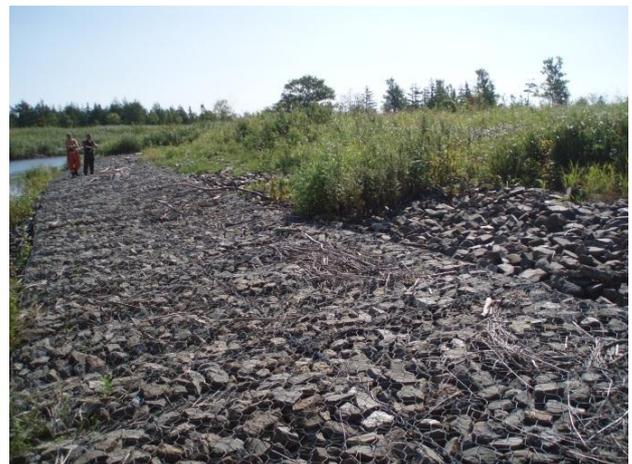
**Photo 5** – Gabion on north slope with minor slumping

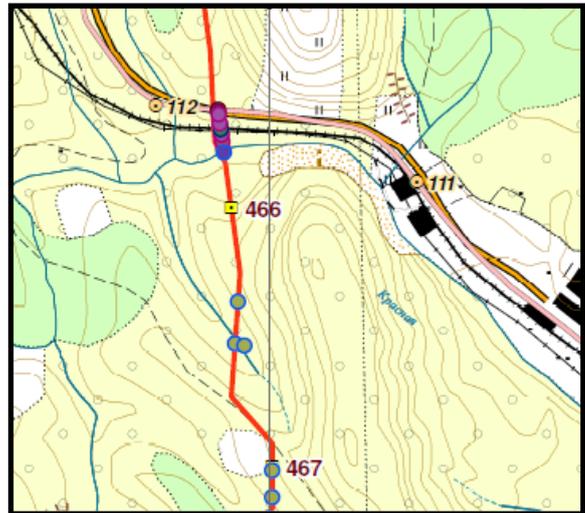
The Krasnaya River crossing has a long steep slope which is protected by slope breakers on the south side and Reno matting protection on the banks. At the time of the visit, the slope appeared to be well vegetated and intact (Photo 1). The RoW on the north side of the river and north of the railroad and federal highway is also well vegetated (Photo 2).

**Photo 1** – View to the south showing well vegetated slope and river crossing

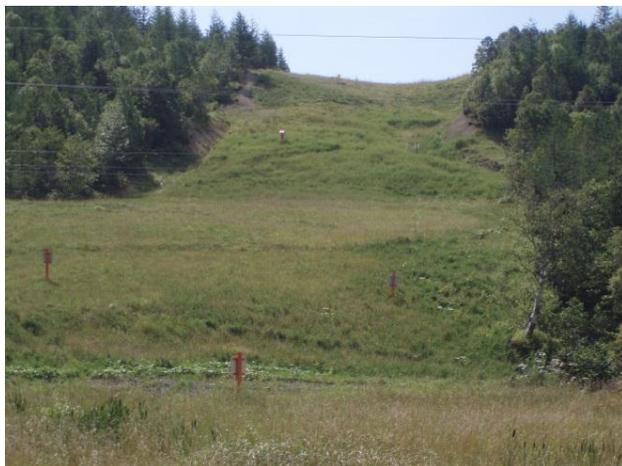
**Photo 2** – View to the north showing well vegetated RoW.

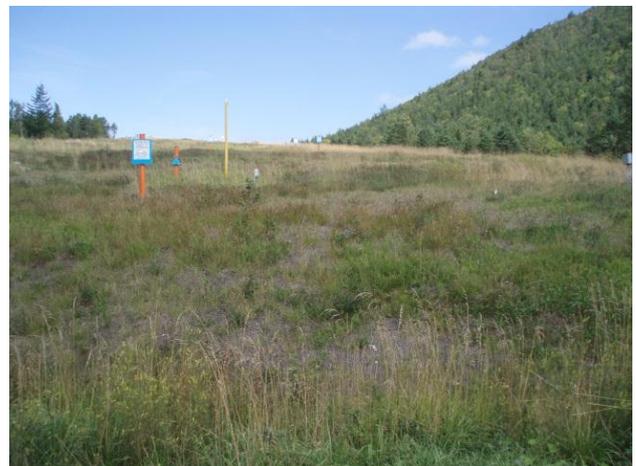
The riverbanks are protected with reno matting through which good vegetation has grown (Photo 3). Some minor damage was evident to reno matting on the western bank in the downstream direction (Photo 4), which is likely to be due to is being placed too far into the channel.

**Photo 3** – View of the river banks

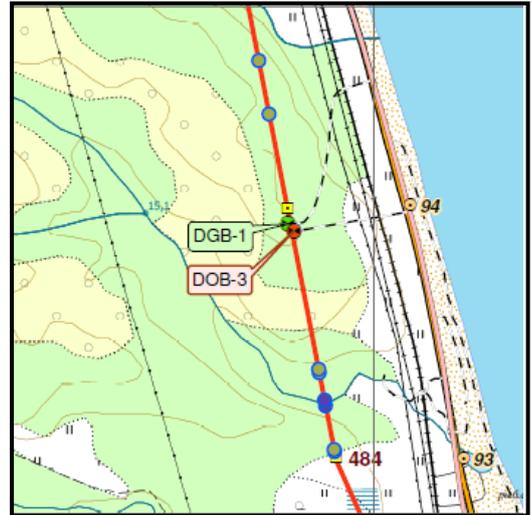
The Slavnaya River is protected with Reno mats and significant re-vegetation has occurred on the matting (Photo 1).

**Photo 1 – Re-vegetation on riverbanks through reno matting**

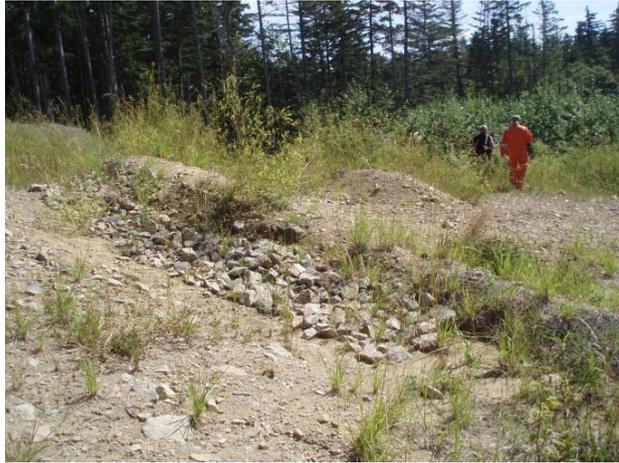
**Photo 4** – Side cut on south side of river

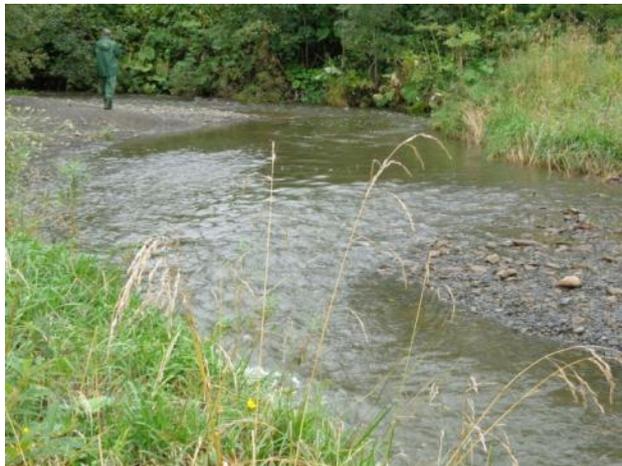
The Kirpichniya River crossing is located in the northern boundary of the river valley. The river banks at the crossing are well protected with Reno mats and thick vegetation (Photo 1 and 2). The river on the downstream side of the RoW bends sharply to the north (and cuts) into the RoW on the Oil Pipe side. It was not possible to see the side of the RoW at the bend during the visit and it is recommended that it will continue to be monitored (Photo 3).

**Photo 1** – View to the downstream showing well vegetated river banks

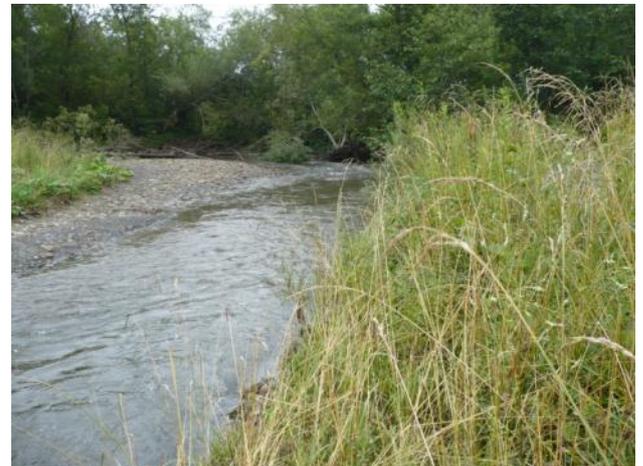
**Photo 2** – View to the upstream showing well vegetated river banks.

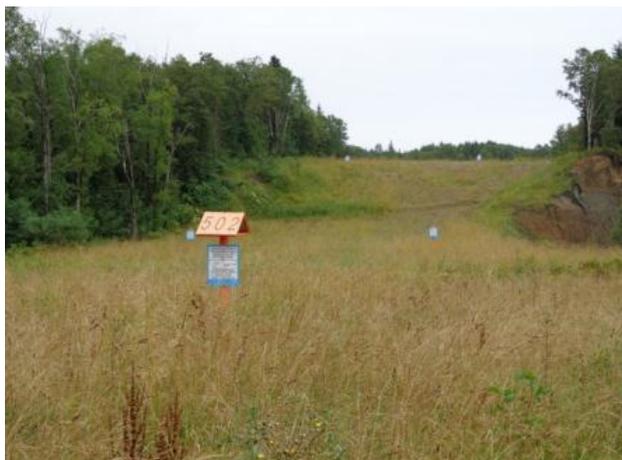
The valley floor is densely vegetated throughout (Photos 3 and 4) and the slope to the south is well protected with vegetation and slope breakers (Photo 4).

**Photo 3** – View to the north across the river showing good ground cover. Also note the river bend on the right side of the slope (see text)

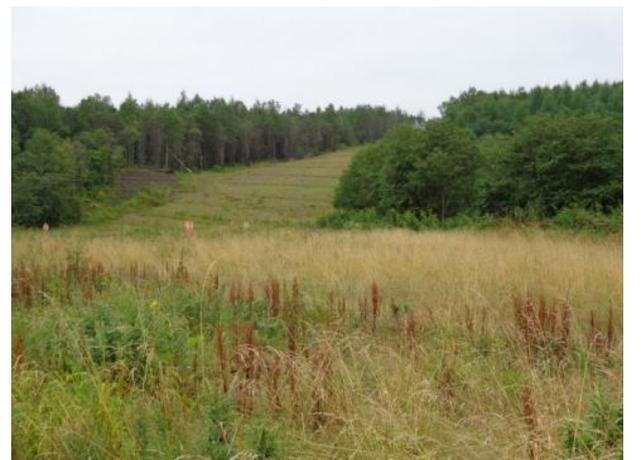
**Photo 4** – View of the river valley to the south with a slope in the background showing very good ground cover and good slope protection.

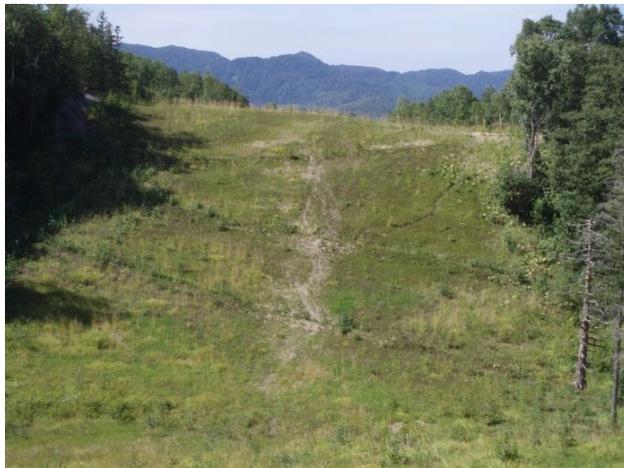
The sandy slopes between KP513 to the Ai River show some improved levels of vegetation over previous years (Photo 1), including some areas where seeding effects are evident (Photo 2). However, overall re-vegetation of these sandy slopes remains limited with some areas still showing very limited or no vegetation at all (Photo 3). The slope breakers which were installed along the sandy area mostly function well but in places need increased in frequency. The sandy area will need surface preparation and re-seeding for improved bio-restoration.

**Photo 1 – View to the north along the RoW**

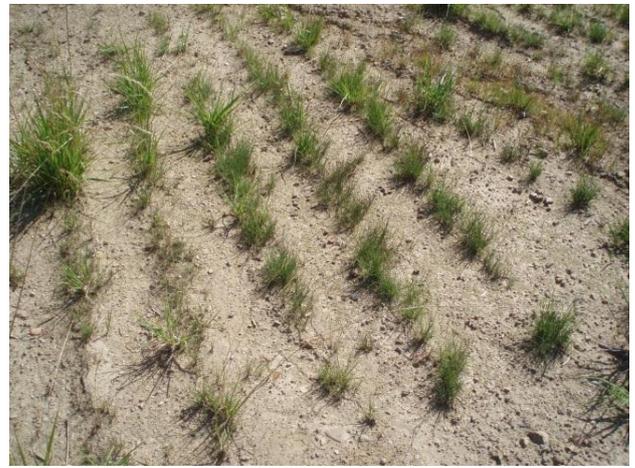
**Photo 2 – Recently seeded area**

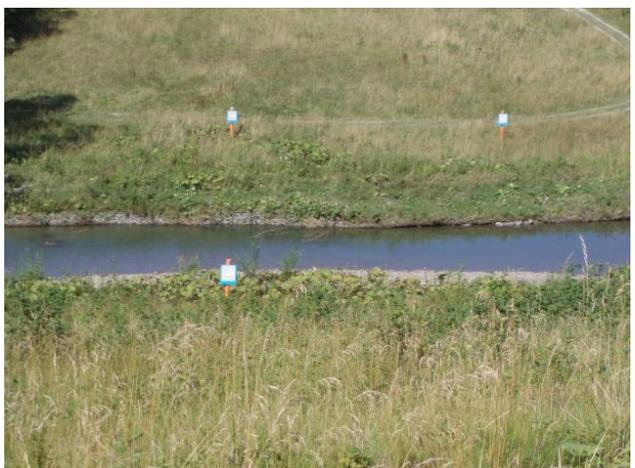
The river itself could not be inspected closely due to the presence of poachers, but from a distance the riverbanks appeared to be well vegetated and in good condition (Photo 4).

**Photo 4 – View of the River**

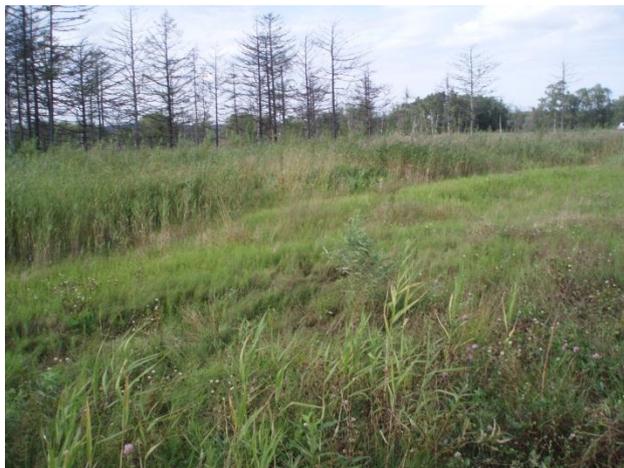
Overall, re-vegetation on the RoW is extensive (Photo 1), although:

**Photo 1** - View to the south along the RoW

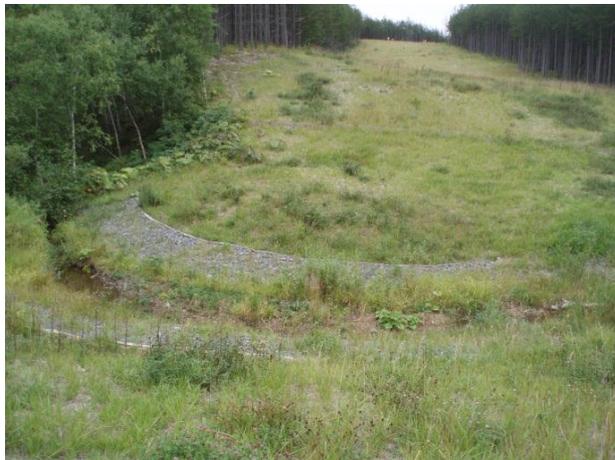
The slopes to the river are steep to both the north and south. The slopes are protected slope breakers that were seen to be in reasonable condition (Photo 3). Re-vegetation on the slopes immediately adjacent to the river has improved significantly over the last 2 years (Photo 1), although some patches of weak re-vegetation remain.

**Photo 1** – View of river showing significantly improved vegetation of the slopes

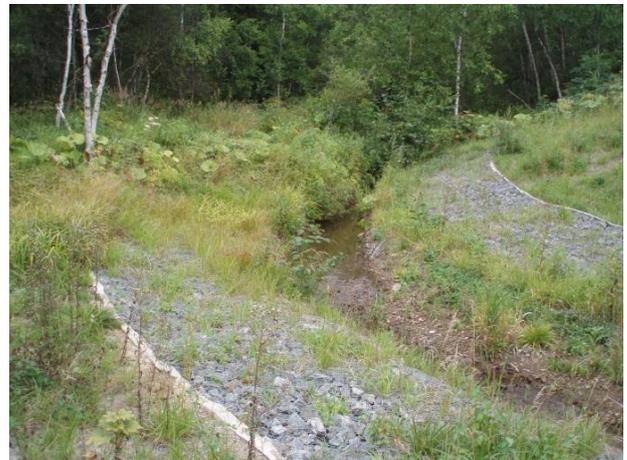
The riverbanks are protected by reno matting which appeared to be in good condition and vegetation through the matting is occurring (Photo 2).

**Photo 2** – Reno matting on the riverbanks with vegetation growth through.

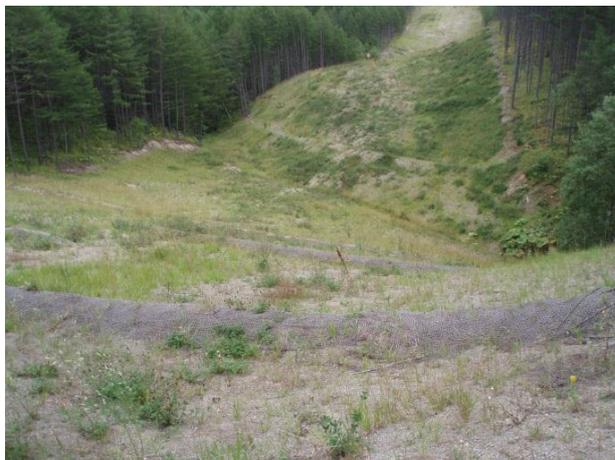
**Photo 3** – Showing slopes with slope breakers but some areas of patchy re-vegetation

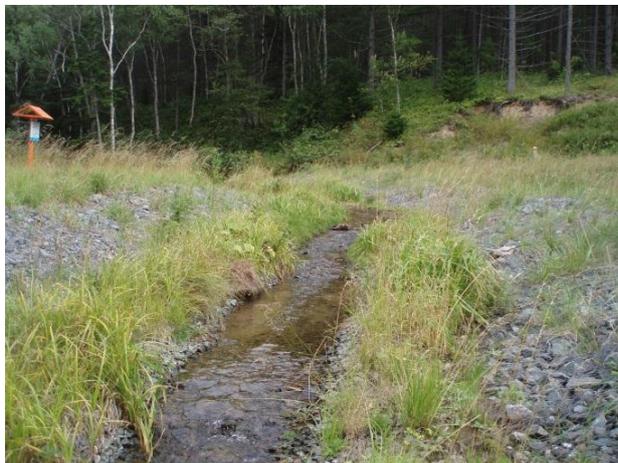
The R. Vodopyanovka banks are protected by reno matting which appeared to be in good condition and vegetation through the matting is occurring (Photo 1). The slopes on the RoW on both sides of the river have only moderate re-vegetation (Photo 2), although this is nonetheless improved over conditions seen during the last visit to this river in 2010. Slopes breakers are installed on the slopes and were found to be in good condition.

**Photo 1** – Showing Reno matting and re-vegetation of the riverbank

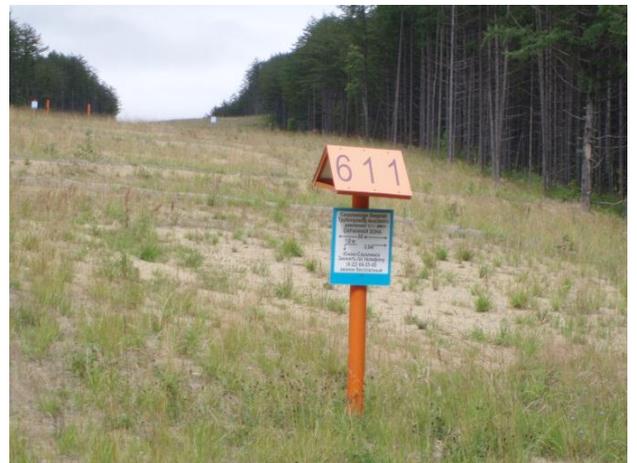
**Photo 2** – Northern slope with moderate grass cover

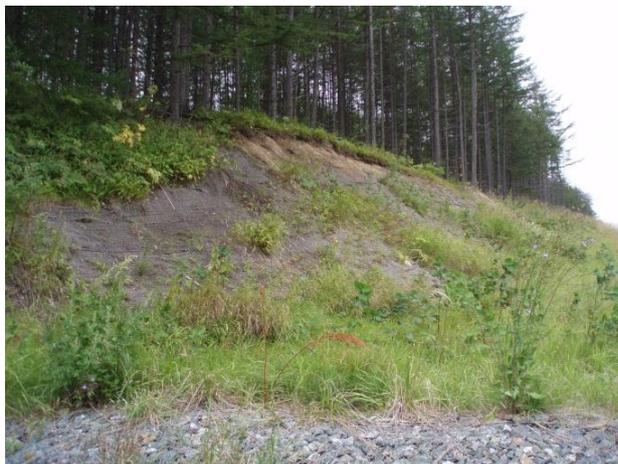
A side cut on western side of the northern slope, close the river has only weak re-vegetation and may be prone erosion in future.

**Photo 3** – Side cut on western side of the northern slope

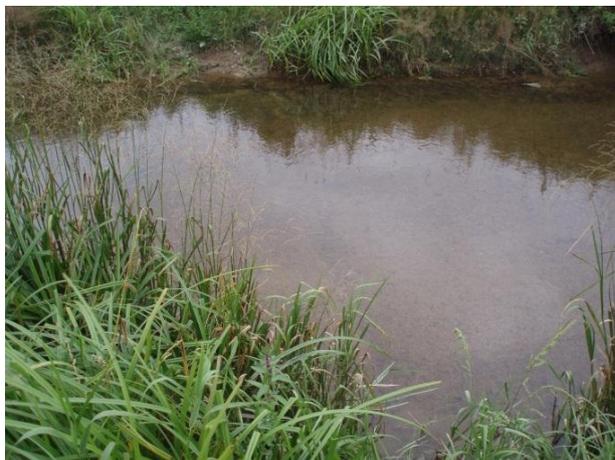
The Korsakov River was crossed using horizontal thrust bore which left the river banks largely un-impacted (Photo 1).

**Photo 1** – View of banks with natural vegetation

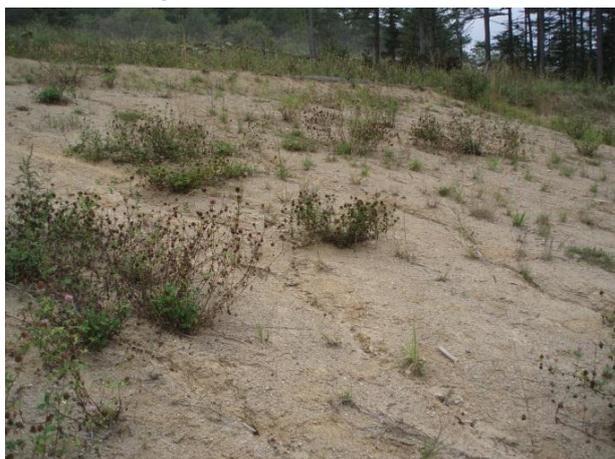
The lower river valley has good vegetation cover (Photo 2) but the slope leading to the river from the north has very poor vegetation and shows strong erosion (Photos 2 and 3). This slope is need of additional and more effective slope breakers and full bio-restoration.

**Photo 3** – View of erosional rill development and lack of grass cover.

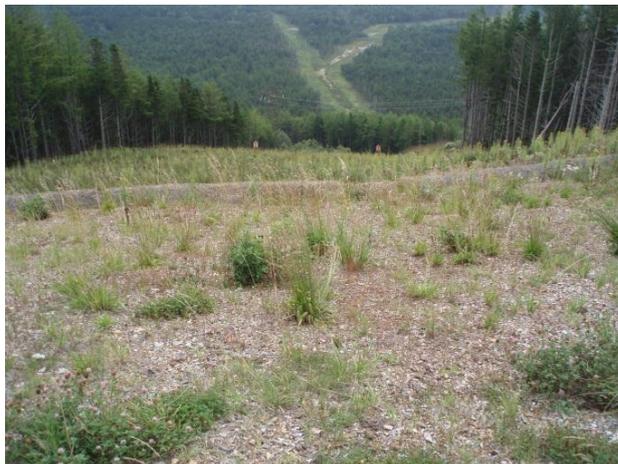
The hill to the north of the river crossing was also inspected. The southern slopes of the hill overlooking the R. Mereya had moderate levels of re-vegetation and the slope was protected by geojute armoured slope breakers which were found to be in good condition (Photo 1). The slopes on the north side of the hill showed generally weaker re-vegetation (photo 2), although it was noted that the soils in the area have a low erosion potential and also there is no stream at the bottom of the slope (hence reducing the environmental significance of any run off).

**Photo 1** – South slope on hill overlooking R. Mereya

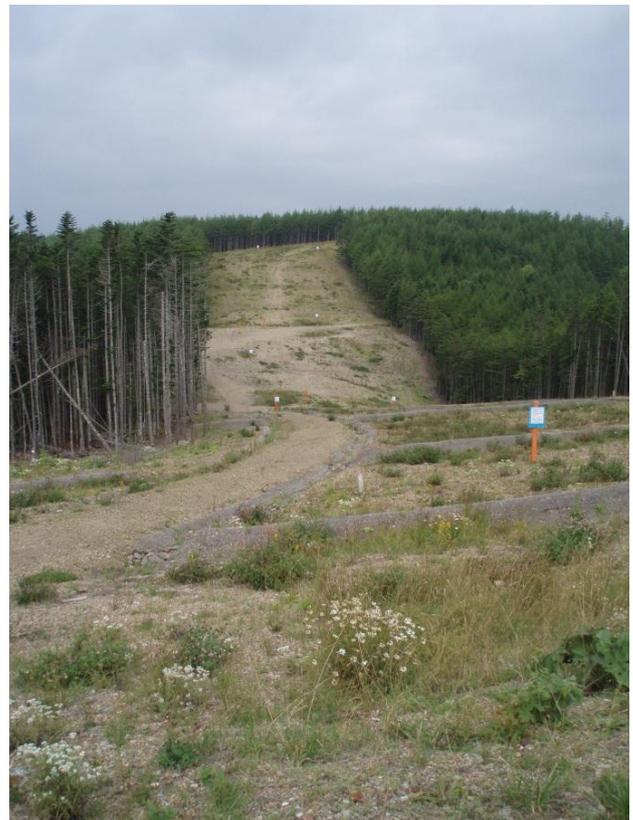
**Photo 2** – North slope on hill overlooking R. Mereya

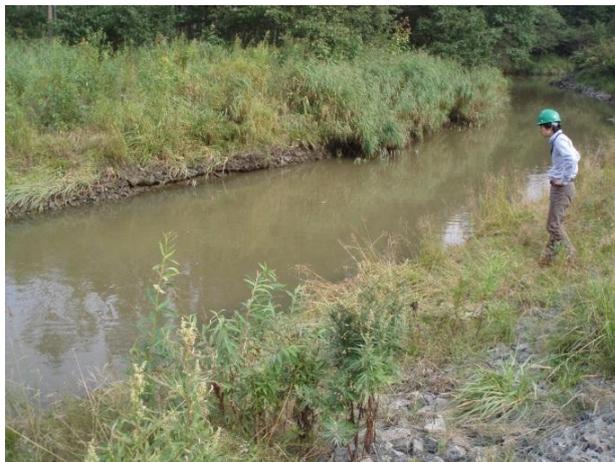
The Mereya River is crossed with two separated RoWs, one for the oil pipe (Photos 1 and 2) and one for the gas pipe (Photos 3 and 4). Both crossings are protected with Reno matting which has begun to disintegrate but have been nonetheless stabilised by good levels of re-vegetation (photos 1 and 3).

**Photo 1** – View to north bank on oil pipe crossing

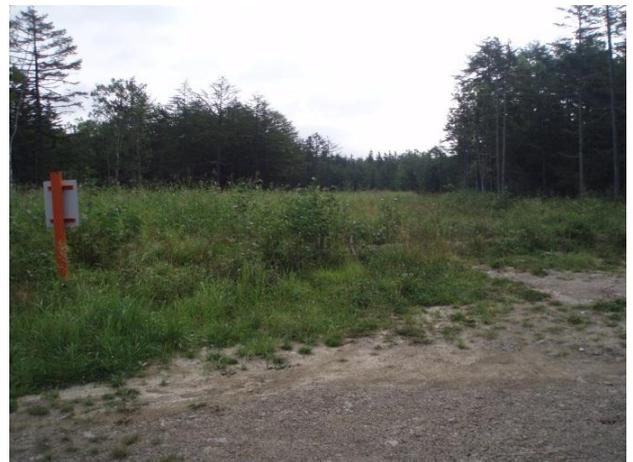
The RoW on adjacent to both river crossings is re-vegetating well (Photos 2 and 4), although some tree growth was identified that needs to be removed.

**Photo 2** – View to the south from oil pipe crossing showing well vegetated RoW

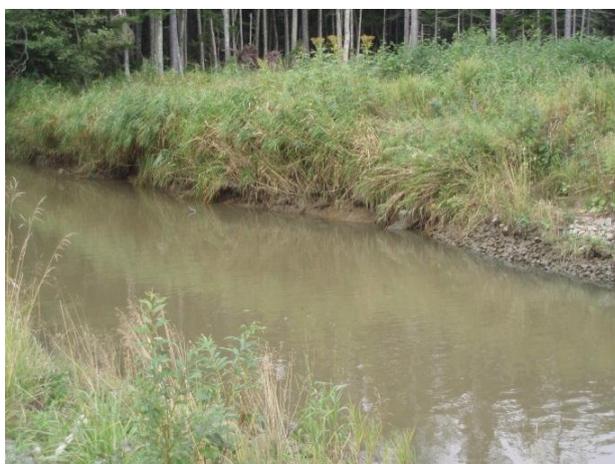
**Photo 3** – View to north bank on gas pipe

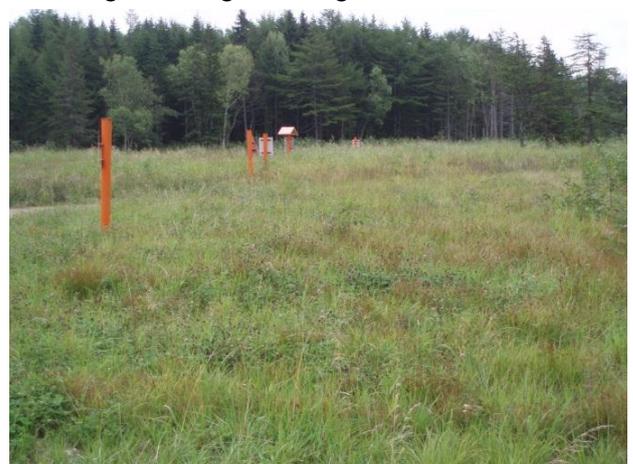
**Photo 4** - View to the south from oil pipe crossing showing well vegetated RoW
