## **Annex D: Individual RoW Descriptions**

**Chaivo peninsula landfall, RoW and Pigging Station KP 71.5 – 74 and KP 0 - 4**

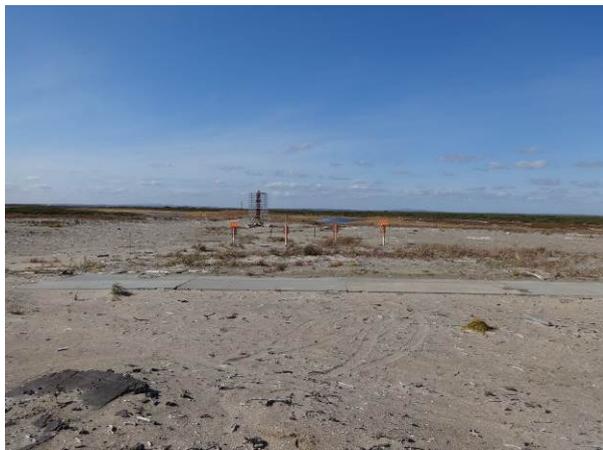
The landfall area of the pipelines from Molikpak PA-A Platform is shown in photos 1 to 4. The immediate near shore area (where the tie-in was performed) is levelled but with very little growth and includes wooden debris (Photo 1). The RoW immediately to the west but within the foot print of the landfall area’s previous activities shows poor technical reinstatement and should be considered for remedial works (Photo 2). Photo 3 provides a panorama that encompasses the entire landfall site. The RoW west of the landfall is well vegetated (Photo 4).

**Photo 1** – View to west across the landfall area showing poor vegetation.

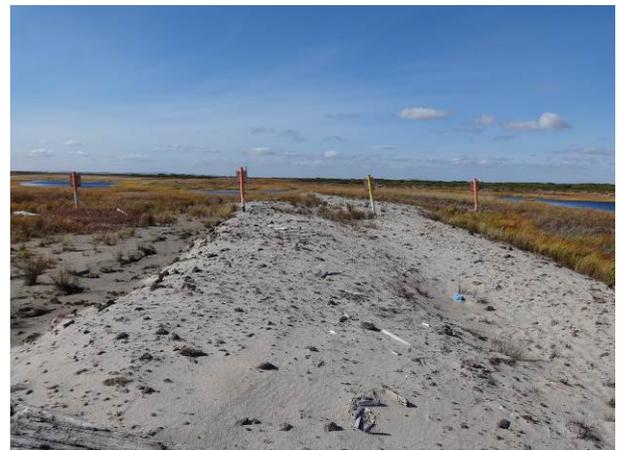
**Photo 2** – View to the west showing the centre of the RoW at the edge the landfall area with poor technical reinstatement and no vegetation.

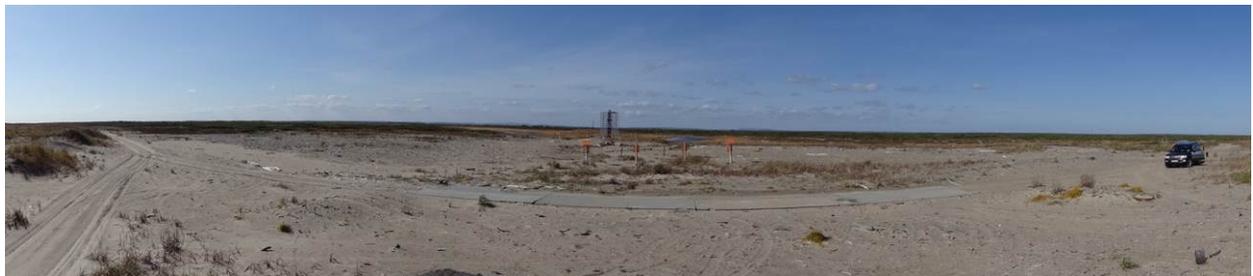
**Photo 3** – Panoramic view of the landfall footprint area taken from shoreline dune.

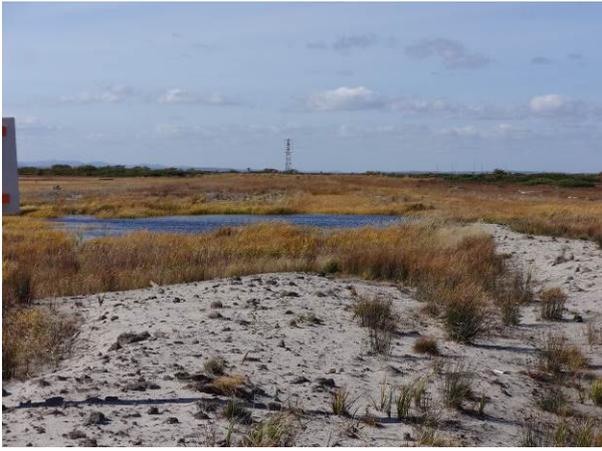
**Photo 4** – (to left) View to the west towards the Piggling Station from the edge of the landfall area showing Good vegetation cover on the RoW.

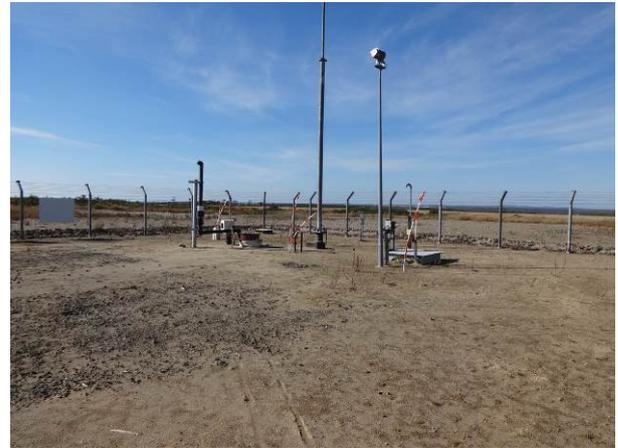
During the visit the team had a brief look at the Pigging Station. The station was clean and without visible stains soil on the ground. The pig traps have a secondary containment in the form of a subsurface sump (Photo 1). It was reported that there is an underground storage tank of unknown dimension and type that collects and stores oil and paraffin (Photo 2).

**Photo 2** – View of the southwest corner of the station showing location of the underground storage tank

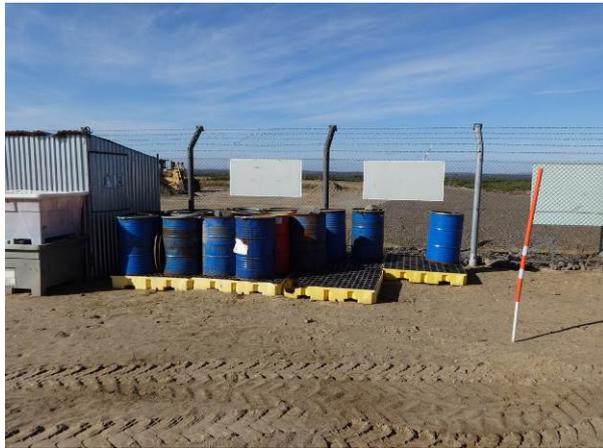
Drum storage was observed near the main gate (Photo 3). The drums were situated on large drip trays that act as secondary containment but with no protection from rain and snow. This will reduce the capacity of the containment and will produce un-intended waste water. The Company should re-evaluate and improve the storage area.

**Photo 3** – View of drum storage on top of drip trays.

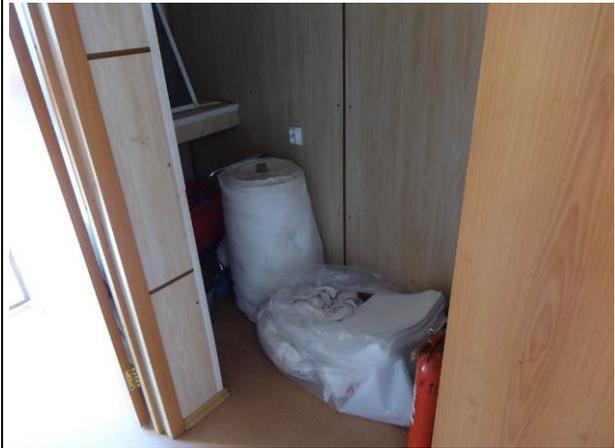
Spill response material was situated in an office trailer and included only relatively small amount of absorbent pads (Photo 4). No spill response equipment/material was observed outside of the trailer.

**Photo 4** – View of available spill response material.

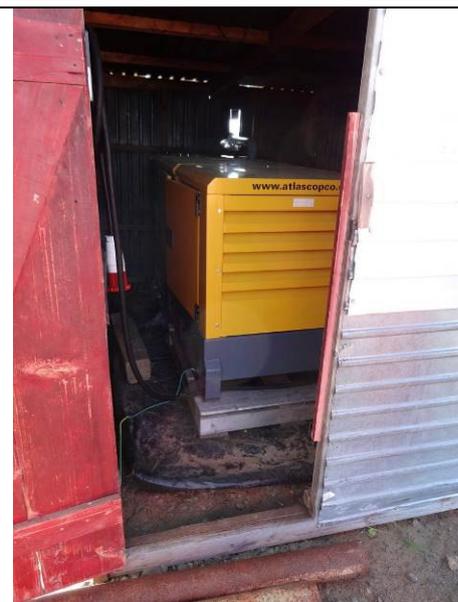
Backup power generator was observed in an enclosure and on secondary containment. There was no external fuel tank (Photo 5).

**Photo 5** – (to left) backup power generator within an enclosure.

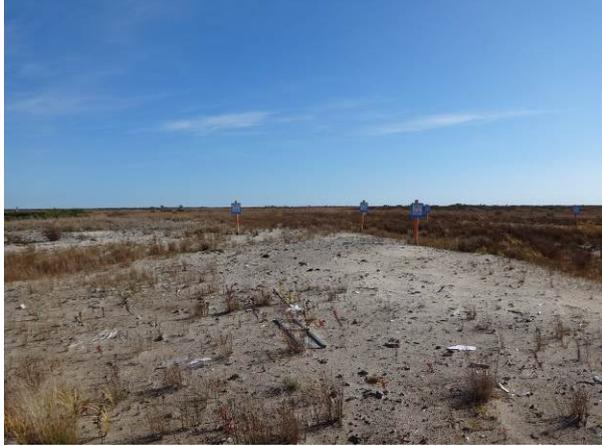
The RoW to the east of the facility was in poor condition for the first 100 meters from the fence line. It was mostly without vegetation cover and included debris field (Photo 6). The Company should consider removing the waste/debris field and reseeding the area. Further east the RoW is in good condition with good vegetation cover (Photo 7).

**Photo 6** – View to the east outside the facility’s fence showing waste/debris field and poor vegetation cover.

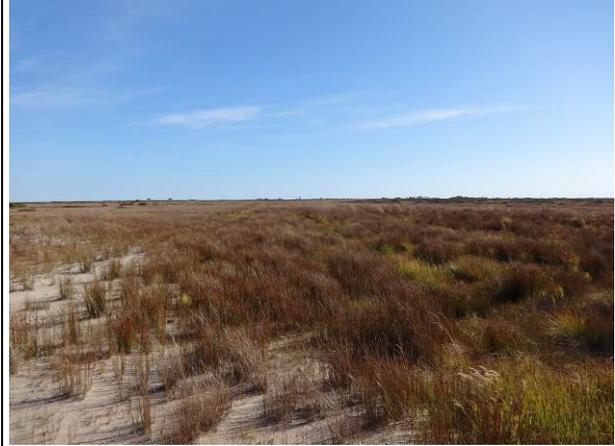
**Photo 7** – View of the RoW further east of facility toward the landfall showing good vegetation cover.

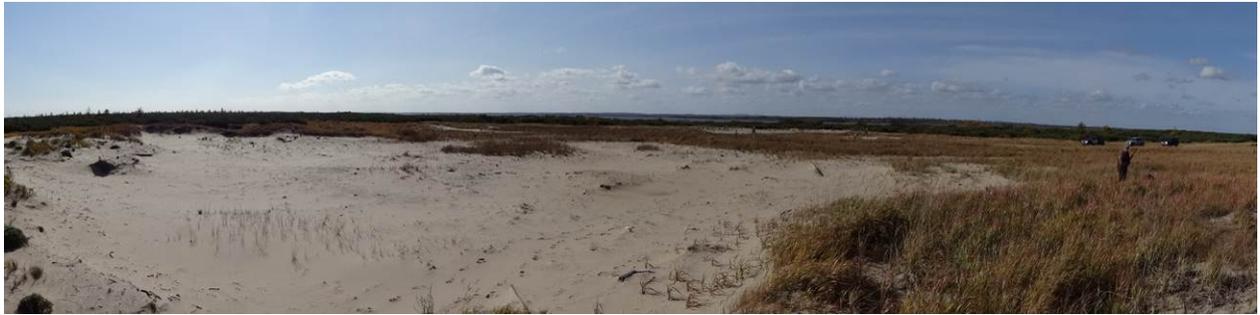
The HDD Site at KP 4.5 is still mostly poorly vegetation. Also waste/debris such as pipe/tubing segments was observed partially buried in the sand.

**Photo 1** – A panoramic view to the west direction of the HDD site. Note the poor vegetation cover and the waste pipes in the foreground.

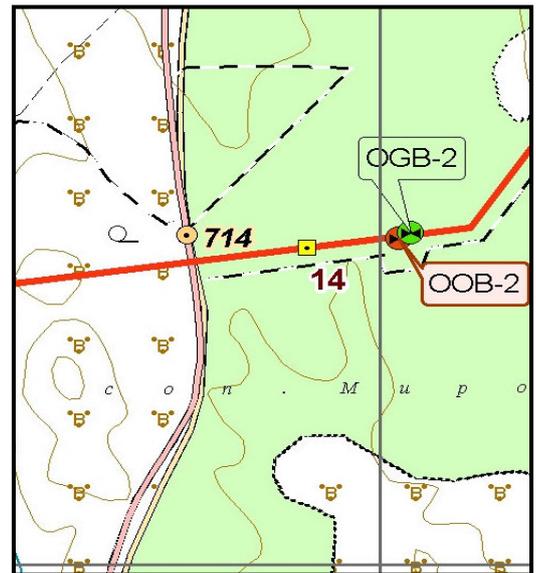
The RoW on the west side of the Federal Highway Road Crossing at HW marker 714 is situated in sandy, soil on a gently climbing slope. The RoW is well vegetated with grass and with the addition of many small trees (mostly Alder). The road cut slope has Geojute cover and is mostly vegetated by Alder trees (Photo 1).

**Photo 1** – (to left) View west across the Federal Highway, showing a vegetated RoW with grass and small trees. The slope in the foreground is the road cut with geojute placed on the slope.

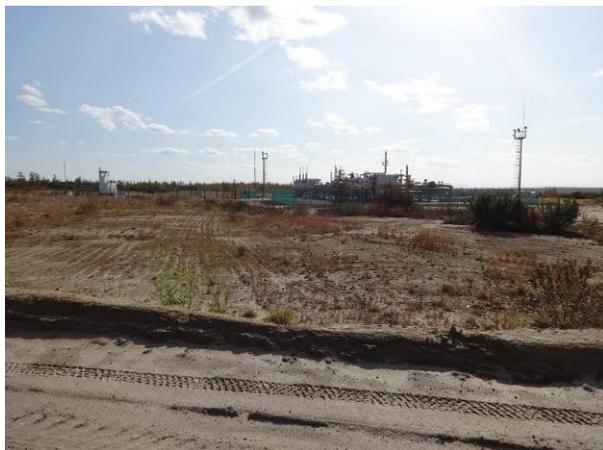
The RoW in the vicinity of the newly constructed GTTN was reseeded and some grass cover is visible. The soil in area is very sandy and recovery/vegetation coverage will need to be monitored and treated accordingly.

**Photo 1** – View to the south towards the GTT Facility showing RoW following recent reseeded.

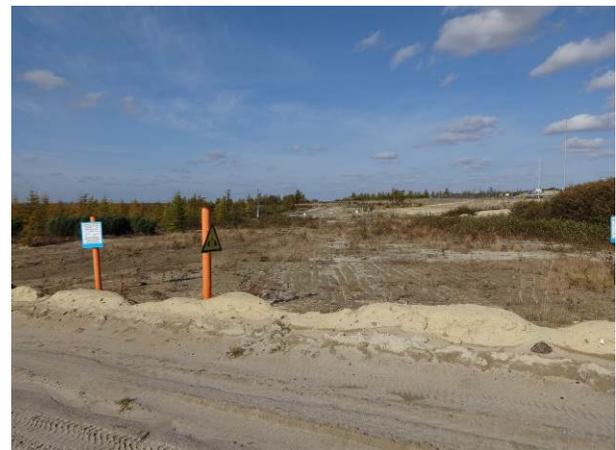
**Photo 2** – View to the north of the reseeded RoW.

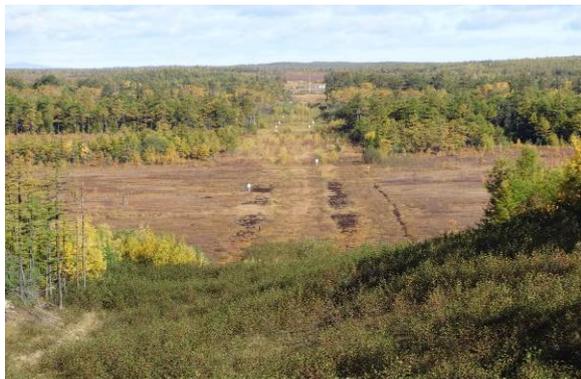
The Dagi River valley is showing very slow improvement; there is only partial vegetation cover over the pipe trenches in the wetlands and further improvement is needed (Photo 1). The southern slope and side cut are well protected with Geojute and vegetation cover. The slope is covered with a dense population of Alder saplings.

**Photo 1** – View to north across the river crossing showing partially recovered wetlands and vegetated slope and side cut. Note the dense population of Alder on the slope leading to the valley.

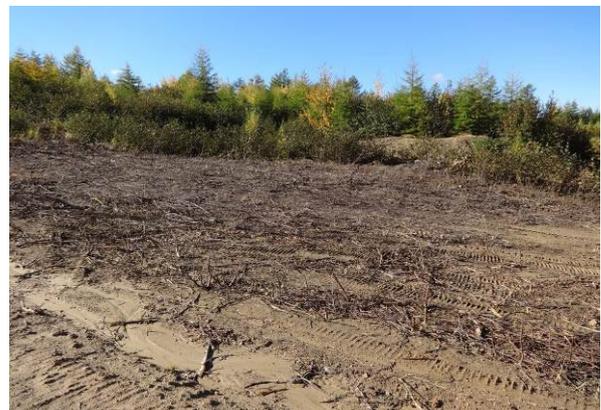
The Company started a program to remove the Alder trees first near the road crossing but more particularly on the RoW south of the road crossing. The method of removal is reportedly mechanical (not witnessed). The area of the RoW in which trees were removed in this way is disturbed and with little or no vegetation besides the stumps of the cut trees (Photos 2 and 3).

**Photo 2** – View of RoW north of the road crossing showing disturbed RoW after tree removal.

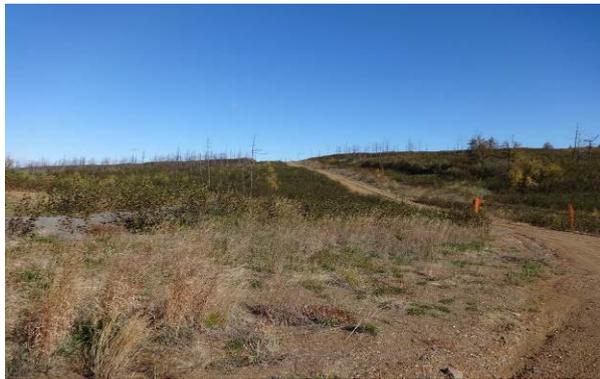
The RoW in this area is has a dense cover of grass and tree saplings (mostly Alder) (Photo 1). The Company made a concerted effort for tree removal in this area. Reportedly, the method used tracked equipment. Results as seen on site are that the trees are cut about a foot above ground with the root system still in place (Photos 1 to 4). In addition, in places the use of the mechanized equipment resulted with scraping of the soil surface and removing other vegetation (Photos 2 and 3). It is recommended that the use of this method be re-evaluated.

**Photo 1** – View to the east of well vegetated RoW with grass and trees. This area was disturbed by tree removal.

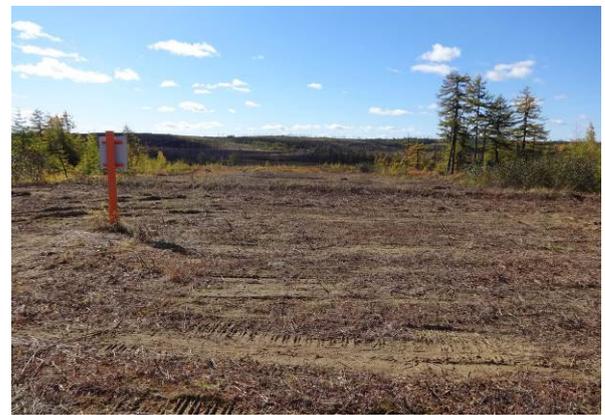
**Photo 2** – View of RoW post removal of trees and surface disturbance.

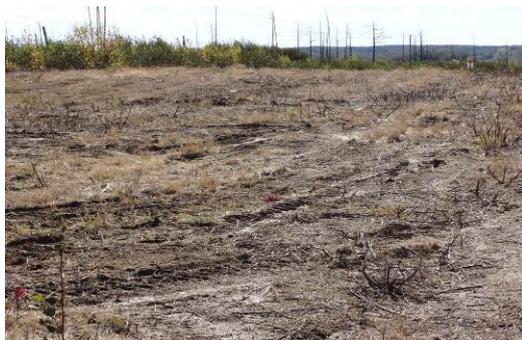
**Photo 3** – View of RoW post removal of trees and surface disturbance

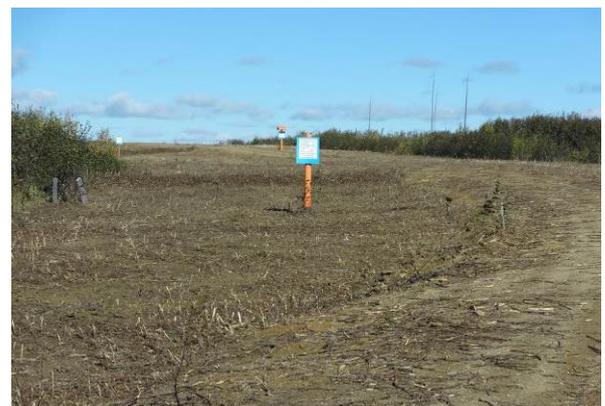
**Photo 4** – View of RoW with removed trees.

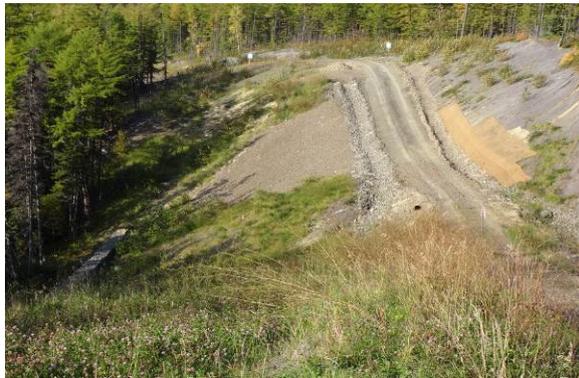
Category 2 repair work was recently completed at KP 87. The work entailed stabilizing a side slope across the width of the RoW (Photo 1). Elsewhere in the area the RoW follows an undulating terrain with moderate slopes. The RoW in the area is well vegetated (Photo 2).

**Photo 1** – View north of well protected slopes with good vegetation cover.

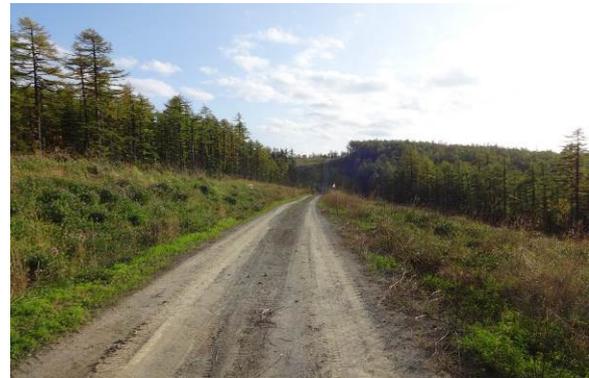
**Photo 2** – View south of well protected slopes with good vegetation cover.

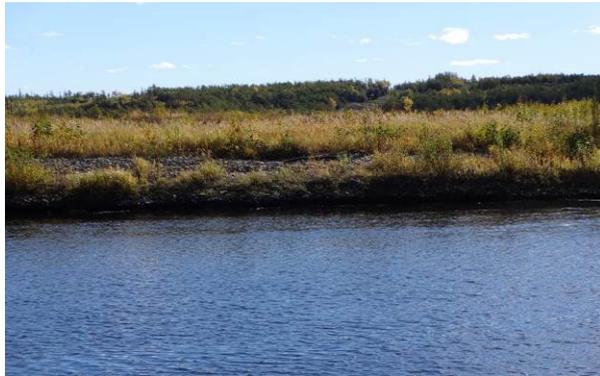
The Djimdan River crossing is well vegetated and appears stable. Some minor undercutting of the Reno mats was observed and the bank should be monitored (Photo 1). The RoW on each side of the river is well vegetated. However, only partial vegetation cover is visible on the RoW in the wetland in the river valley (Photo 2). The RoW on the east slope leading to the river is covered by dense growth of Alder trees that reach two or more meters in height (Photo 3).

**Photo 1** – View south across the river showing good vegetation cover on bank – partially covering the Reno matting.

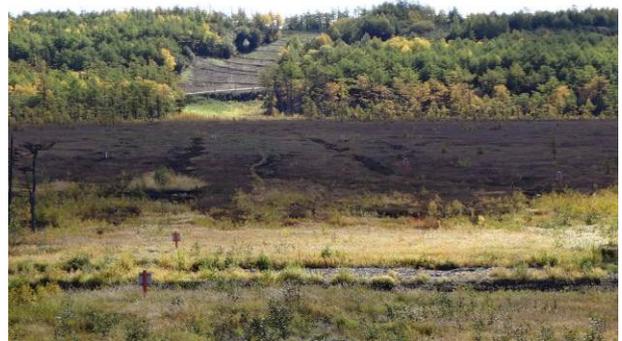
**Photo 2** – View south across the valley showing partially reinstated RoW in the wetlands and well protected slope on the other side of the valley.

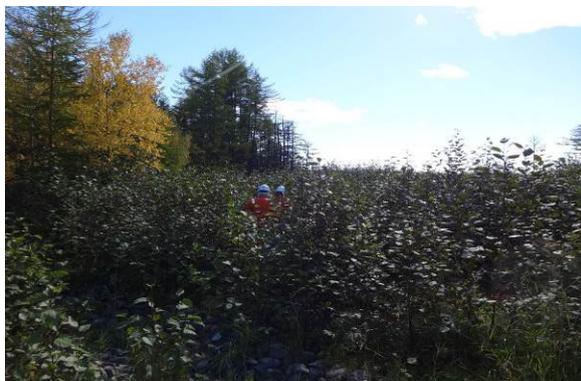
**Photo 3** – (to left) View of RoW between NOB 16 and the river showing significant tree growth. Note the white helmets in the centre of the photo for scale.

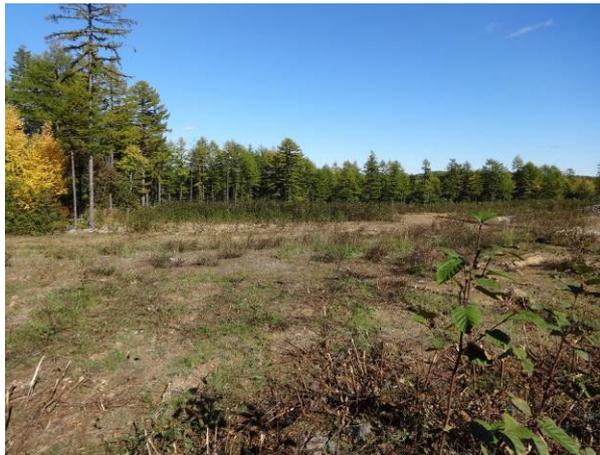
During a previous visit of this site the RoW was observed to be “mostly well vegetated and with some thick patches of tree saplings.” Since then, the Company cut trees on the RoW in the area. The trees are cut at about 20 – 30 cm above ground using tracked equipment that disturbs the RoW surface and damages other growth.

**Photo 1** – View of a partially deforested RoW. Trees were cut about 20 - 30 cm above ground.

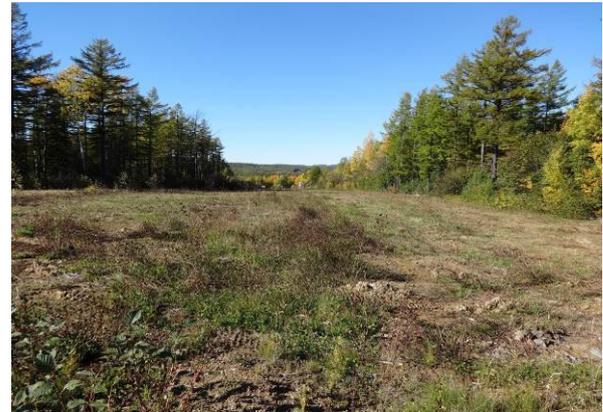
**Photo 2** – View of fully deforested RoW. Note disturbed soil by the use of heavy equipment for the tree cutting.

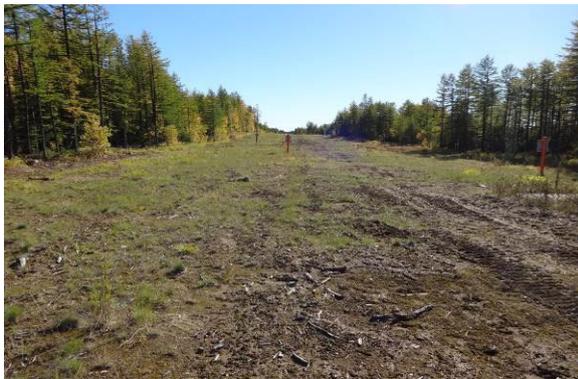
**Photo 2** – View south showing partially vegetated RoW. Note the tracks of heavy equipment that disturbs the surface of the RoW.

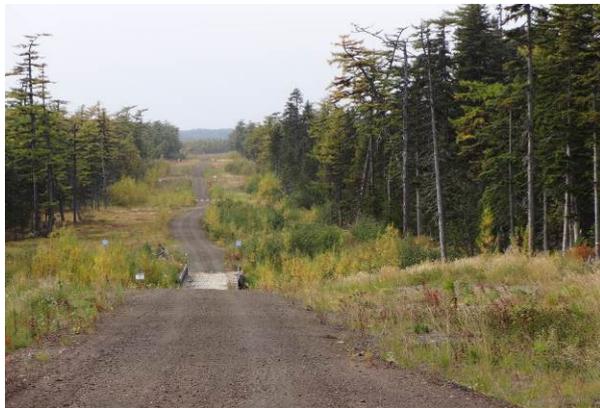
The wetlands, which start at approximately KP 152.7, are well recovered (Photos 4). A previous BIODIV.07 Item was raised regarding inadequate drainage across the access road on the wetlands. The Company addressed the item by improving flume/culvert construction across the road (Photos 5 and 6).

**Photo 4** – View to the north showing recovered wetland

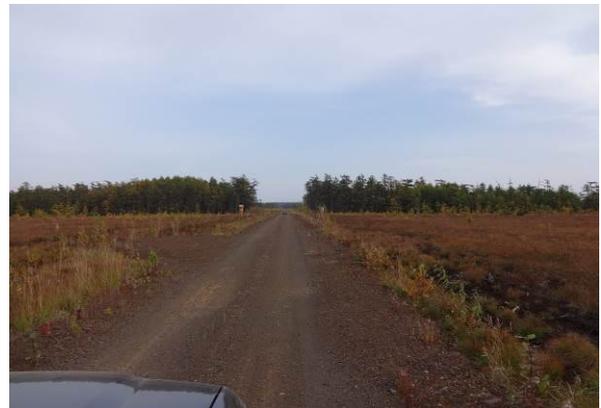
**Photo 5** – View of repaired flume pipe(s) in the wetlands across the access road to NOB 24

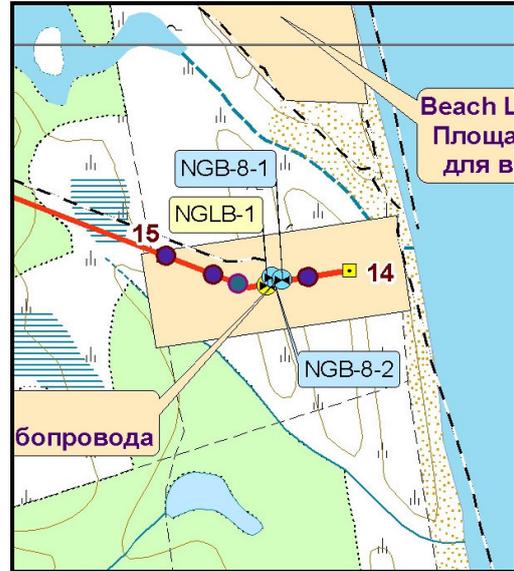
The Landfall from the LUN-A Platform at KP 14 is sparsely vegetated at the project’s footprint in the near shore dune environment (Photo 1). However further to the west (in the approx. area of KP 16) the RoW is mostly to completely covered with grass as see in Photos 2 and 3.

**Photo 1** – View to the west showing partially vegetated landfall footprint and mostly vegetated RoW.

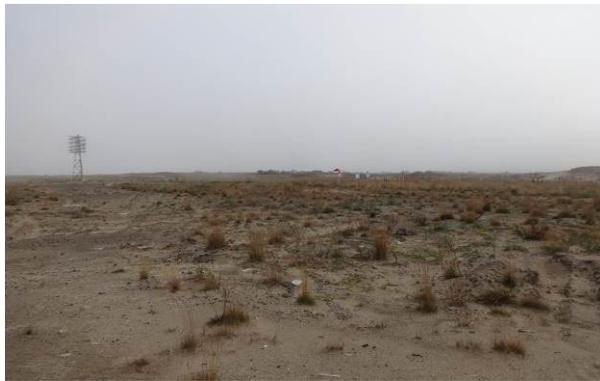
**Photo 2** – View to the west showing partially vegetated RoW.

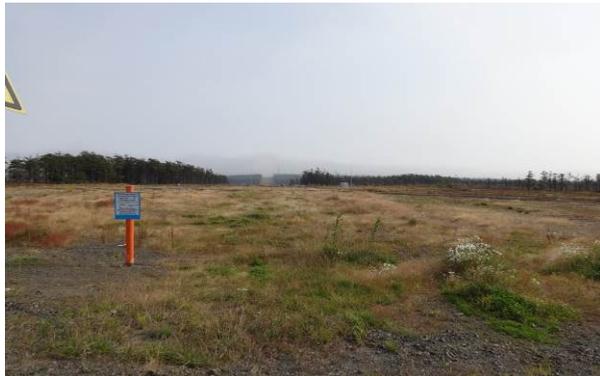
The Vatung river is situated at the edge of a wetland. The RoW east and west of the river crossing has good grass cover (Photos 1 and 2). The riverbanks are in good condition and are protected with Reno mats and reinforced (internally) with Enkamat geotextile. The mats are in good condition and partially vegetated with grass and moss (Photos 3 and 4).

**Photo 2** – View to the west showing good vegetation cover on the RoW across the river.

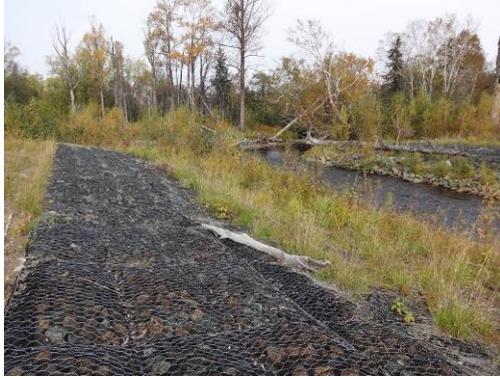
Plelyarna River banks are well protected with Reno mats and Enkamat and are partially covered with grass that comes up through the mats (Photos 4 and 5).

**Photo 5** – View across and upstream of the river showing stable vegetated banks with Reno mats.

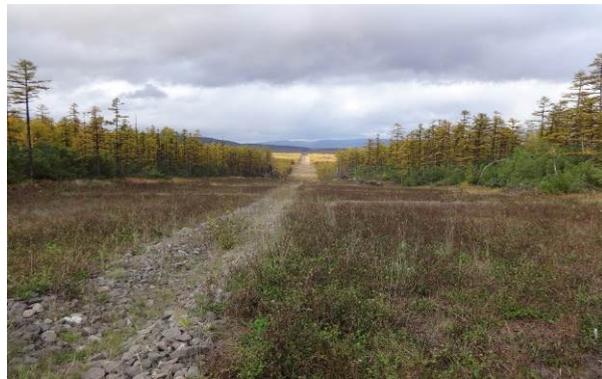
The sandy slopes in this section of the RoW show continuing improvement over previous years. To the north from the road crossing the RoW shows good vegetation cover and good slope protection, including a riprap-covered central channel to aid in slope drainage (Photo 1). To the south the grass coverage away from the road crossing is generally improving but is still patchy/sparse in places and needs further improvement. Slopes breakers in each direction are well constructed.

**Photo 2** – View to the south showing sandy slopes with grass cover and good slope breakers.

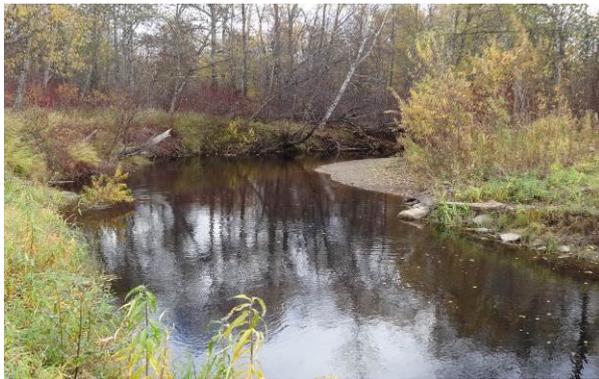
The Taulan River crossing is in good condition. The riverbanks are protected with Reno mats, which are mostly covered with soil and vegetation. Willows were planted on the banks during construction and are now being cut. The upstream bank should be monitored for possible erosion.

**Photo 1** – View to the downstream showing stable well vegetated banks.

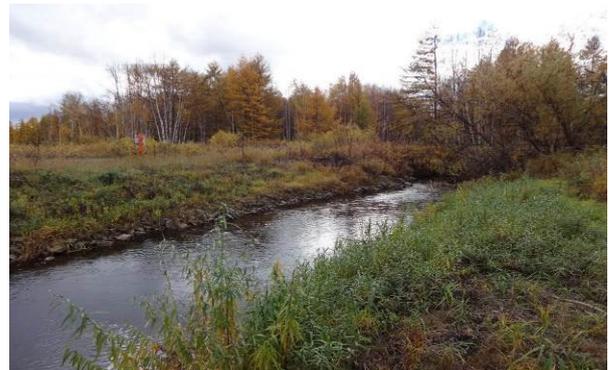
**Photo 2** – View to the upstream showing well vegetated banks with grass and willows.

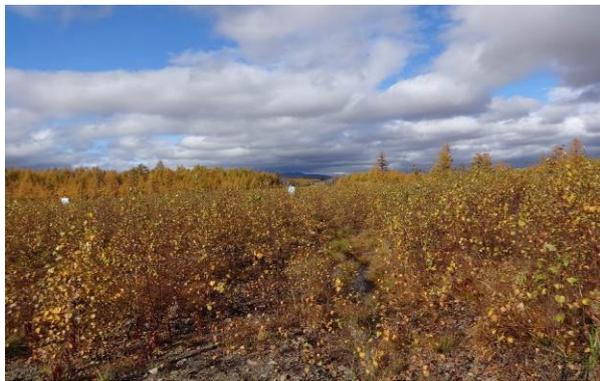
The RoW in the area of SOB 05 has good ground cover but also has established trees growth. Some of the trees are over 2 m in height (Photo 1). This is the case particularly on the north side of SOB 05, while the south side is has more grass and less trees (Photo 2).

**Photo 1** - View of the RoW to the north of SOB 05 showing well vegetated RoW with many tall trees.

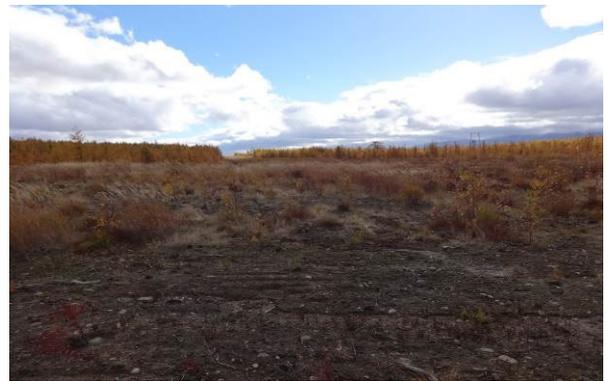
**Photo 2** –View of the RoW to the south of SOB 05 showing well vegetated RoW with some trees.

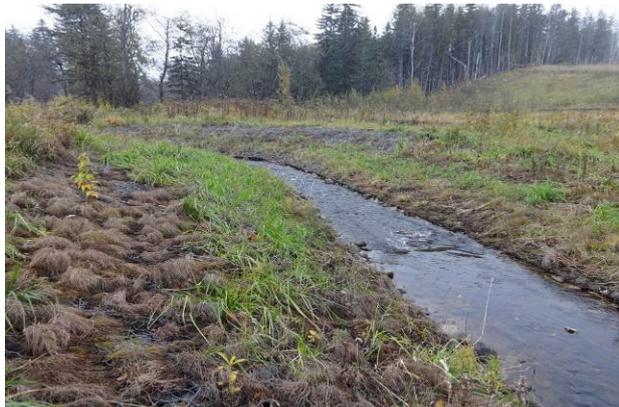
The Devyataya River crossing appears to be in good condition. The banks are protected with Reno mats and vegetation is starting to establish itself through the mats (Photos 1 and 2).

**Photo 1** – View to the downstream showing stable banks and ground cover on the Reno mats.

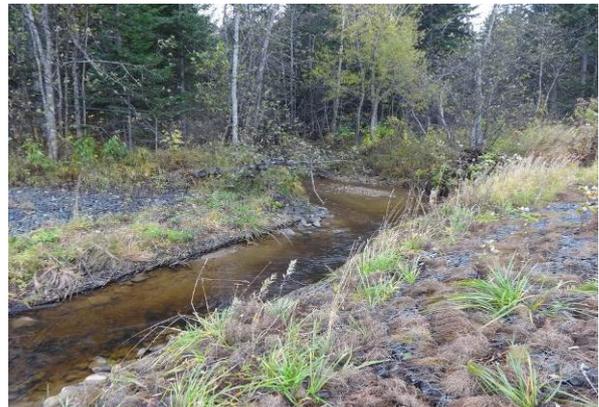
**Photo 2** – View to the upstream showing stable banks and ground cover on the Reno mats.

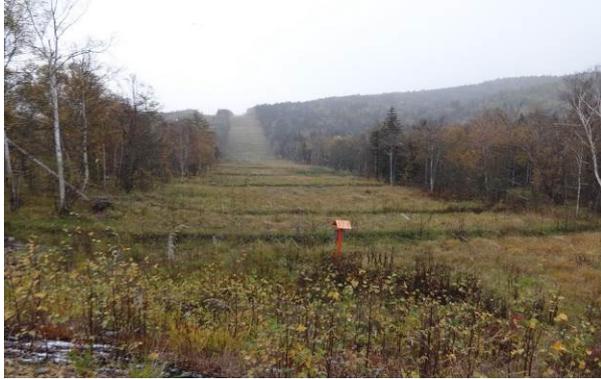
The slopes leading to the river have very good ground cover, which includes grasses, low lying bushes and some trees. Slope breakers on the RoW are well constructed and in good conditions and good vegetation cover (Photos 3 and 4).

**Photo 3** – View to the south showing the slopes leading to the river.

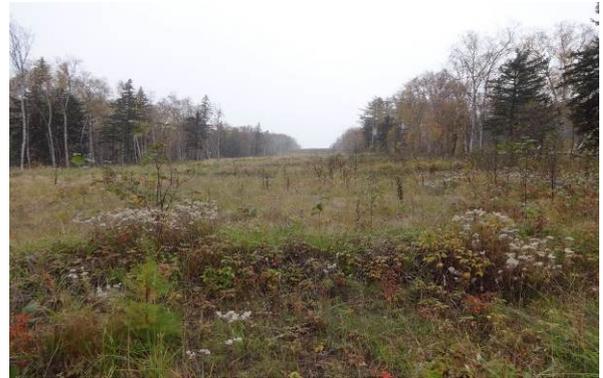
**Photo 4** – View to the north upslope from the river showing the variety of vegetation cover.

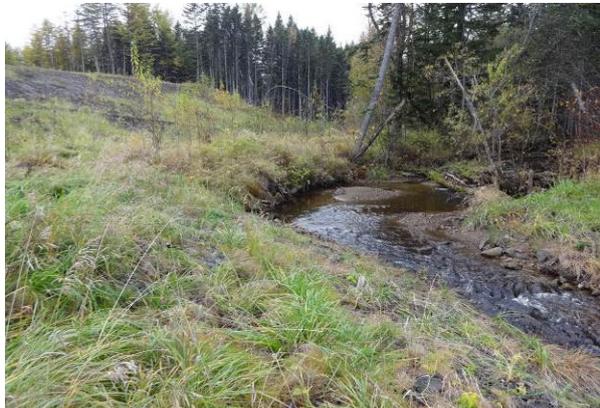
The river crossing is generally in good condition but the upstream section should be monitored for potential undercutting by the stream. The banks are protected with Reno mats and vegetation is starting to grow through the mats (Photos 1 and 2).

**Photo 1** – View to the downstream showing stable river banks

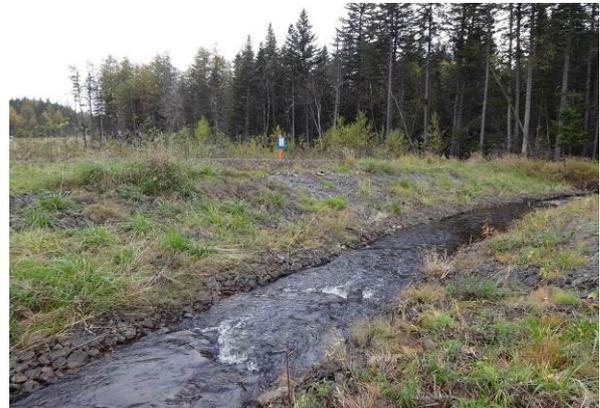
**Photo 2** – View to upstream showing Reno mats and vegetation cover.

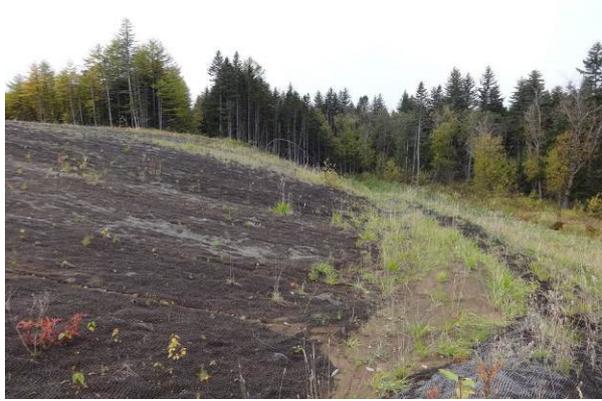
The RoW has good ground cover and the slope leading to the river is stable (Photos 3 and 4). A steep portion of the slope at the edge of the access road is protected with Geojute, but has poor vegetation cover and may need to be reseeded (Photo 5).

**Photo 5** (left) – View of the very top of the slope next to the access road showing slope protection with Geojute but mostly without vegetation.

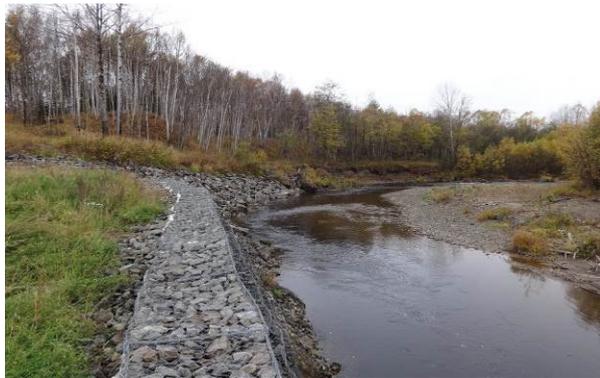
Little has changed since last’s year monitoring visit. The multi-level gabion wall bank protection and upstream riprap are intact but showing wear and tear and should be monitored (Photos 1 and 2).

**Photo 1** – View to the upstream of the south bank of the river, showing multi-level gabion wall and large riprap protection in the upstream.

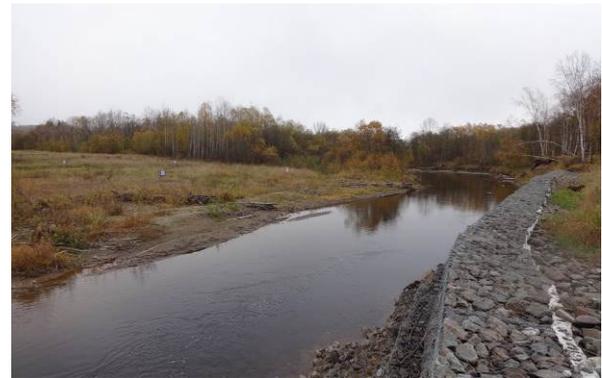
**Photo 2** – View to downstream showing the multi-level gabion wall and the vegetated opposite bank.

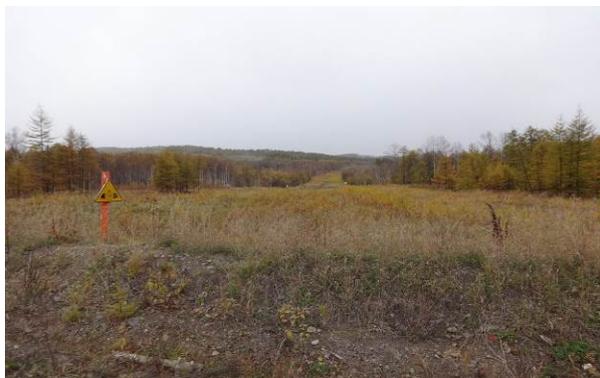
The RoW on both sides of the crossing shows good vegetation cover and slopes are protected with slope breakers.

**Photo 3** – View to across the river from the top of the slope on the south side showing good ground cover on the RoW on both sides of the crossings.

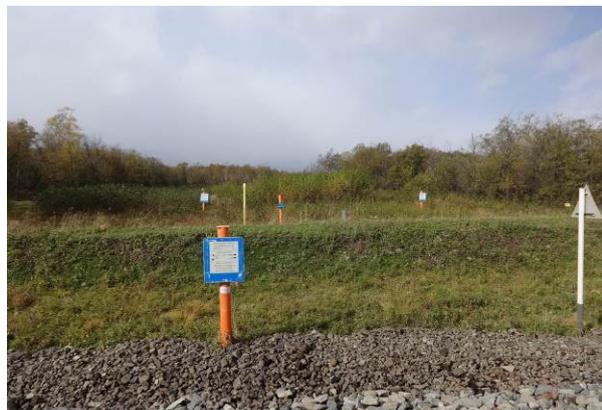
The RoW in the area of the road crossing is mostly flat and with good vegetation on both sides of the road. However the RoW on both sides of the road includes many tall trees in addition grasses and bushes.

**Photo 1** – View to the south showing the RoW with good ground cover and tall trees.

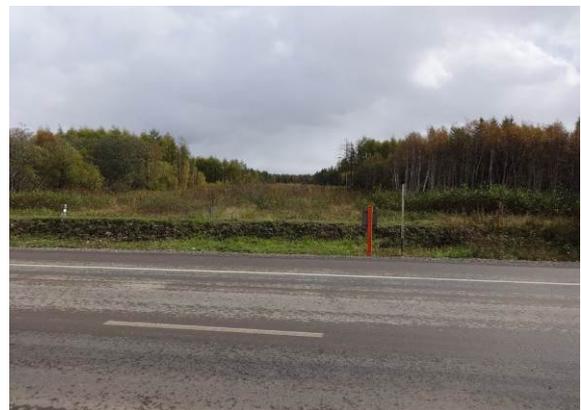
**Photo 2** – View to the north showing the RoW with good ground cover and tall trees.

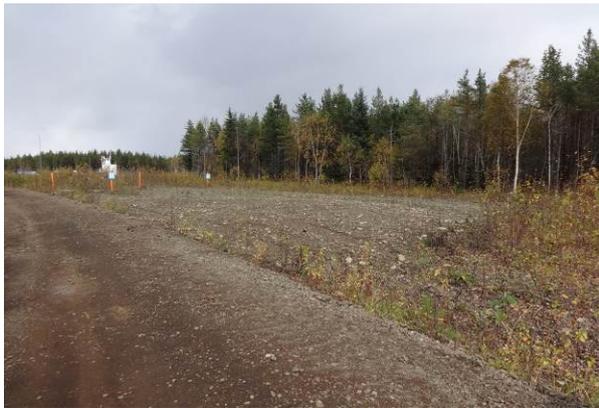
A dig up at KP 258 was recently finished. The surface profiling (as part of the technical reinstatement) was well done and blends into the profile of the adjacent RoW. Also, only a limited area was disturbed in this process as is evident from the undisturbed vegetation in the adjacent areas. The site was reportedly seeded but it is too early to observe any results (Photo 1).

**Photo 1** – View of the dig-up site.

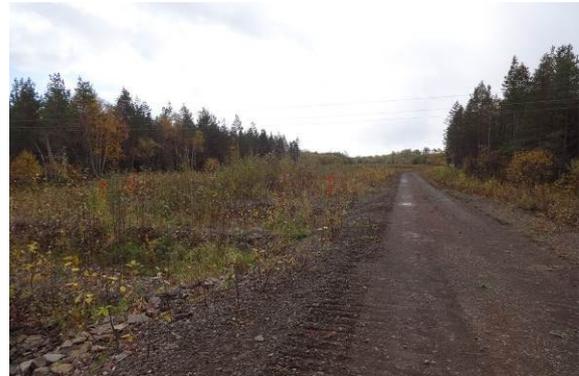
The RoW in the area of the dig-up is very well vegetated but also includes many trees (Photo 2).

**Photo 2** – View of well vegetated RoW with trees.

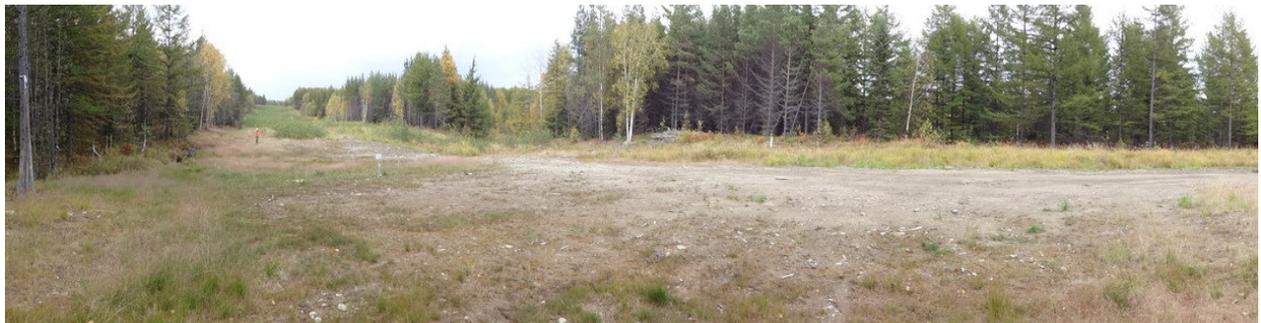
A dig up at KP 295 was completed in 2012 and the technical reinstatement was conducted on the actual dig up location. However, there are still aspects of the technical reinstatement that are not concluded including reinstatement of the access road to the site and protection of the small stream that crosses the RoW immediately north of the dig up. Partial biological reinstatement was also conducted, but this has had poor results to date (Photos 1 to 3). A wide access road to the dig up in the centre of the RoW is quite prominent and includes tree logs used as the road base (Photo 4).

**Photo 1** – A panorama of the dig up area on the RoW showing the disturbed section

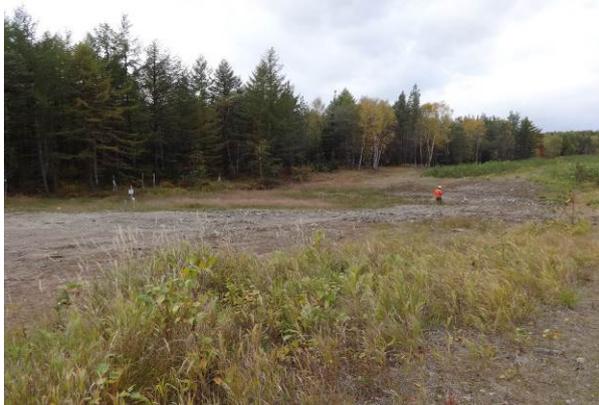
**Photo 2** – View to the north showing the dig up area.

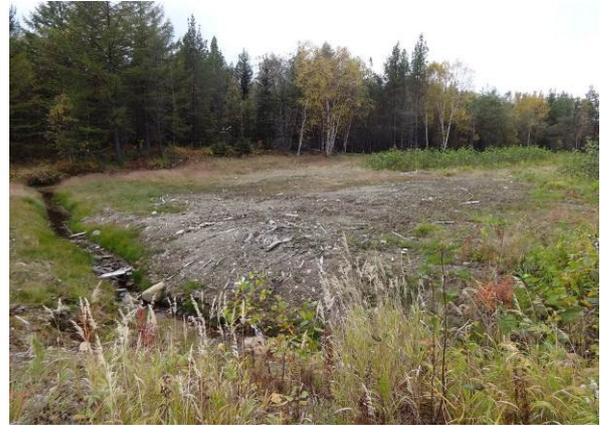
**Photo 3** – View to the west showing a small drainage that was disturbed at the edge of the dig up area.

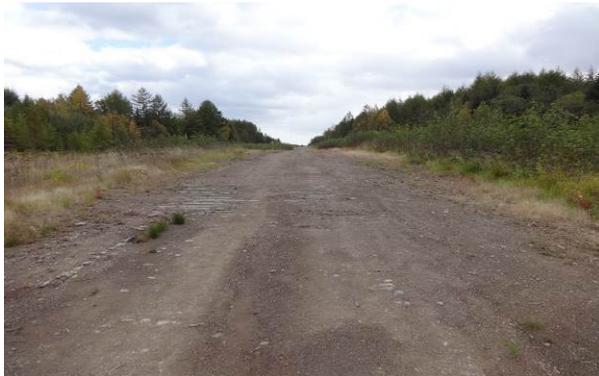
**Photo 4** – View to the north showing the access road that was constructed for the dig up. Also note the tall Alders on the right side of the RoW.

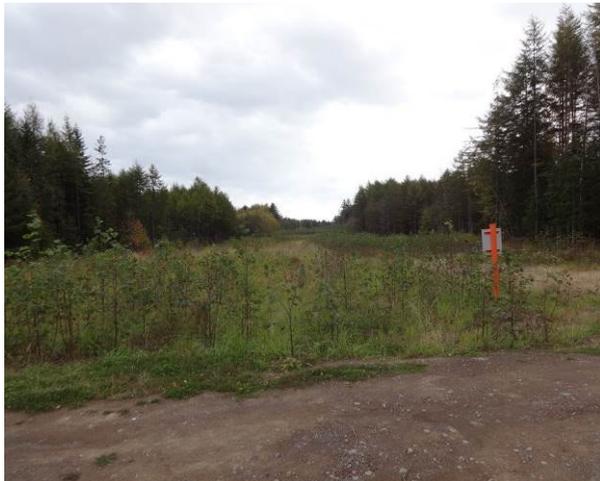
**Photo 5** – View to the south showing the RoW with good vegetation cover and many trees.

The RoW north and south of the river is well vegetated including grasses and trees (Photo 4).

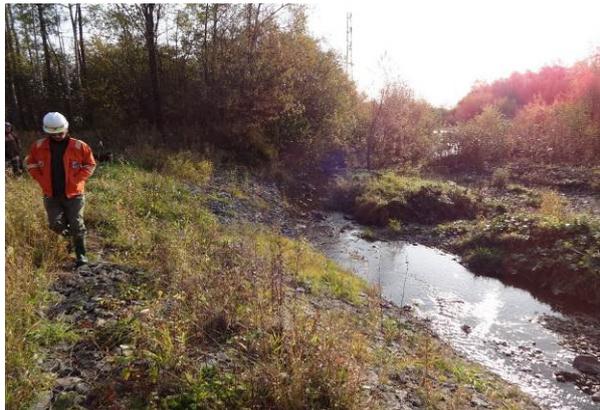
The Gastellovka River is a high energy, braided river with multiple channels. The bank of the northern channel (currently the minor channel) is well fortified against the RoW to the north with Reno mattings, which are in good condition and with vegetation growing through the mats (Photos 1 and 2).

**Photo 2** – View to the upstream of the Reno mats on the north bank of the northern channel

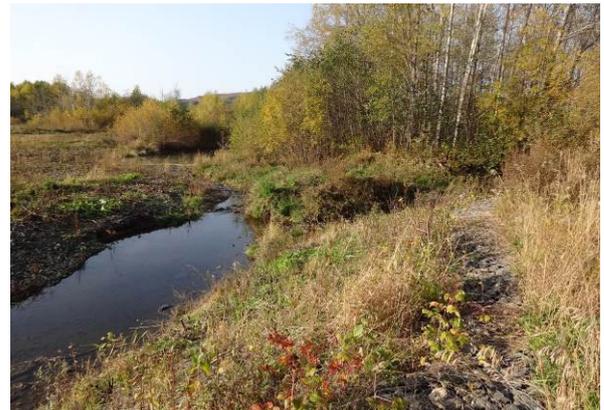
A larger channel farther to the south was not reached but Reno mats placed on the southern bank were observed from the distance (Photo 3).

**Photo 3** – View across the river showing Reno mats on the south channel banks.

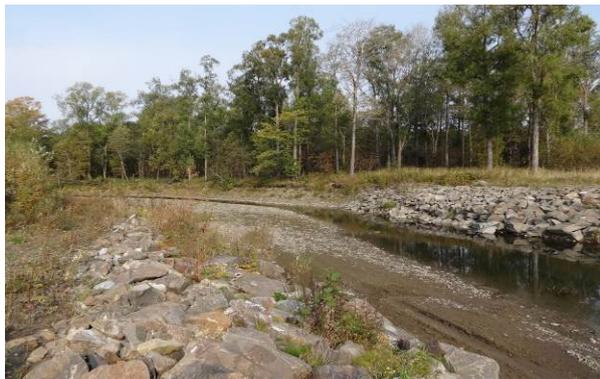
The Nitui River is a high energy, multi-channel braided river. During the October 2013 visit only the main southern channel was viewed. The southern channel was protected on both banks with good size riprap and appears to be in good condition (Photos 1 and 2).

**Photo 2** – View to the downstream showing riprap on southern channel banks

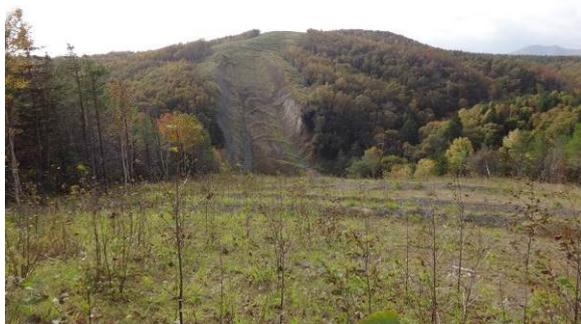
The Gar River slopes were observed from the north. The southern slope was well vegetated but with soil slippage at the lower portion. This slippage needs to be evaluated by maintenance and treated accordingly (Photo 1).

**Photo 1** – View northern slope with vegetated RoW with fortified slope breakers and with a soil slippage.

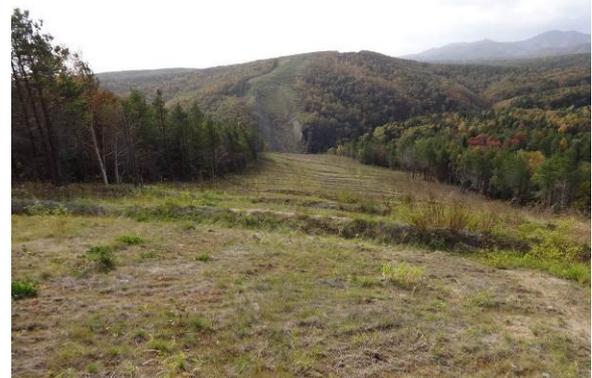
The north slope appeared to be in good condition. Good quality slope breakers, protected with geojute, were present on the northern slope. This, combined with a reasonable level of re-vegetation, affords a good level of slope stabilisation (Photo 2).

**Photo 2** – View of southern slope showing good re-vegetation on upper portions of slope

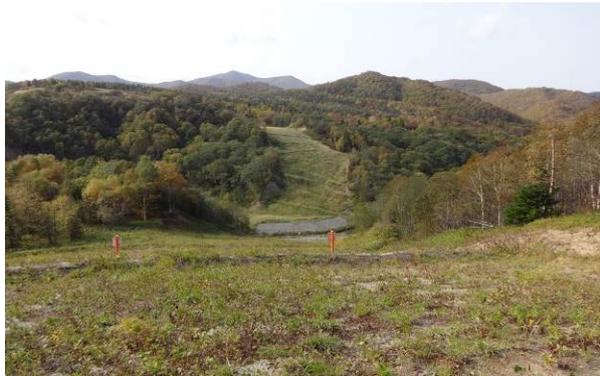
In 2012 the slope and the RoW leading to it were covered by thick growth of Alder trees/sapling some as tall as 2 meters. Since then a significant effort to remove trees was conducted on the north slope (Photos 1 to 3). However, the pruned stumps are already regenerating growth from side branches (Photo 3).

**Photo 2** – View to the south showing both slopes with good slope protection and many cut tree saplings.

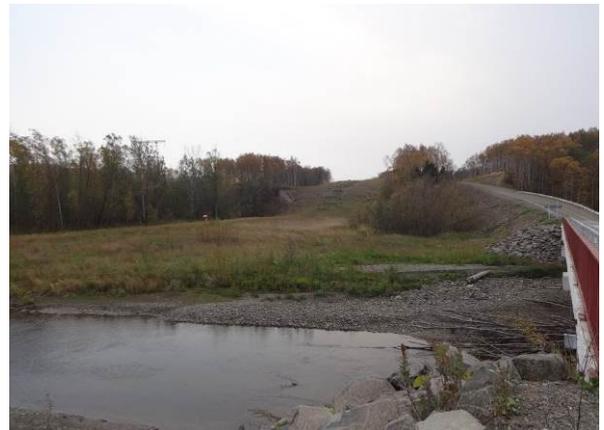
The Lazovaya river crossing is protected with Reno mats on both banks. The mats on the north bank are in good condition and the river has deposited much sediment in front the mats. The mats on the south bank are intact, but are slightly undercut by the river and should be monitored (Photos 1 to 3).

**Photo 1** – View downstream showing Reno matting on the north and slightly undercut matting on the south.

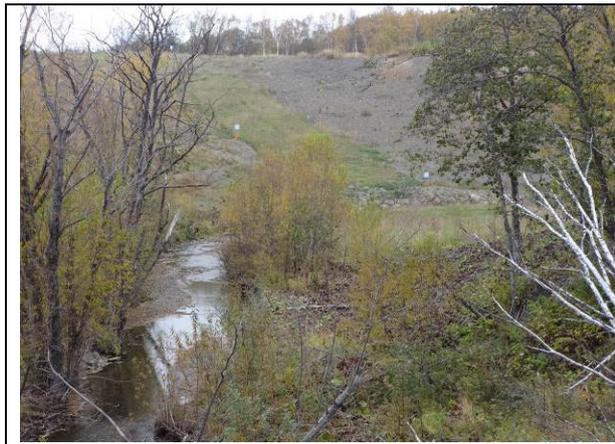
The RoW is generally well vegetated, but a large side cut on the south side east of the crossing is mostly bare of vegetation and may need to be re-seeded.

**Photo 1** – (to left) View to the downstream showing large riprap on the east bank and bare side slope east of the river.

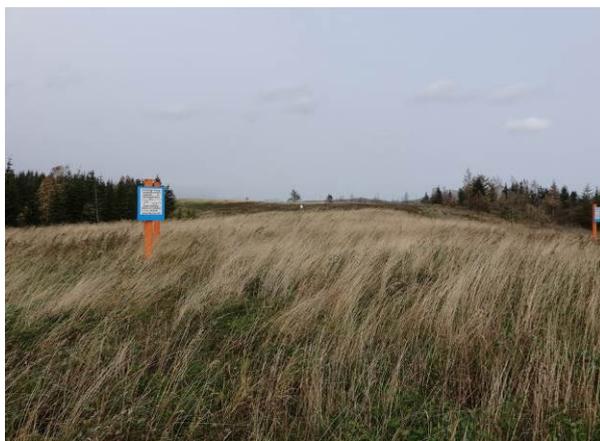
The RoW slope south of MOB 17 has good protection with many slope breakers. However, the slope has very poor vegetation cover and will need to be re-seeded (Photo 2).

**Photo 2** – View to the south past MOB 17 showing RoW slope with good slope breakers but with poor vegetation cover.

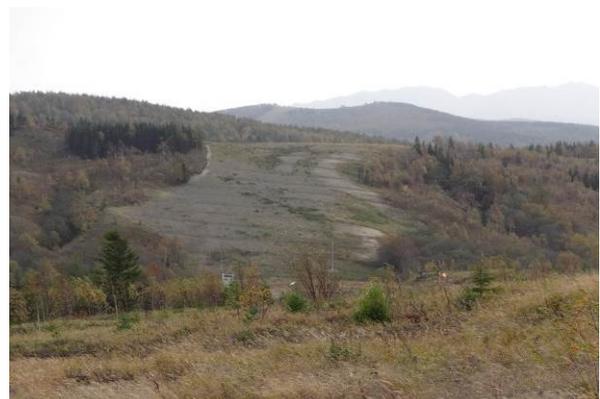
The RoW north of MOB 17 has generally good vegetation cover, which consists mostly of grass but also with a few Alder trees (Photos 1 and 2). The RoW in this area has an erosional side drain (which is quite deep and steep) on the south side of the RoW. This feature originates at the side of the RoW and could with time propagate uphill and onto the RoW, and therefore should be carefully monitored (Photo 3). In addition, in the same area there are few bald spots on the sandy RoW that show some erosional rills and should be re-seeded (Photo 4)

**Photo 3** – View of the south edge of the RoW with a deep erosional feature.

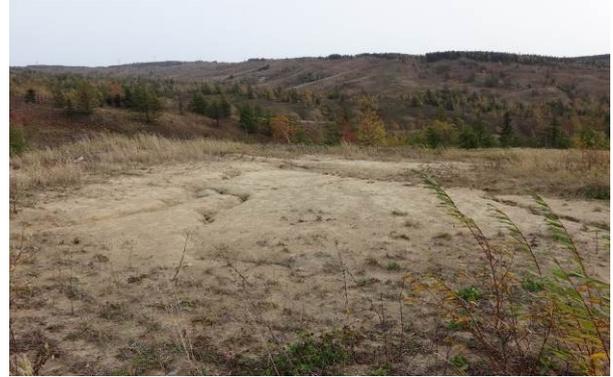
**Photo 4** – View of one of several bold spots that developed erosional rills.
