## **Annex D: Individual RoW Descriptions**

**Chaivo peninsula landfall, RoW and Pigging Station KP 71.5 – 74 and KP 0 - 4**

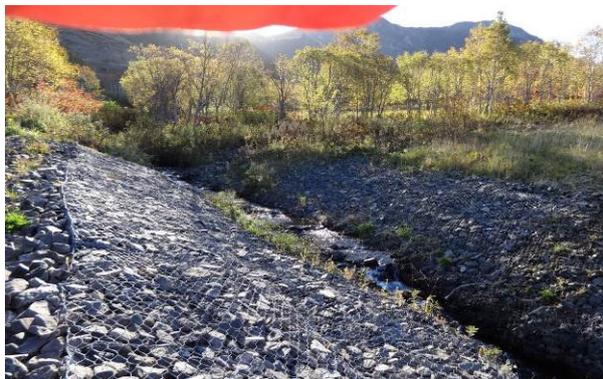
The riverbanks are protected on both sides of the river by Reno matting, and some vegetation is already establishing itself and coming up through the mats Photos 1 and 2).

The slopes on each side of the river have good vegetation cover. The south slope has a drainage channel running down the east side. The channel bifurcates towards the bottom and a separate unprotected channel splits off and flows across the RoW and into the river. This poses an erosion potential on the RoW and contributes unfiltered flow and sediments to the river itself (Photo 1 and 3).

**Photo 1** – View to the upstream showing Reno matting and vegetation

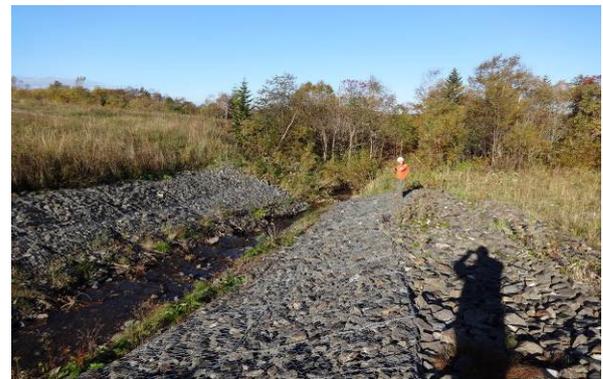
**Photo 2** – View to the downstream showing Reno matting in condition

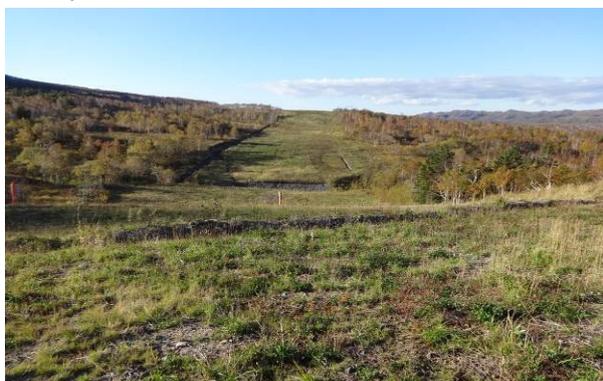
**Photo 3** – View to the south across the river showing good vegetation of the RoW. Also note the split channel to the east of the RoW.

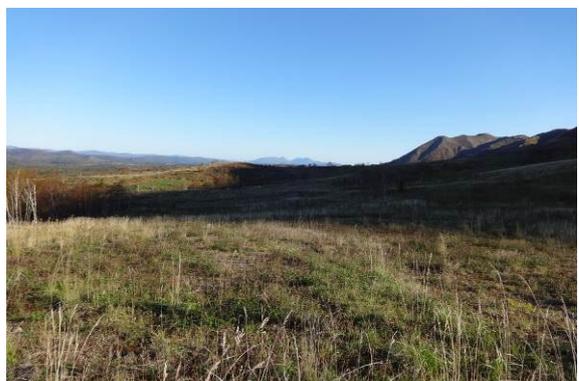
Reno mats and gabions are used as erosion protection on small seasonal drainage channels which cross the RoW north of the access road on (Photo 4).

**Photo 4** – Hard engineering of seasonal drainage channel and good vegetation cover

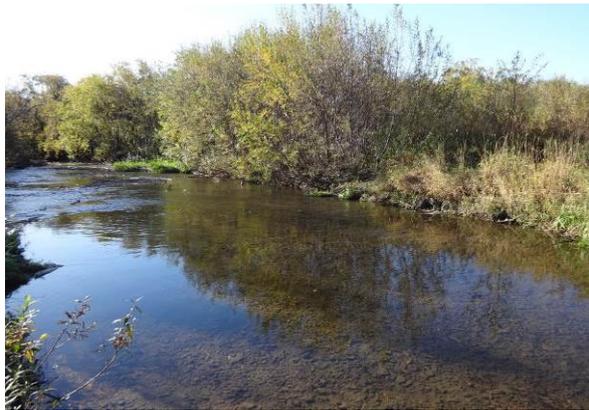
The Tikhaya River flows adjacent to the railroad and both were crossed using a horizontal thrust boring method. This resulted in undisturbed river banks which can be seen in their natural state in Photos 1 and 2).

**Photo 1** – View of riverbanks.

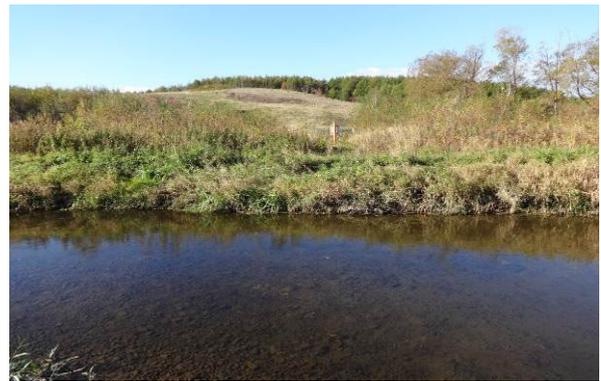
The RoW to the north and south of the river are well vegetated with grass and include some trees (Photos 2 and 3).

**Photo 2** – View south across the river and railroad.

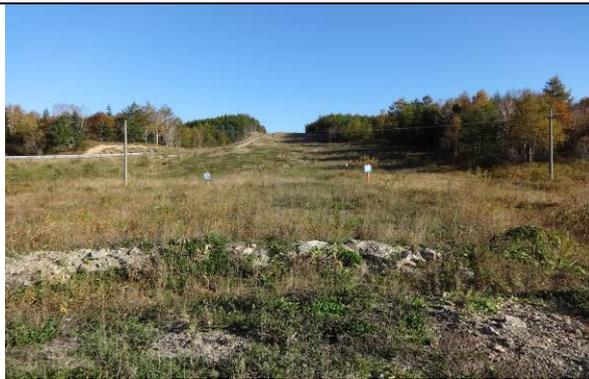
**Photo 3** – (to left) View slope to the north of the crossing

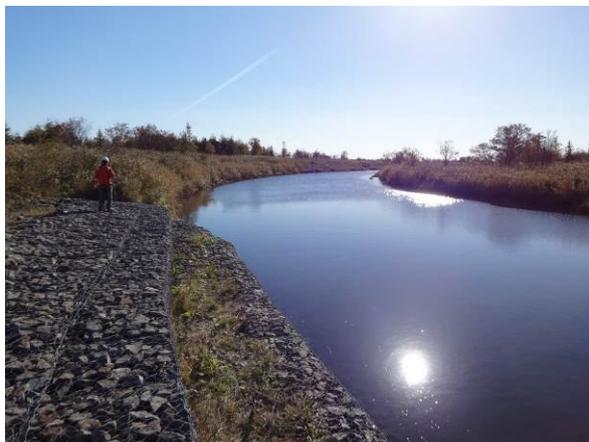
The Manui River crossing was found to be in generally good condition. The south bank is protected with gabions and Reno matting, and a gabion wall protects the north bank (Photo 1 and 2).

**Photo 1** – View downstream showing gabion wall on the north bank

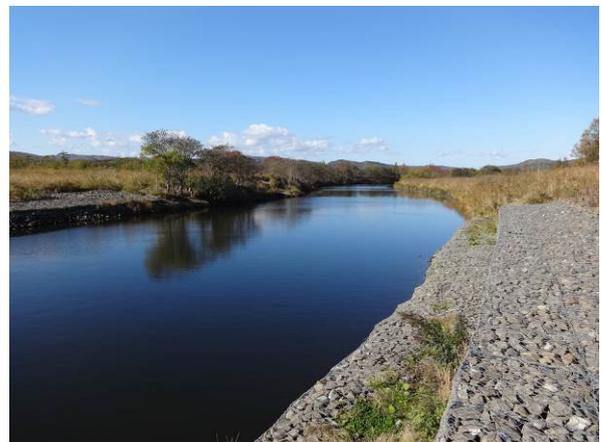
**Photo 2** – View upstream showing gabions and vegetation on the bank.

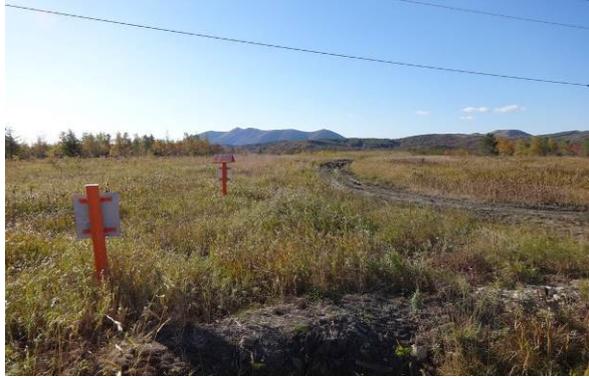
The river was visited using an access road from the north – the opposite side of the river from the wetlands area. The RoW north of the river is well vegetated but damage was observed on the RoW, which is reportedly due to the activities of the FOC contractor (Photos 3 and 4).

**Photo 3** – View to the north showing RoW with good vegetation and an access road made by FOC contractor

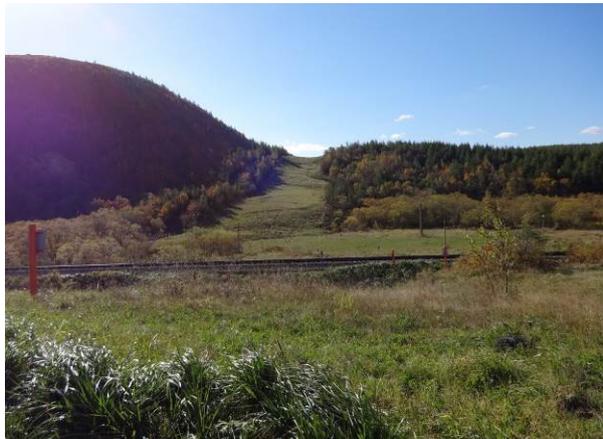
The Krasnaya River crossing has a long steep slope, which is protected by slope breakers on the south side and Reno matting protection on the banks. At the time of the visit, the slope appeared to be well vegetated and intact (Photo 1). However, (not visible on the photos) there is damage along the east side of the RoW due to the driving of a tracked vehicle – unknown by whom. Company should find out if this was done by a subcontractor (see similar situation described in the Manui River location).

**Photo 1** – View to the south showing well vegetated slope and river crossing.

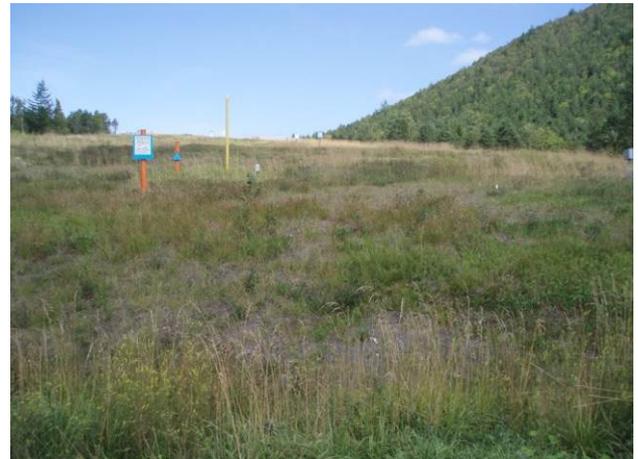
The RoW on the north side of the river and north of the railroad and federal highway is also well vegetated (Photo 2).

**Photo 2** – View to the north showing well vegetated RoW.

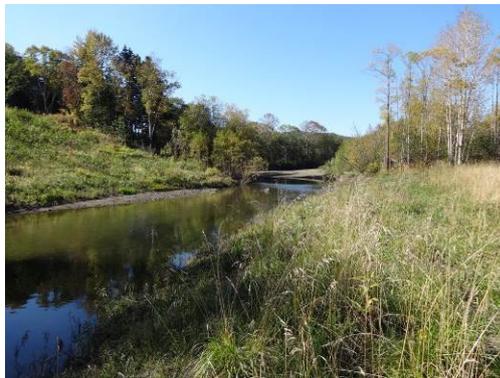
The Ai river is situated in a wide, flat valley bordered by short but steep slopes. The river crossing appears in good condition and with very well vegetated banks (photo 1). The slope south of the river appears stable and well vegetated.

**Photo 1 – View of re-vegetation of banks**

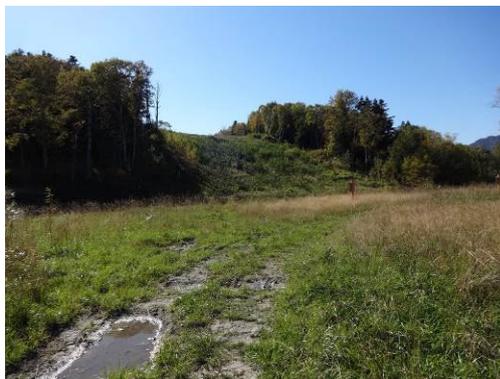
**Photo 3 – View across the river at RoW with running track leading to BVS**

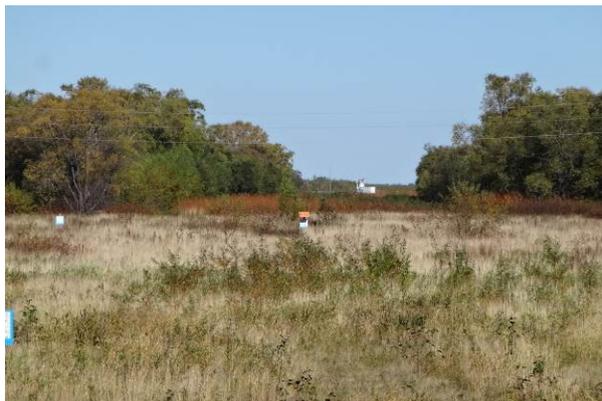
The RoW is very well vegetated both north and south of DOB 10. However, both sides contain trees and saplings of various sizes (Photos 1 and 2).

**Photo 1** - View to the north along the RoW showing grass cover and trees in the background

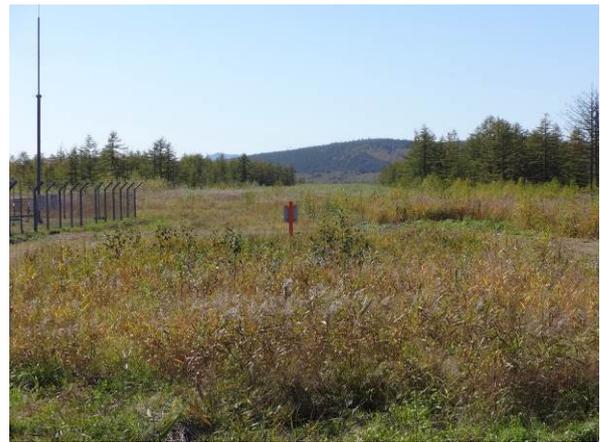
**Photo 2** – View to south from DOB 10 showing many trees growing on the RoW.

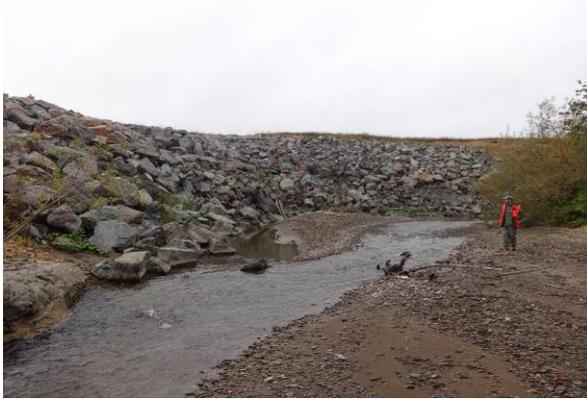
Upstream from the crossing the river has tight meander that impacts the east edge of the RoW. The company protected the meander bank from further erosion with heavy riprap wall (Photo 3). This area should continue to be regularly monitored.

**Photo 3** – View upstream from the RoW showing bank protection with large riprap.

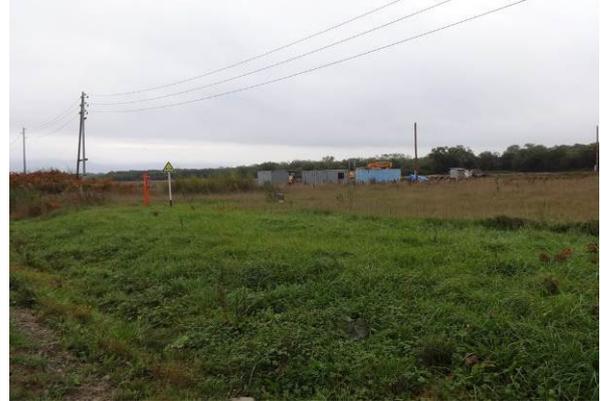
During the visit a construction activity was observed at the junction of the RoW with the public road. Reportedly this activity involved the installation of infrastructure for a new housing area.

**Photo 4** – View of the RoW to south of the access road showing well vegetated RoW and start of construction immediately adjacent to it.

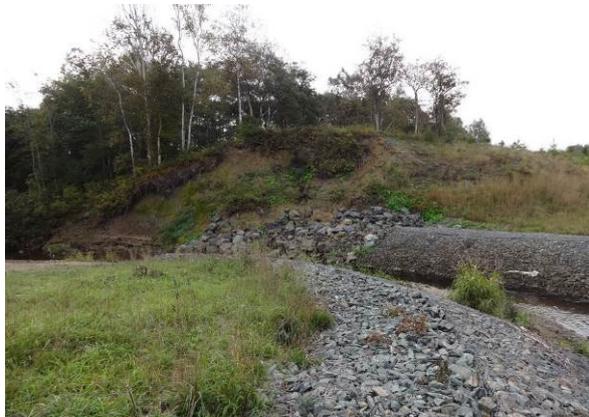
The river crossing is protected with Reno mats and riprap on both riverbanks. The mats are generally in good condition, but some undercutting by the river on the southern bank will require monitoring and potential future repair (Photos 1 and 2).

**Photo 1** – View to the river banks showing protection by Reno mats and riprap

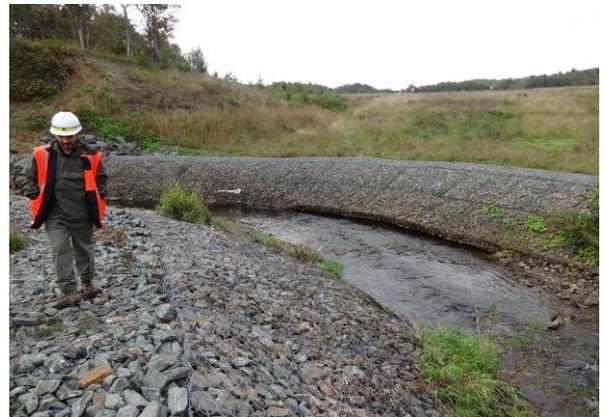
**Photo 2** – View of the southern bank showing undercutting of Reno mats at mid crossing.

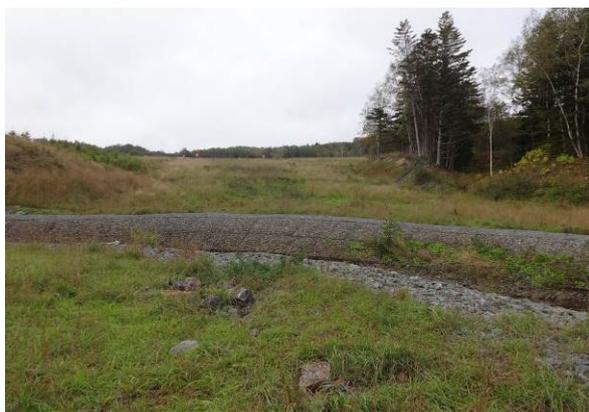
The RoW south and north of the river crossing has good vegetation cover.

**Photo 3** – View across the river at RoW with good vegetation cover

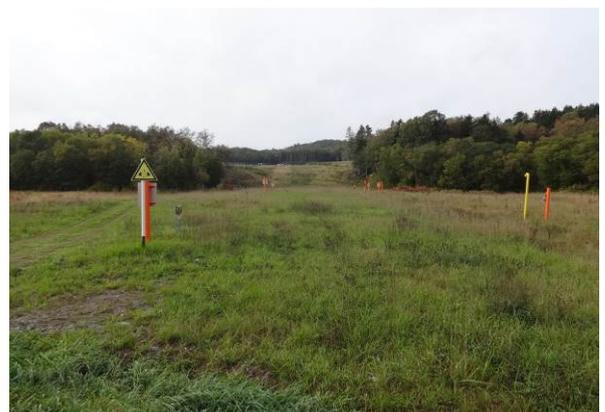
**Photo 4** – View to the north from the river showing RoW with good vegetation cover

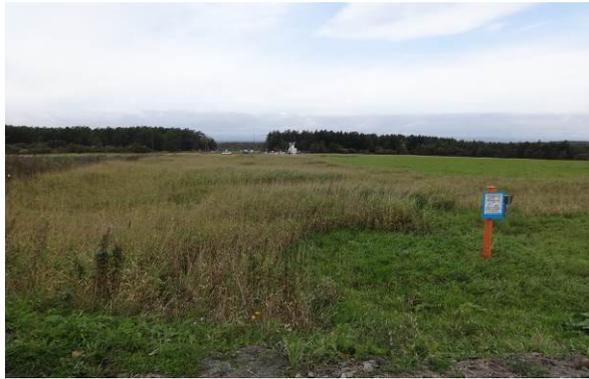
The RoW road crossing east of AOB 2 shows good vegetation on both side of the road.

**Photo 1** – View of the RoW to the west showing good vegetation cover to AOB 2 in the distance

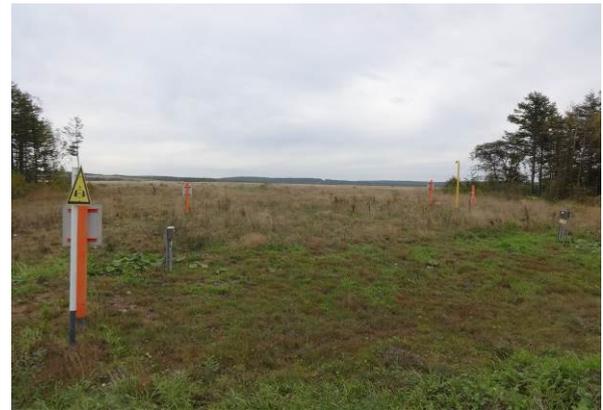
**Photo 2** – View of the RoW to the east showing good vegetation cover.

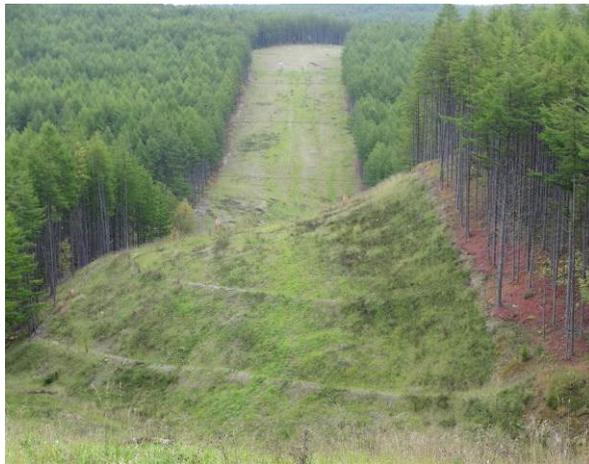
The slopes to the river are steep to both the north and south. The slopes are protected by slope breakers, which are in reasonable condition. The RoW south of the river was re-seeded and fertilized, and shows good initial growth (Photo 1). The RoW to the north shows good vegetation cover (Photo 2).

**Photo 1** – View of the slopes leading to the river showing good vegetation cover.

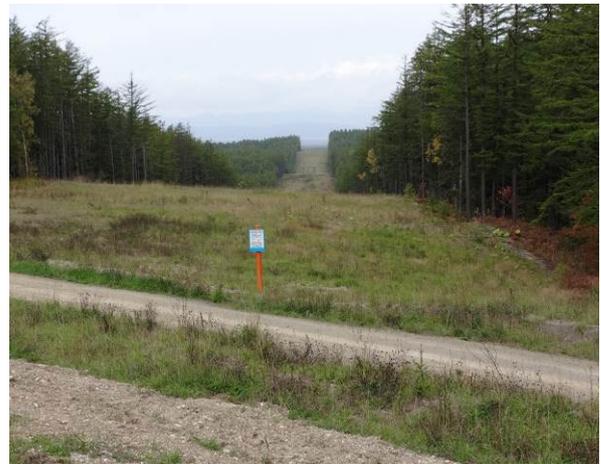
**Photo 2** – View of the RoW to the south showing good vegetation cover..

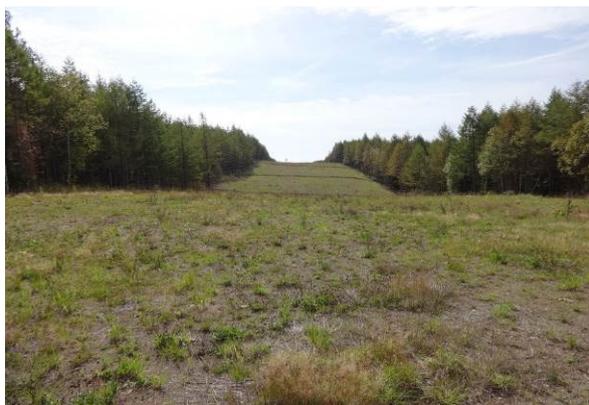
**Photo 2** – KP 607 - view to the south with good vegetation cover

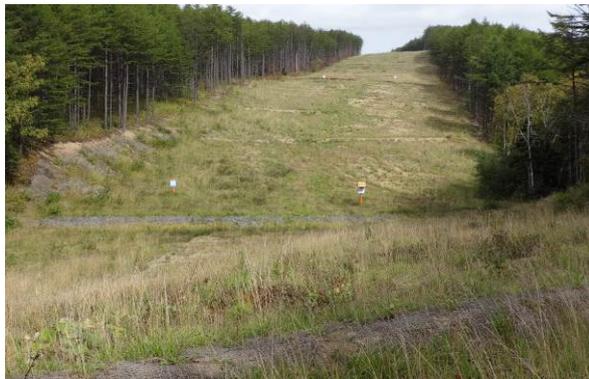
**Photo 2** – View to the south showing RoW with good vegetation cover.

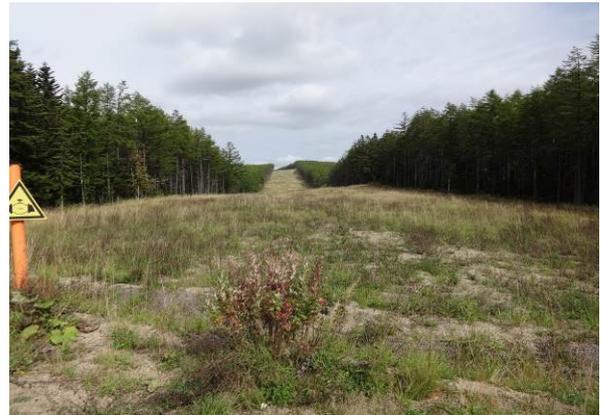
The RoW north of the road crossing is well vegetated (Photo 3).

**Photo 3** – (to left) view the south showing RoW with good vegetation cover.

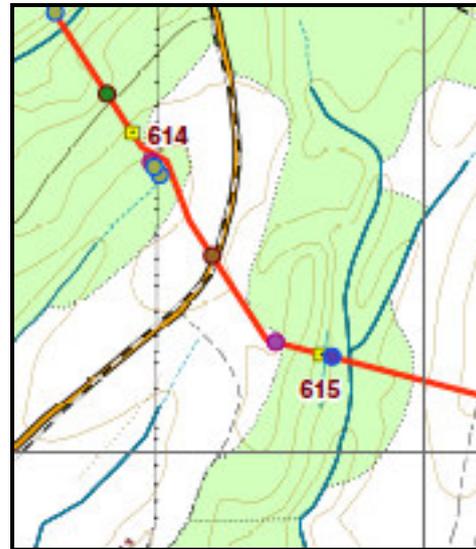
The RoW north and south of the road crossing is very well vegetated and protected with slope breakers (Photos 1 and 2).

There is evidence that the area is used by vehicle traffic and tracks are clearly visible on the RoW. Consideration should be given as to how to inhibit these types of travel on the RoW.

**Photo 1** – View to the south showing good grass cover

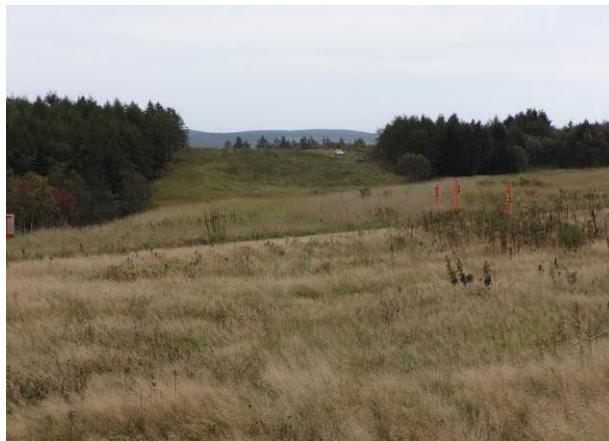
**Photo 2** – View to the north showing good grass cover.

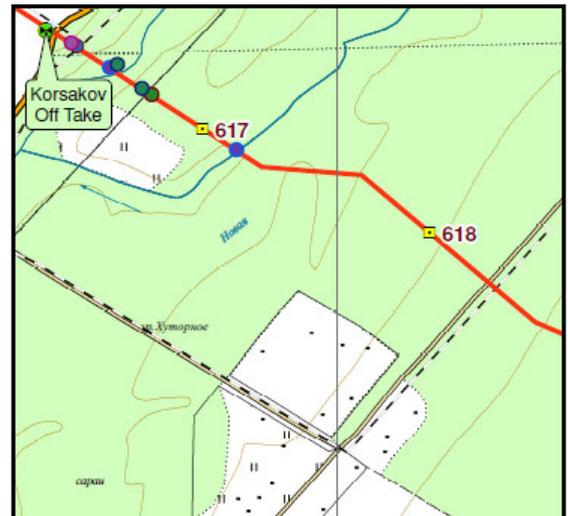
The Korsakov River was crossed using horizontal thrust bore which left the river banks largely un-impacted (Photo 1).

**Photo 1** – View south across the river showing good vegetation cover and slope breakers on the slopes.

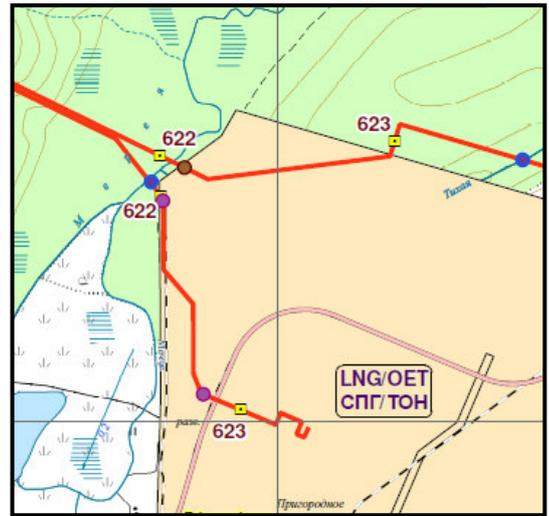
The Mereya River is crossed with two separated RoWs, one for the oil pipe and one for the gas pipe (Photos 1 and 2). Both crossings are protected with Reno matting. Although the mats are not in the best of condition, much vegetation growth has come up through the matting and the banks appear to be stable.

**Photo 1** – View to north bank on oil pipe crossing

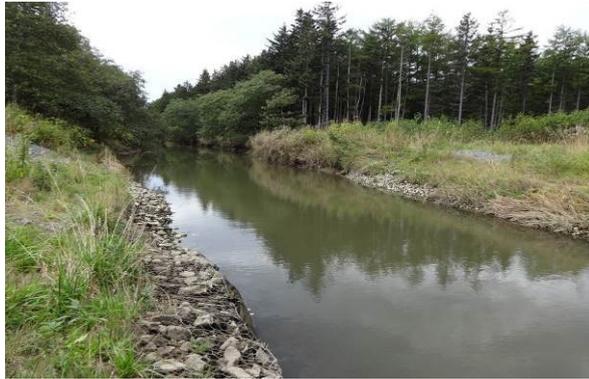
**Photo 2** – View to the north from gas pipe crossing showing well vegetated RoW

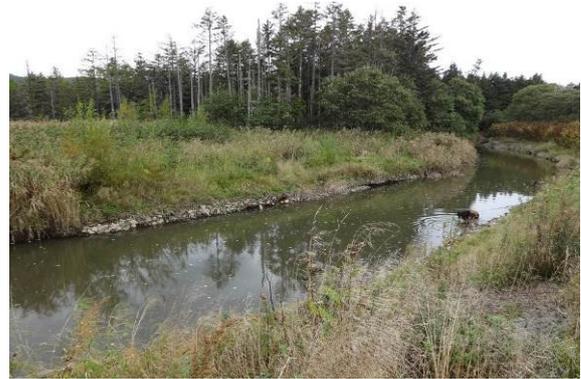
The RoW on adjacent to both river crossings is re-vegetating well (Photos 3 and 4), although some tree growth was identified that needs to be removed.

**Photo 3** – View to north bank on the oil pipe crossing

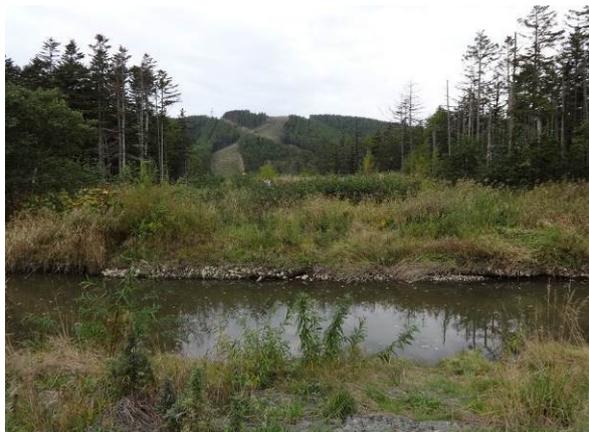
**Photo 4** - View to the south showing well vegetated RoW
